Stream Assessment Form (Form 1)

Unified Stream Methodology for use in Virginia

Project #	Project Name (Applicant)	Locality	Cowardin Class.	HUC	Date	SAR # / Data Point	Impact/SAR Length	Impact Factor	
	Martinsville Connector (VDOT)	Henry	R3	02070010	3/01/2019	A		N/A	
Name(s) of Evaluator(s)		Stream Name and Information					Stream Map		
SA, JB		Unnamed Tributary to Marrowbone Creek

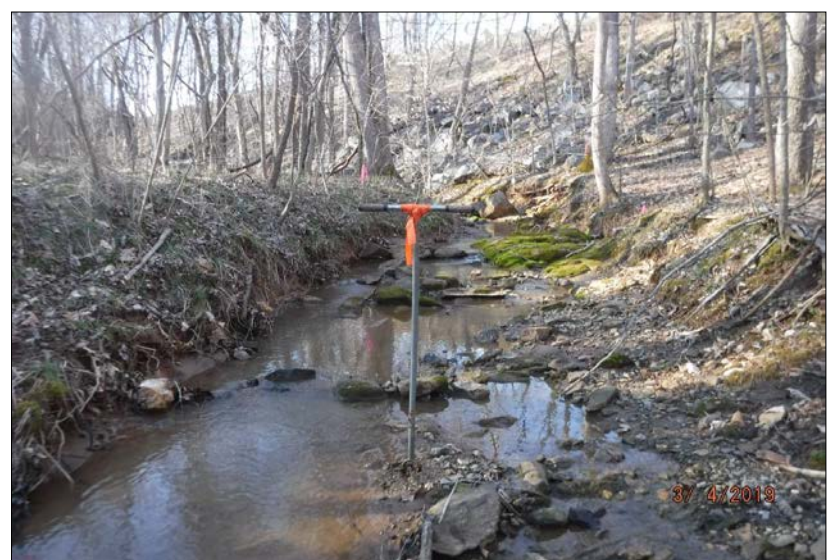
Looking upstream at Stream Reach 1-A. The reach was incised with active erosion at a culvert. The right riparian buffer consisted of 80% mature tree cover and 20% impervious surfaces associated with State Route 220. The left riparian buffer consisted of 100% mature tree cover. The instream habitat was present in 30%-50% of the reach and consisted of riffles, pools, leaf packs and substrate of various particle sizes. The channel was riprapped at the culvert upstream.

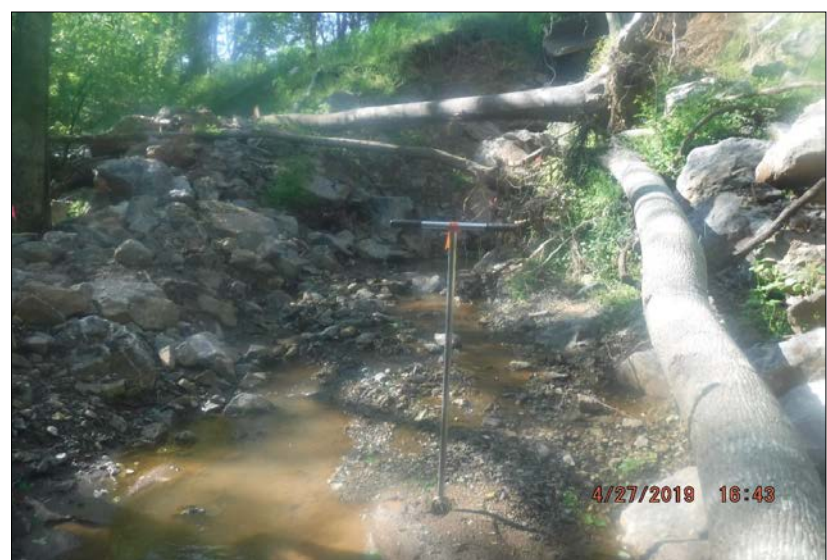
Looking upstream at Stream Reach 1-B. The stream is often incised with erosion present on both banks. The left bank riparian buffer consists of mature forest with greater than 60% tree canopy cover and impervious surfaces. The right bank consists of a wetland and mature forest with greater than 60% tree canopy cover. Instream habitat is present in less than 10% of the stream. Channel alteration is present in 60-80% of the reach from a concreted culvert and rip-rap.

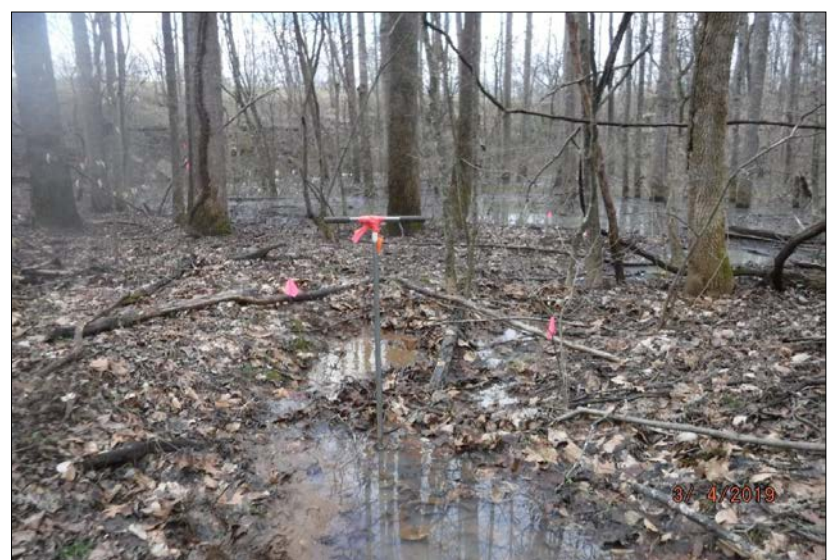
Looking downstream at Reach 3-A. The reach was level with stable banks and few areas of active erosion; however, severe aggregation is occurring within the reach due to a collapsed culvert crossing State Route 220 and associated with Reach 2-A. The riparian buffers consisted of 100% mature tree cover and wetlands. The in-stream habitat was present in less than 10% of the reach. The channel had no sign of alteration.

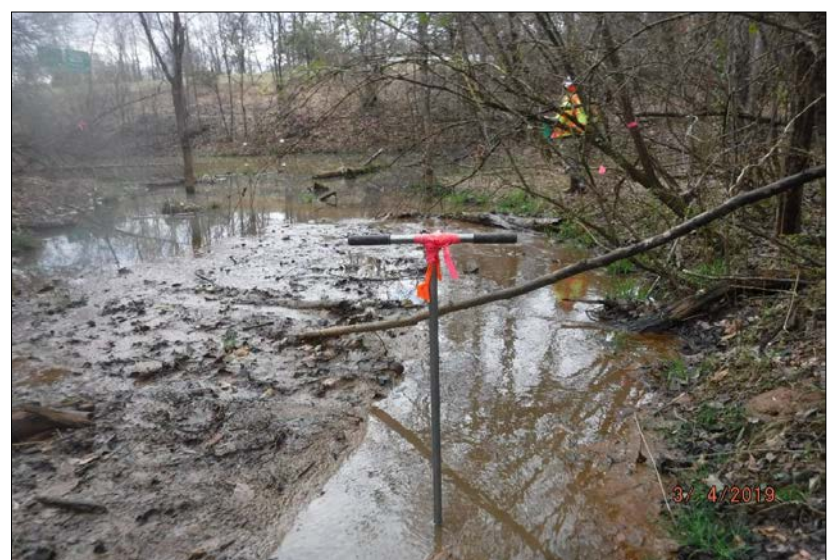
Looking downstream at Stream Reach 4-A. The reach was level with stable banks and had few areas of active erosion, however severe aggregation was present due to restricted flow at the culvert crossing near State Route 220. The riparian buffers consisted of 50% mature tree cover with wetlands and 50% impervious surface associated with State Route 220. The in-stream habitat is present in less than 10% of the reach. Channel alteration was present at a riprapped culvert.

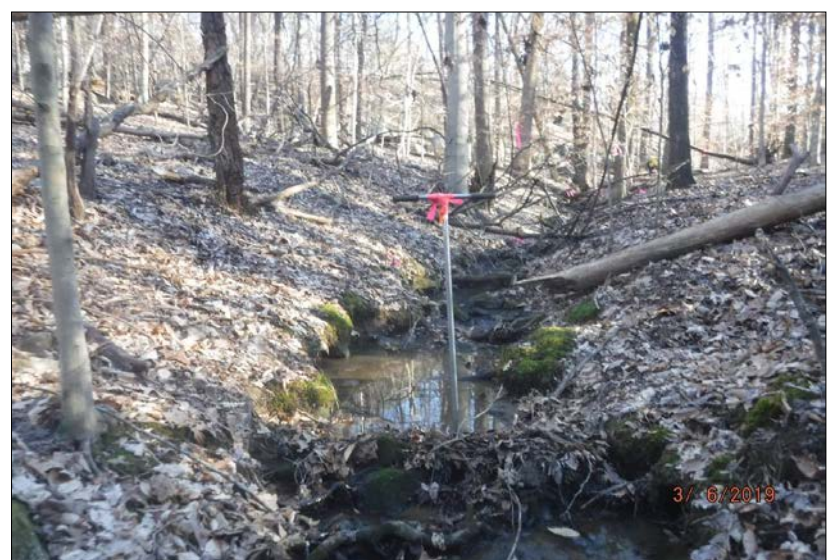
Looking upstream at Stream Reach 5-A. The reach had few areas of active erosion. The riparian buffers consisted of 100% mature tree cover. Instream habitats present in 30%-50% the reach consist of riffles, pools, leaf packs and various particle sizes with minor areas of aggregation throughout. The reach starts at a culvert stabilized with riprap.

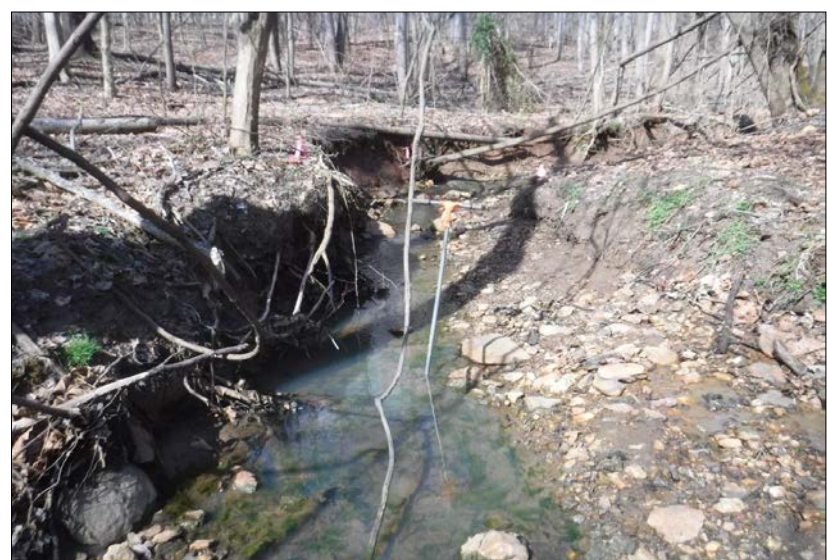
Looking upstream at Stream Reach 6-A. The reach was incised with active erosion at the culvert at the top of the reach. The riparian buffers consisted of 80% mature tree cover and 20% impervious surfaces associated with State Route 220. Instream habitat is present in 10-30% of the reach and consisted of riffles, pools, leaf packs and substrate of various particle sizes. The channel was riprapped at the culvert.

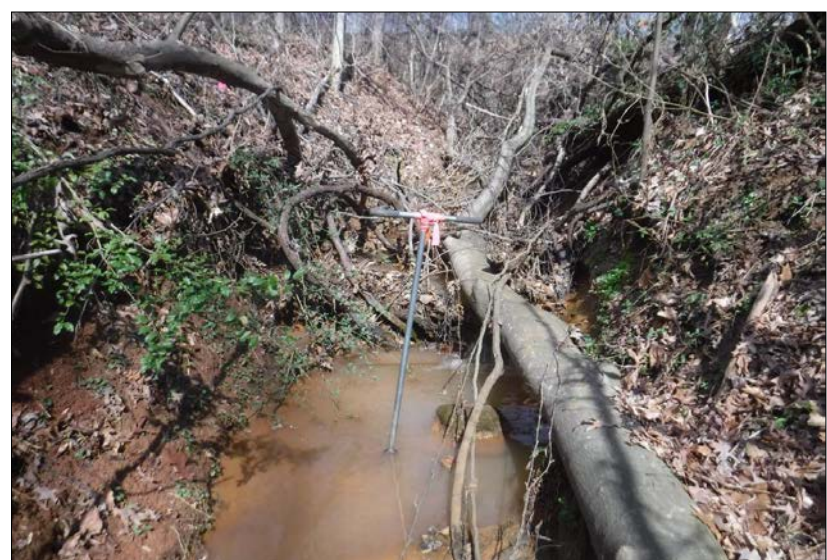
Looking upstream at Reach 7-B. The reach was incised with areas of active erosion throughout and severe aggregation in pools and areas of slow-moving water. The riparian buffers consisted of 60% mature tree cover and 40% impervious surfaces associated with State Route 220. In-stream habitat was present in less than 10% of the reach and was degraded due to severe aggregation. 60-80% of the channel was culverted under State Route 220.

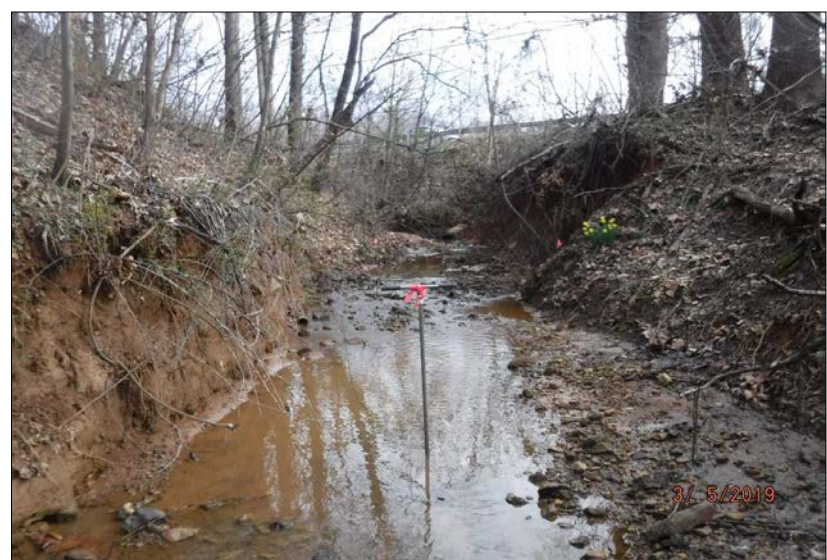
Looking upstream (northeast) at Reach 7-D. The reach was severely incised with active erosion throughout. The riparian buffers consisted of 80% mature tree cover and 20% impervious surfaces associated with State Route 220. The instream habitat throughout the reach consist of riffles, pools, leaf packs and substrate of various particle sizes, however, all habitat elements were degraded by severe aggregation. The channel was culverted under State Route 220 and riprapped at culverts.

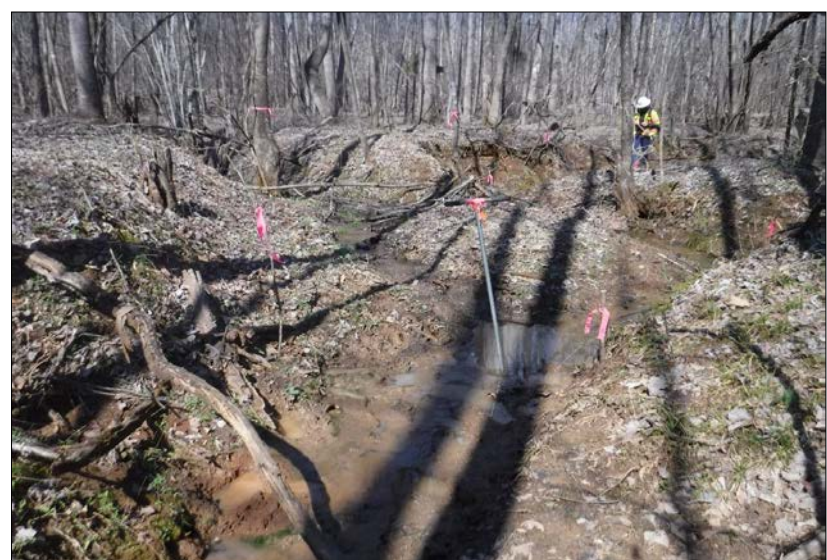
Looking upstream at Stream Reach 8-A. The reach was marginally incised with active erosion at a culvert and in a few areas of the reach. The right riparian buffer consisted of 60% mature tree cover and 40% impervious surfaces associated with State Route 220. The left buffer consisted of 90% mature tree cover and 10% impervious surfaces associated with State Route 220. In-stream habitat was present in less than 10% the reach. The channel was riprapped and channelized through a culvert.

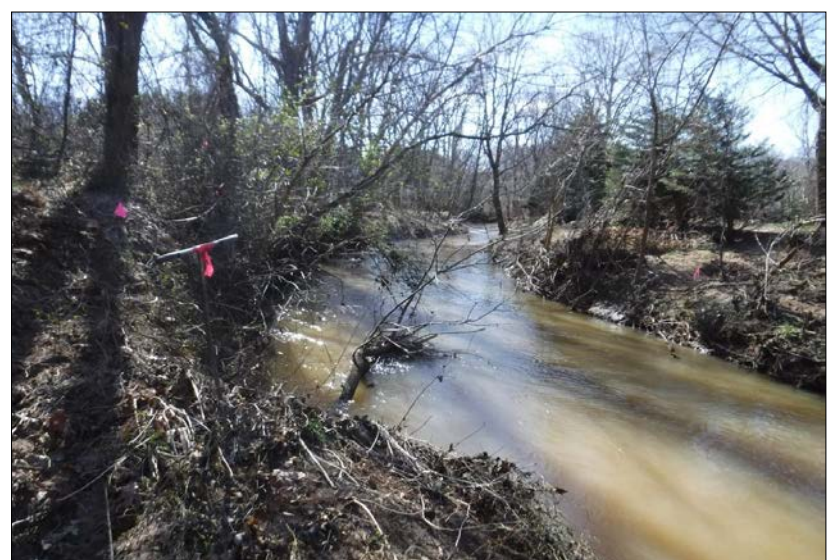
Looking upstream at Reach 10-A (Marrowbone Creek). The reach was suboptimal with stable and vegetated banks and a few areas with active erosion. The right riparian buffer consisted of 30% mature forest with wetlands and 70% non-maintained herbaceous areas. The left riparian buffer consisted of 95% maintained residential lawns and 5% impervious surface associated with parking lots and roads. The in-stream habitat consisted of riffles, pools, leaf packs and various particle sizes, however, the stream was degraded by aggregation and pollution. The reach was riprapped and channelized through culverts.

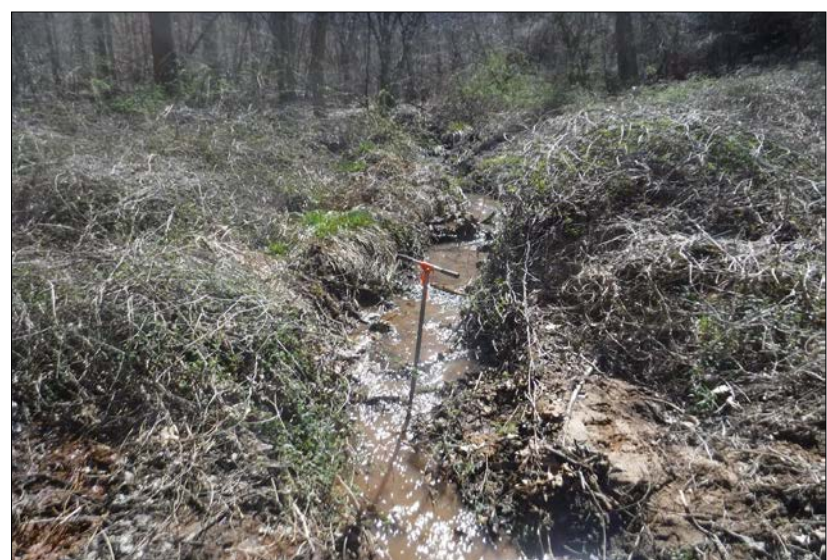
Looking upstream at Reach 11-A. The reach channel was marginal with stable and vegetated banks with some areas of erosion. The riparian buffers consisted of impervious surfaces associated with State Route 220 and forested areas with an immature forest/shrub canopy. The in-stream habitat was degraded by severe aggregation. The reach was channelized and riprapped at a culvert under State Route 220.

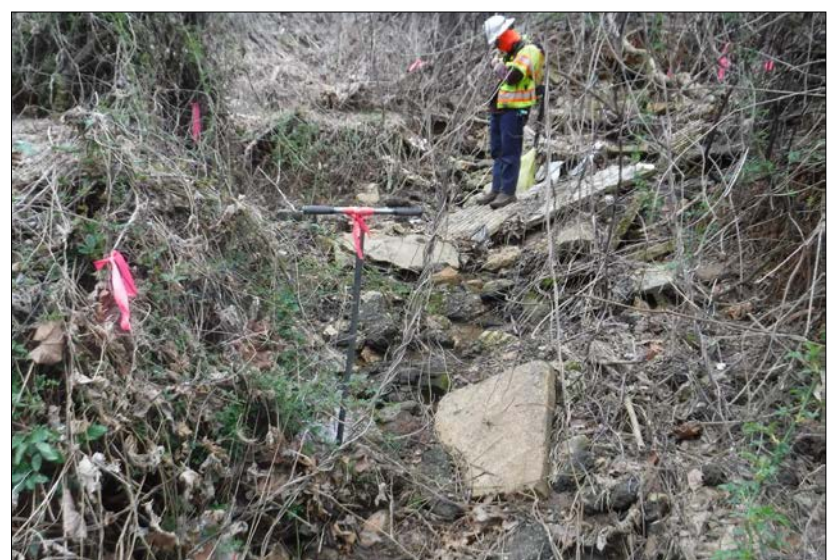
Looking upstream at Stream Reach 14-A. The reach was poor with frequent, active erosion throughout. The right riparian buffer consisted of 45% mature tree cover, 15% non-maintained herbaceous vegetation, and 40% impervious surfaces associated with State Route 220. The left riparian buffer consisted of 55% mature tree cover, 5% non-maintained herbaceous vegetation, and 40% impervious surfaces associated with State Route 220. The in-stream habitat was degraded by severe erosion. The reach was channelized through culverts.

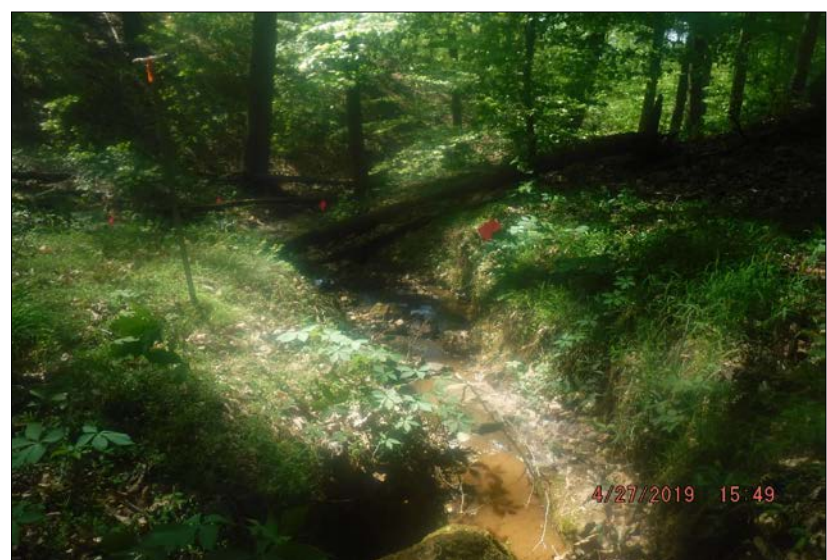
Looking downstream at Stream Reach 15-B. The stream is slightly incised and a majority of stable banks with 60-80% vegetative surface protection. The left and right bank riparian buffers consist of mature forest with greater than 60% tree canopy cover. Instream habitat is present in less than 10% of the stream. No channel alteration is present within the stream.

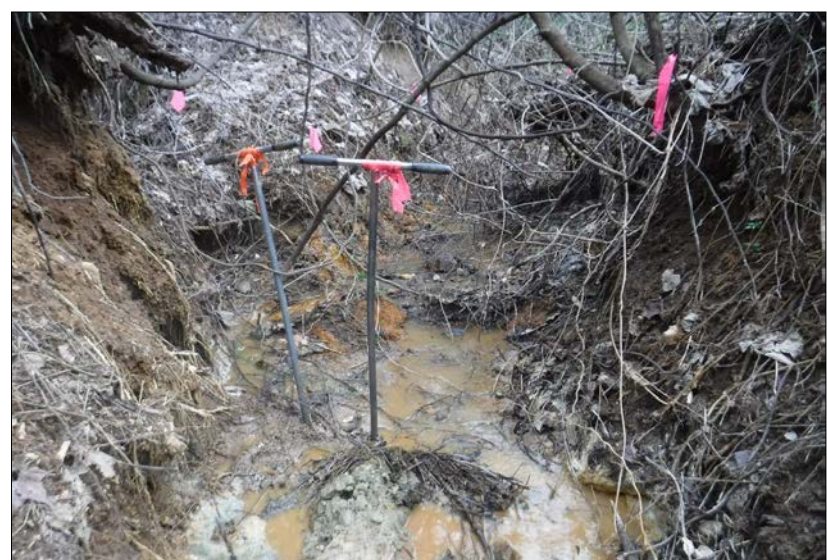
Looking upstream at Reach 17-A. The reach was severely incised with frequent, active erosion throughout. The riparian buffers consisted of 85% mature tree cover and 15% impervious surfaces associated with State Route 220. The in-stream habitat was degraded by severe aggregation. The reach was channelized riprapped at a culvert.

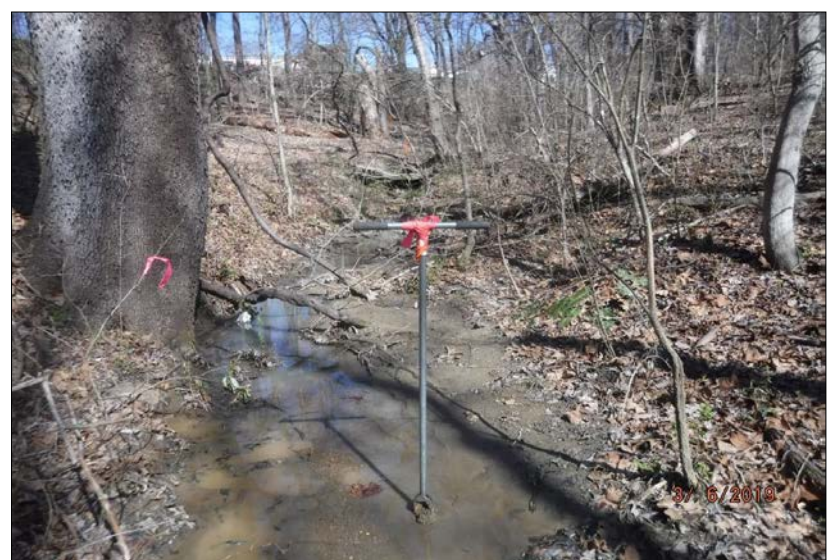
Looking upstream at Stream Reach 18-A. The reach channel was poor with sediment covering a large portion of the bed. The riparian buffers consist of 20% impervious surface associated with State Route 220 and 80% mature forested areas. In-stream habitat was present and consisted of riffles, pool, head-cuts and leaf packs, however, the reach was degraded by aggregation. The reach was channelized through a culvert and was riprapped for stability.

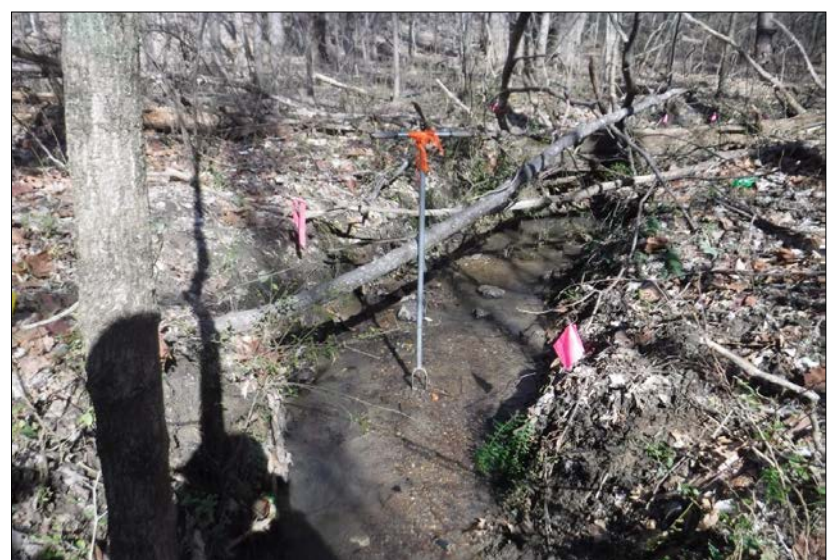
Looking upstream at Stream Reach 20-A. The reach channel was marginal with areas of active erosion and aggregation. The riparian buffers consist of 100% mature forested areas with wetlands. Instream habitat was present in 10-30% of the reach with many areas degraded by aggregation. The reach showed no signs of alteration.

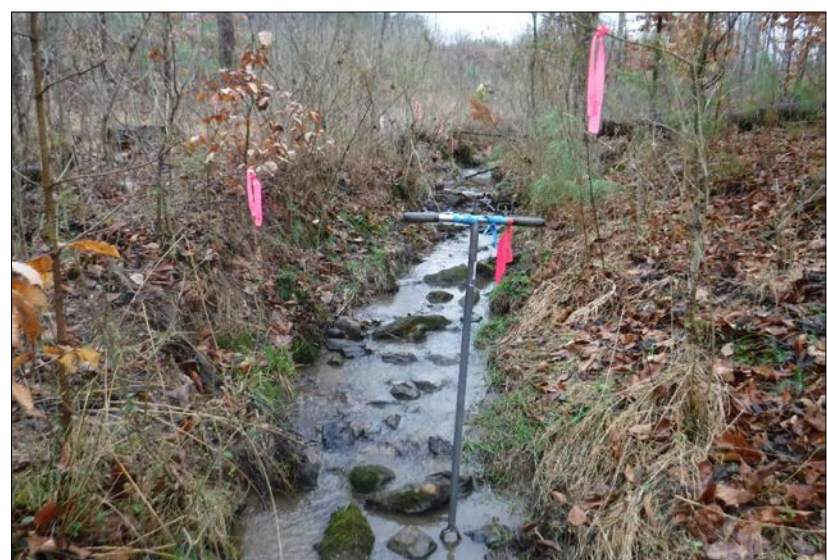
Looking upstream at Reach 21-A. The reach was marginal with some active erosion throughout. The riparian buffers consisted of 10% mature tree cover and 90% non-maintained shrub/tree layer. The in-stream habitat consisted of riffles, pools, leaf packs, varied particle sizes, and head-cuts. The reach had no signs of alteration.

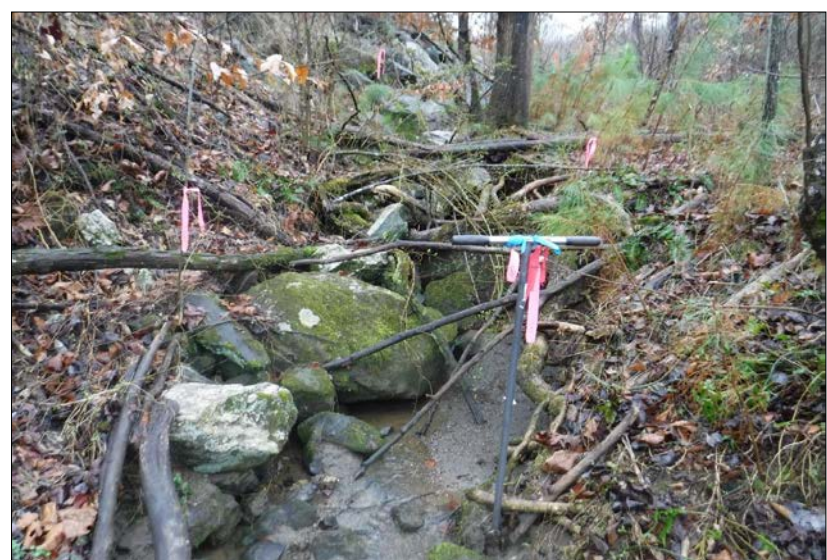
Looking upstream at Stream Reach 21-B. The reach was marginal with some active erosion throughout. The right riparian buffer consisted of 30% mature tree cover and 70% non-maintained shrub/tree layer. The left riparian buffer consisted of 100% non-maintained shrub/tree layer. Instream habitat was present 10-30% of the reach and consisted of riffles, pools, leaf packs, substrate of varied particle sizes, and head-cuts, however, the reach was degraded by aggregation.

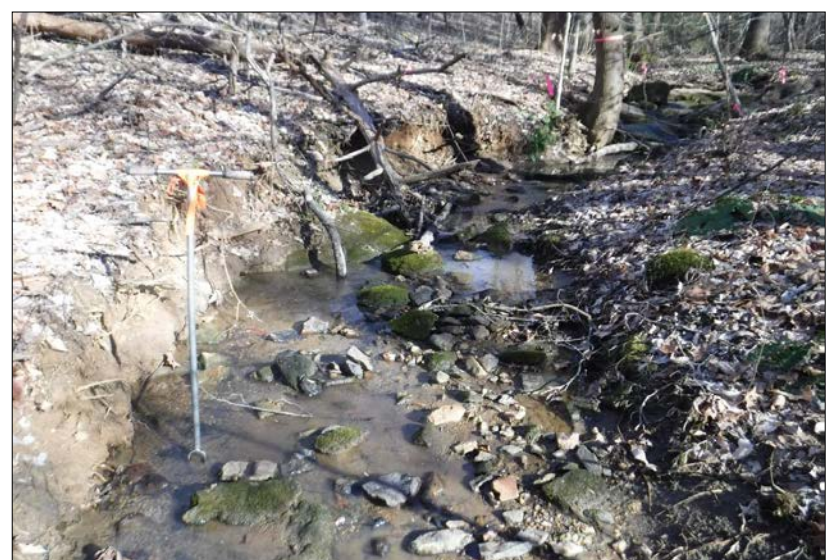
Looking upstream at Stream Reach 22-A. The reach channel was marginal with common areas of active erosion and sever aggregation. The riparian buffers consist of 100% mature forested areas. Instream habitat was present in 30-50% of the reach and consisted of riffles, pools, head-cuts, leaf packs, and substrate of varied particles sizes. The reach showed no signs of alteration. The reach showed no signs of alteration.

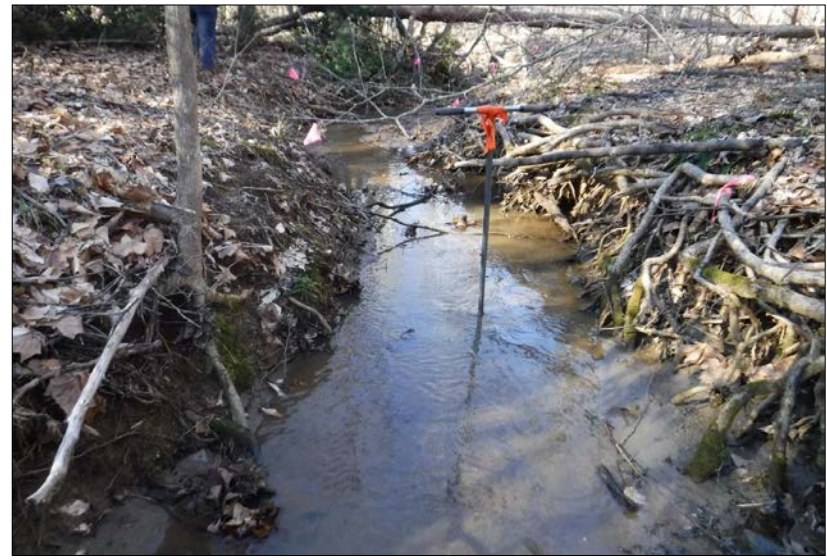
Looking upstream at stream reach 22-B. The reach channel was marginal with areas of active erosion and frequent aggregation. The right riparian buffer consisted of 100% mature forested areas. The left riparian buffer consisted 85% mature forested areas and 15% impervious surfaces associated with State Route 220. Instream habitat was present in 10-30% of the reach. The reach showed no signs of alteration.

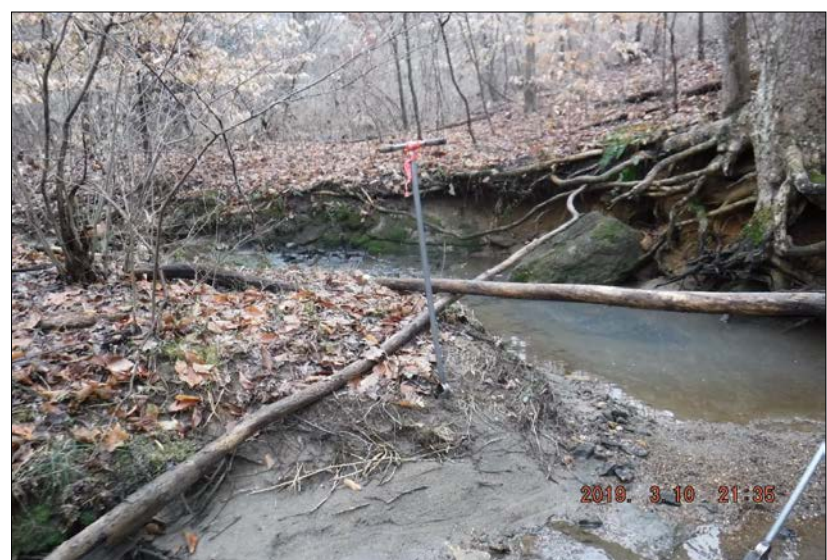
Looking upstream at stream reach 23-A. The reach was incised with active erosion throughout. The right riparian buffer consisted of 100% mature tree cover. The left riparian buffer consisted of 100% mature tree cover. Instream habitat was present in 30-50% of the reach. The reach was channelized through culvert at the top of the reach.

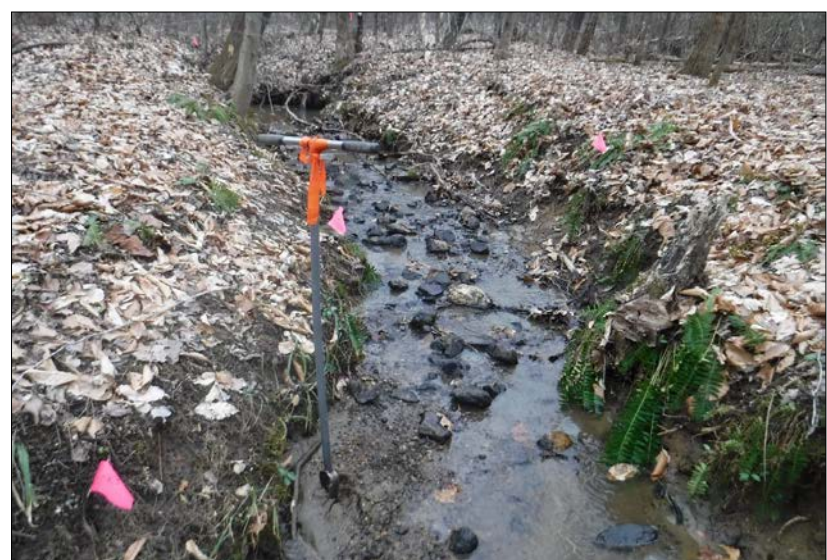
Looking upstream at stream reach 24-B. The reach was marginal with some active erosion throughout. The right riparian buffers consisted of 100% mature tree cover. Instream habitat was present in 30-50% of the reach and consisted of riffles, pools, leaf packs, substrate of varied particle sizes, and head-cuts.

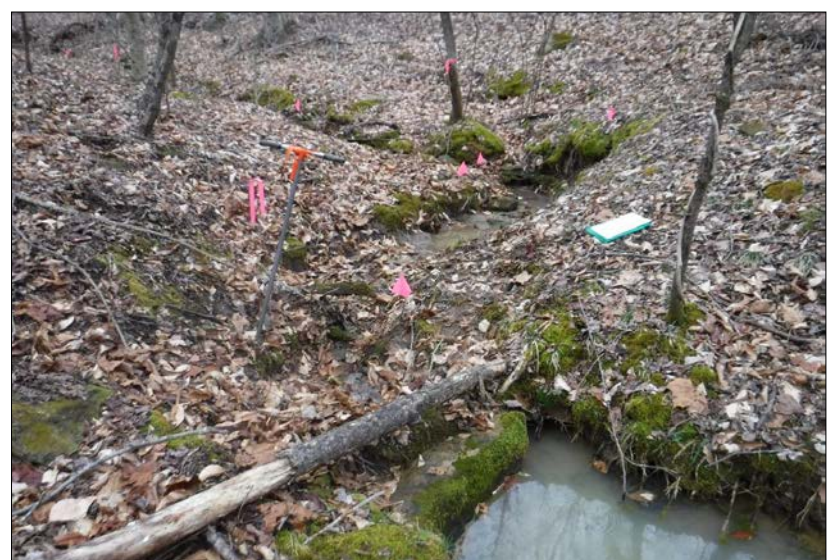
Looking upstream at stream reach 27-A. The reach was suboptimal with level and stable banks with minor areas of active erosion. The riparian buffers consisted of 100% mature forested areas. Instream habitat was in present in 10-30% of the reach. The channel had no signs of alteration.

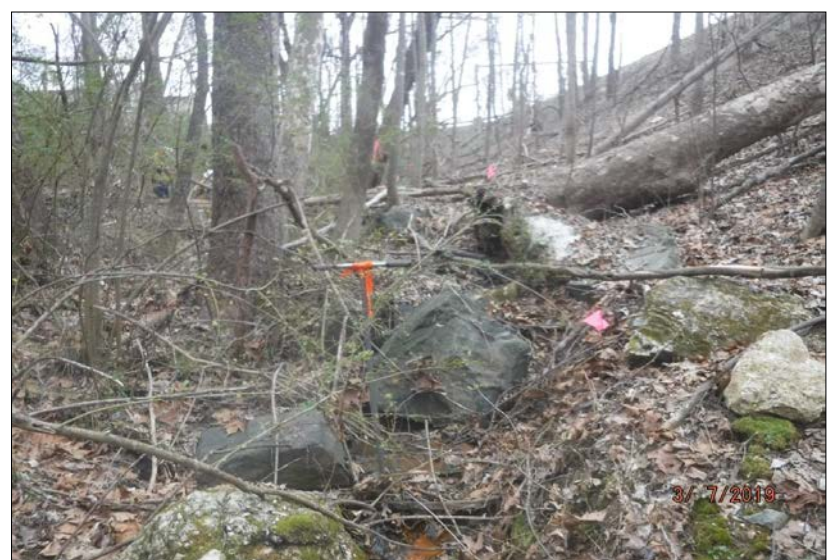
Looking upstream at stream reach 28-A. The reach channel had stable banks but had areas of frequent aggregation. The riparian buffers consist of 50% impervious surface associated with State Route 220, 50% mature forested areas with an unmaintained understory. Instream habitat was present in 10-30% of the reach and consisted of riffles, pools, and head-cuts. The reach was degraded by frequent aggregation. The channel was riprapped at the top of the reach.

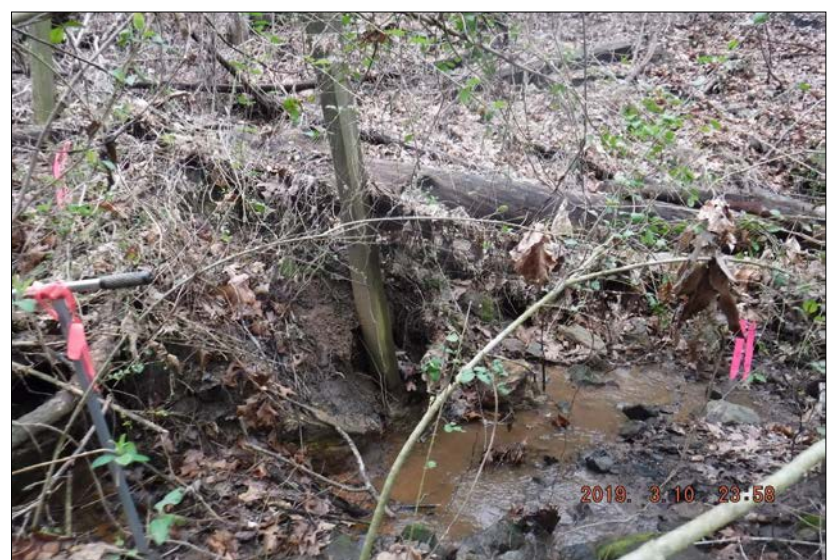
Looking downstream at stream reach 30-A. The reach was marginal with some areas of active erosion throughout. The riparian buffer consisted of 100% mature forested cover. Instream habitat present in 30-50% of the reach and consisted of riffles, pools, leaf packs, substrate of varied particle sizes, and head-cuts. The reach was channelized through culverts and stabilized with riprap.

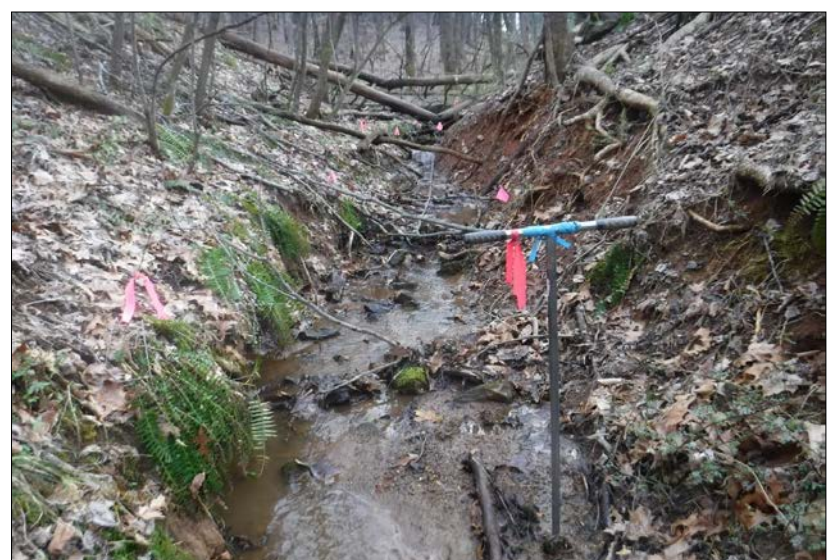
Looking upstream at stream reach 31-B. The reach was poor with frequent areas of active erosion. The right riparian buffer consisted of 100% mature forested areas. The left riparian buffer consisted of 30% mature forested areas and 70% impervious surfaces. The in-stream habitat consisted of riffles, pools, leaf packs, and head-cuts, however, the reach was degraded by aggregation. The reach was channelized through a culvert.

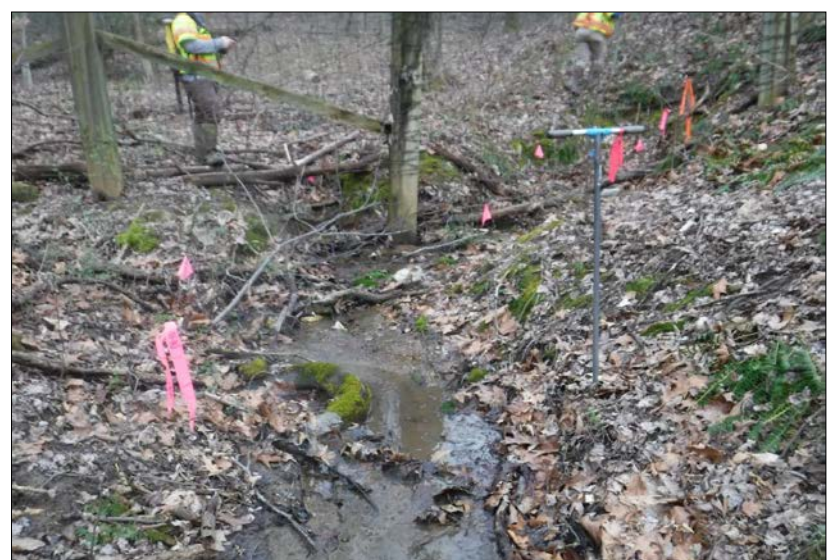
Looking upstream at stream reach 32-A. The reach was marginal with vegetated banks and some areas of active erosion. The riparian buffers with 100% mature forested areas. Instream habitat was present in 10-30% of the reach and consisted of riffles, pools, leaf packs, and head-cuts. The reach was channelized through a culvert at the bottom of the reach.

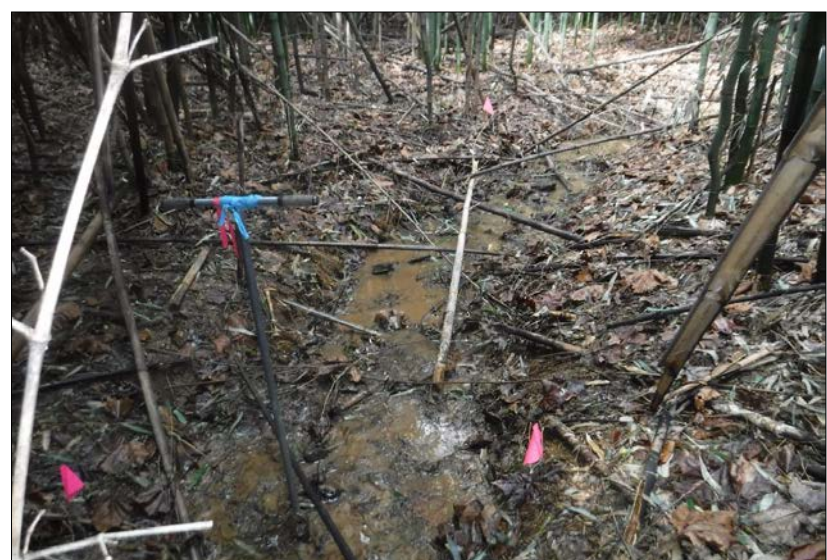
Looking downstream at stream reach 36-A. The reach was marginal with some areas of active erosion. The riparian buffers consisted of 75% non-maintained herbaceous areas and 25% impervious surfaces associated with State Route 220. Instream habitat was present in less than 10% of the reach. The reach was channelized through a culvert at the top of reach.

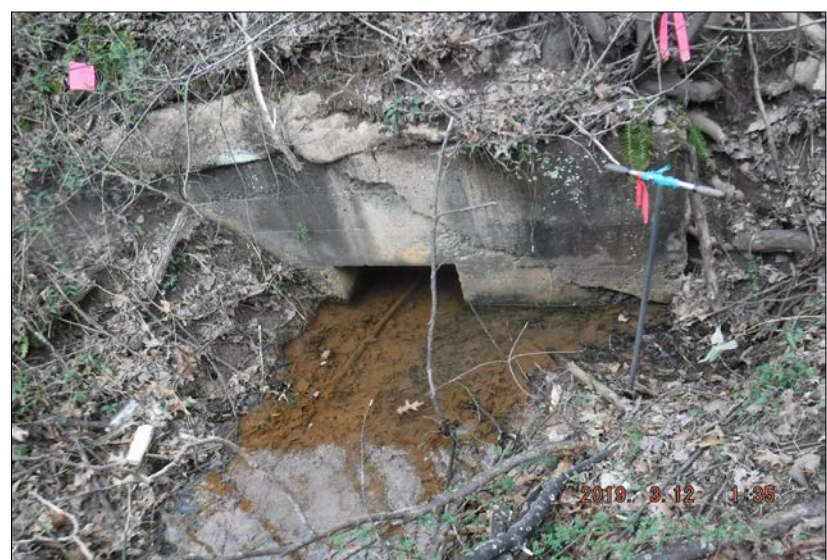
Looking downstream at stream reach 39-A. The reach was poor with frequent areas of active erosion. The riparian buffers consisted of 70% mature forested areas, 20% maintained lawns, and 10% non-maintained densely vegetated herbaceous areas. Instream habitat was present in less than 10% of the reach. The reach was channelized through a culverts.

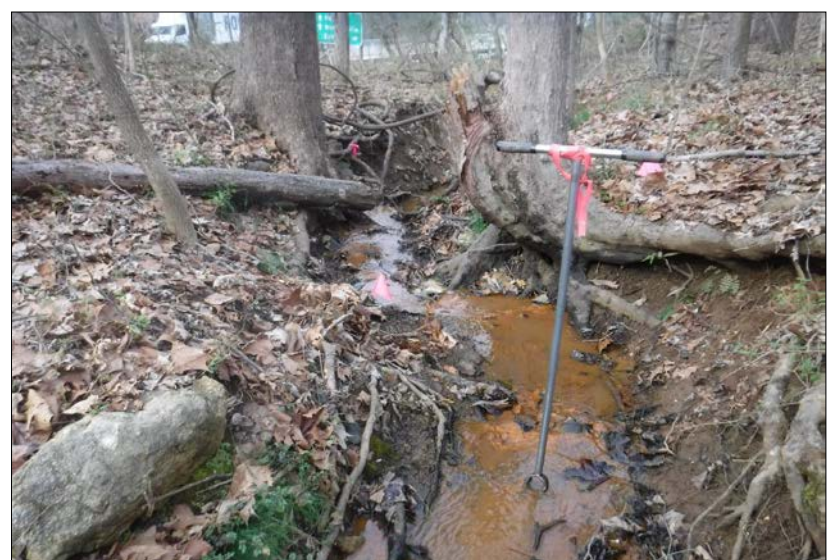
Looking downstream at stream reach 39-B. The reach channel was marginal with some areas of active erosion throughout. The riparian buffers consisted of 90% mature forested cover and 10% impervious surface associated with State Route 220. Instream habitat was present in less than 10% of the reach. The reach was channelized through culverts and stabilized with riprap at the top and bottom of the reach.

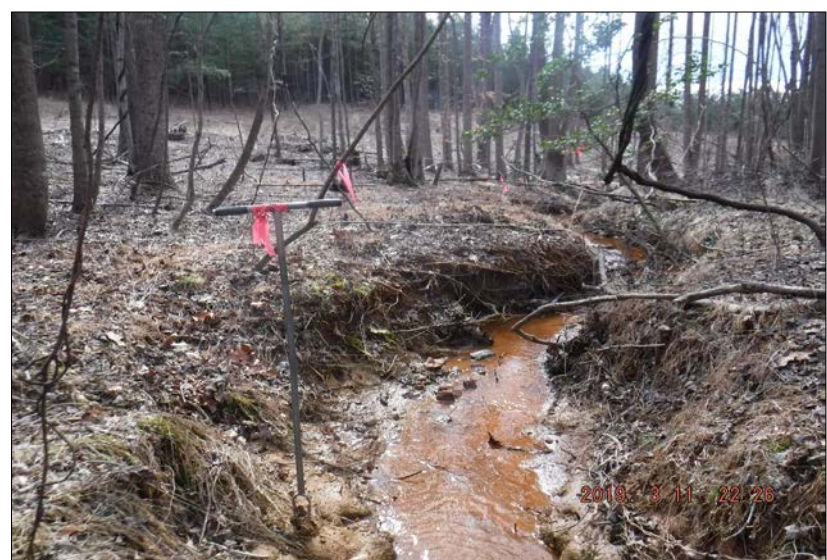
Looking downstream at stream reach 39-C. The reach was poor with frequent areas of active erosion. The right riparian buffers consisted of 90% mature forested areas and 10% impervious surfaces associated with State Route 220. The left riparian buffer consisted of 40% mature forested and 60% non-maintained herbaceous vegetation. Intream habitat was present in less than 10% of the reach and degraded by severe aggregation and active erosion. The reach was channelized through a culvert at the top of reach.

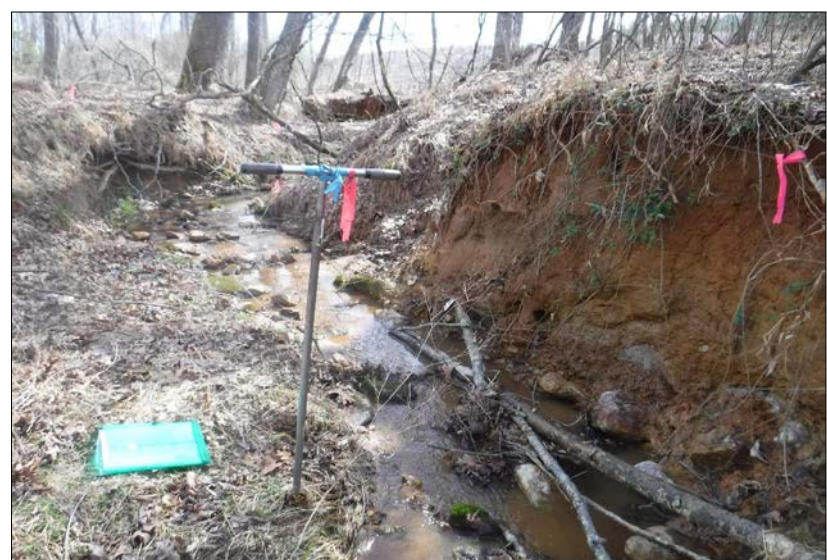
Looking downstream at stream reach 40-A. The reach was poor with frequent areas of active erosion. The riparian buffers consisted of 25% mature forested areas and 75% impervious surfaces associated with State Route 220. Instream habitat was present in less than 10% of the reach and consisted of riffles, pools, leaf packs, and head-cuts, however, the reach was degraded by severe aggregation and active erosion. The reach was channelized through a culvert.

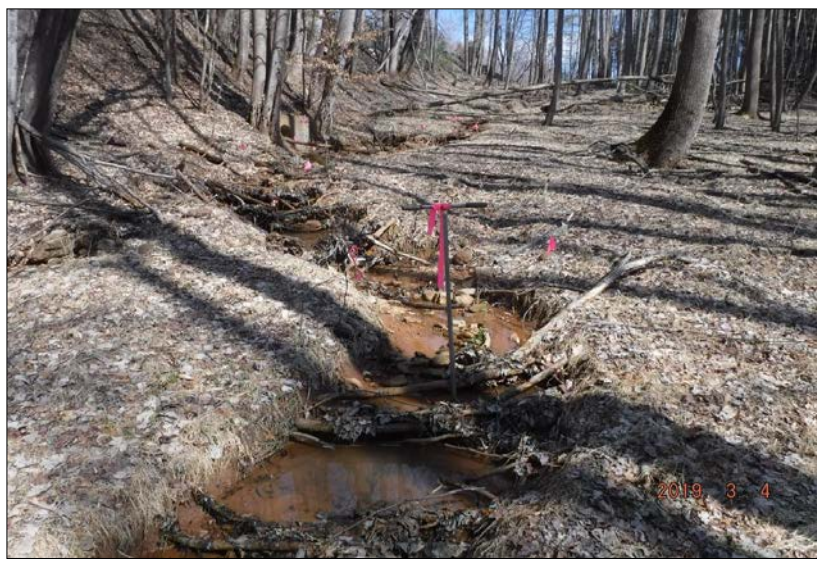
Looking upstream at stream reach 41-A. The reach had eroded banks with vegetation present. The right riparian buffer consisted of 65% mature tree cover, 30% maintained herbaceous vegetation and 5% impervious surface associated with State Route 220. The left buffer contained 75% mature tree cover and 25% maintained herbaceous vegetation. Instream habitat was suboptimal with stable elements in 30-50% of the reach. No channel alterations was present in the reach.

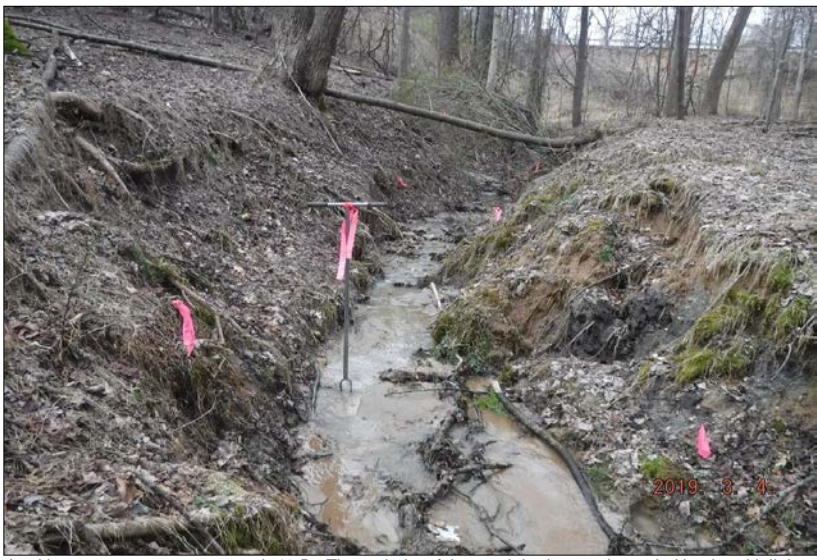
Looking upstream at stream reach 43-B. The majority of the reach had severely eroded banks with little vegetative protection present. The right and left riparian buffers consisted of 98% and 95% cover by forest with greater than 60% canopy cover, respectfully, which included fringe wetlands. The remaining riparian buffers on both banks consisted of non-maintained dense herbaceous vegetation. The in-stream habitat was suboptimal with stable elements within 30-50% of the reach, and channel alterations occurred near State Route 220.

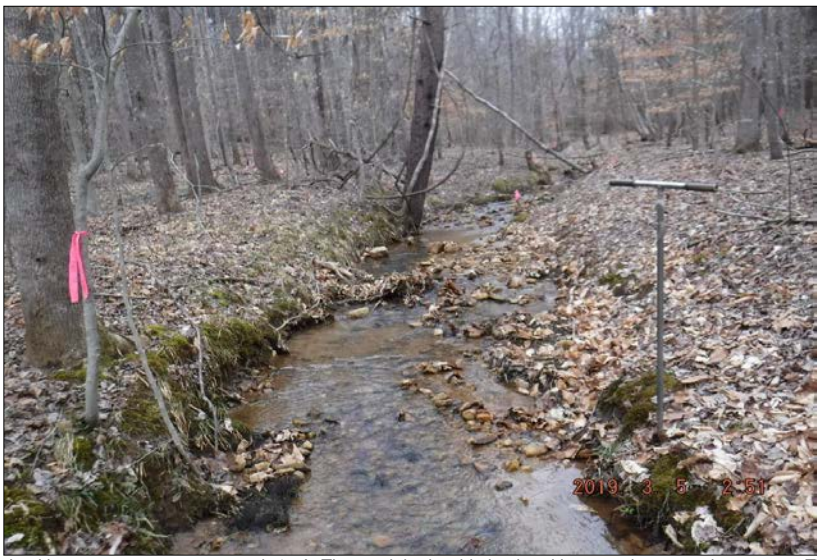
Looking upstream at stream reach 45-A. The reach had stable banks with vegetative protection present. The right and left riparian buffer consisted of 100% mature forest containing wetlands. The in-stream habitat was optimal with stable elements in greater than 50% of the reach.

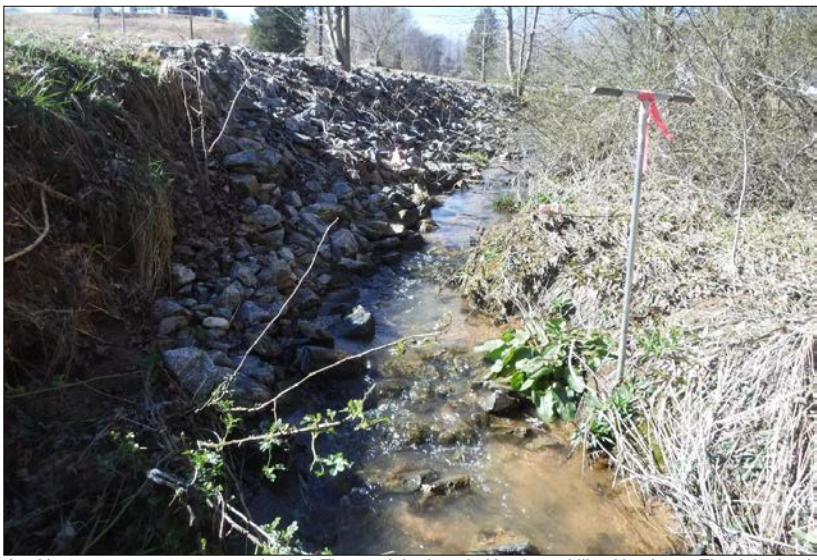
Looking upstream at stream reach 48-F. The reach had eroded banks stabilized by riprap. The right riparian buffer consisted of 80% maintained herbaceous vegetation, 2% impervious surface and 18% mature forest cover. The left buffer consisted of 85% mature forest cover and wetlands, 5% dense shrub and herbaceous vegetation and 10% maintained herbaceous vegetation. The in-stream habitat was optimal and contained various substrate sizes. Channel alterations include riprap, culverts and debris in stream.

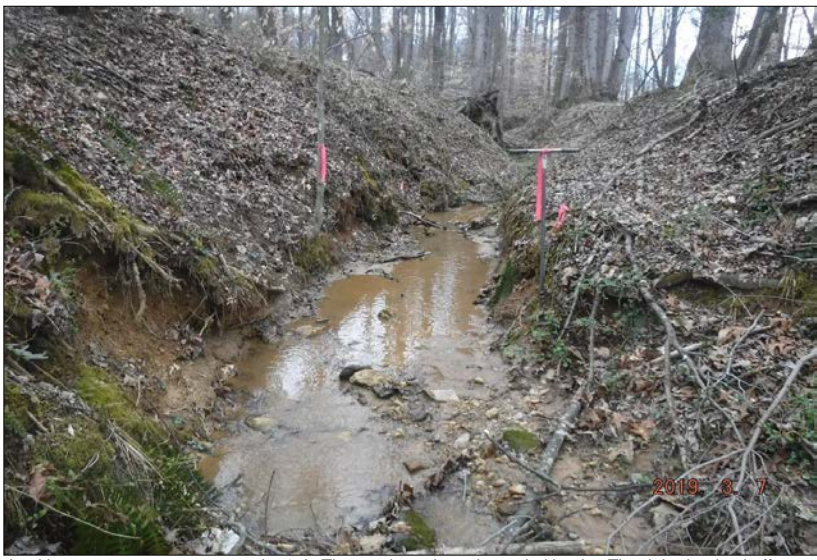
Looking upstream at stream reach 50-A. The reach moderately eroded banks. The right riparian buffer consisted of 10% maintained lawn and 90% forest with >60% canopy cover. The left buffer consisted of 10% forest with >60% canopy cover and 90% maintained lawn. The instream habitat was suboptimal with stable elements in 30-50% of the reach. No channel alteration was present in this reach.

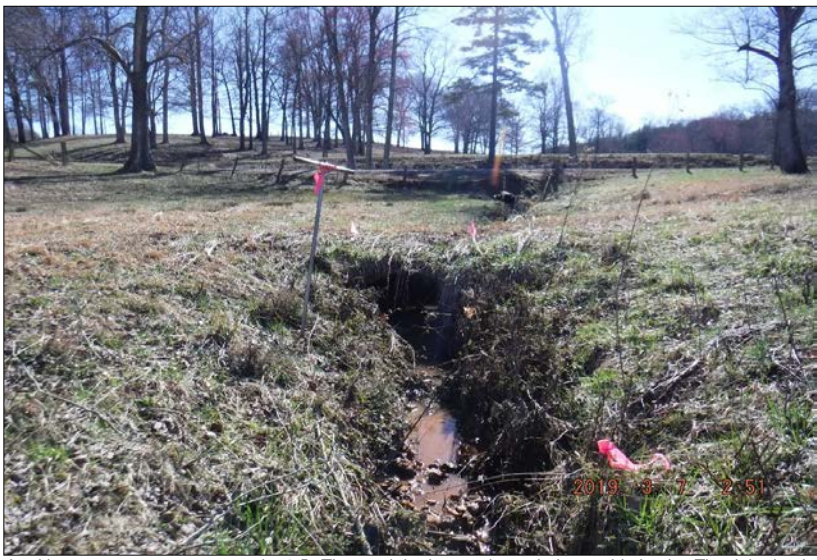
Looking upstream at stream reach 52-B. The reach had severely eroded, unstable banks. The right riparian buffer consisted of 55% maintained pasture, 15% impervious surface and 30% wetland. The left riparian buffer consisted of 90% maintained pasture and 10% wetland. The in-stream habitat was poor and lacked stable elements. Channel alterations were severe and included multiple culverts, straightening of channel and impacts from livestock.

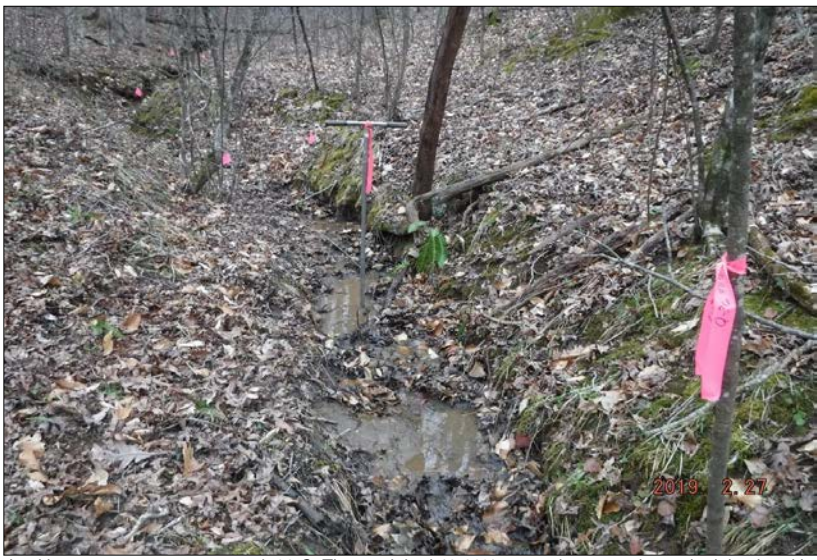
Looking upstream at stream reach 90-C. The reach had 40-60% vegetative protection on both banks with transient sediment and moderate erosion. The right riparian buffer consisted of 75% mature forest cover and 25% mature forest cover with 30 to 60% canopy cover. The left buffer consisted of 80% mature forest cover and 20% mature forest cover with 30 to 60% canopy cover. In-stream habitat elements were lacking, and no channel alterations were observed.
