Stream Assessment Form (Form 1)

Unified Stream Methodology for use in Virginia

Project #	Project Name (Applicant)	Locality	Cowardin Class.	HUC	Date	SAR # / Data Point	Impact/SAR Length	Impact Factor	
	Martinsville Connector (VDOT)	Henry	R3	02070010	3/01/2019	A		N/A	
Name(s) of Evaluator(s)		Stream Name and Information					Stream Map		
SA, JB		Unnamed Tributary to Marrowbone Creek

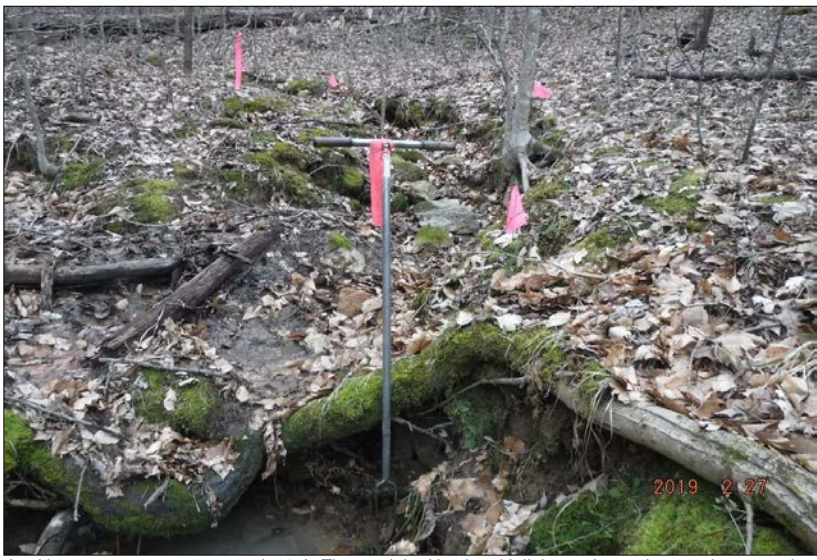
Looking upstream at stream reach 92-A. The reach had banks with little erosion and vegetative protection present. The right riparian buffer consisted of 5% mature forest cover and 95% mature forest with 30-60% canopy cover that lacked an understory. The left riparian buffer consisted of 97% mature forest with 30-60% canopy cover that lacked an understory, and 3% mature forest cover. The reach lacked in-stream habitat elements and did not have any channel alterations.

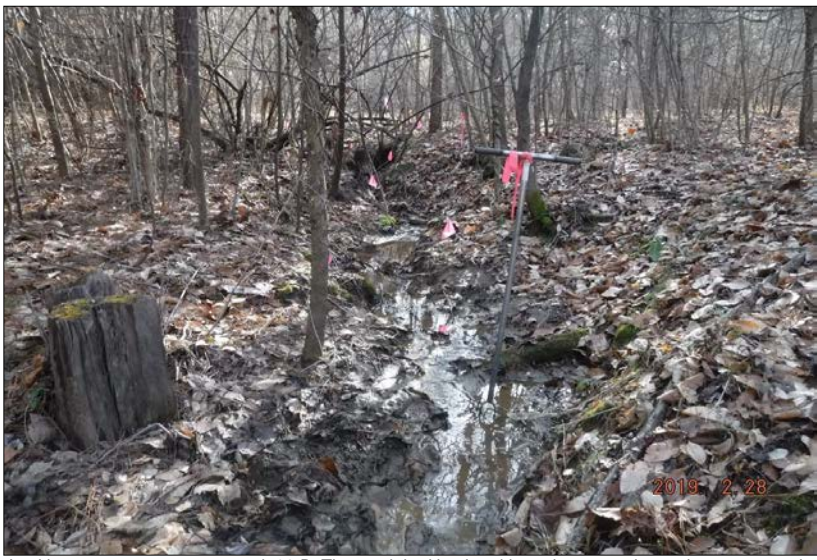
Looking upstream at stream reach 92-B. The reach had banks with moderate erosion and some vegetative protection present. The right riparian buffer consisted of 2% mature forest cover and 95% mature forest with 30-60% canopy cover that lacked an understory. The left buffer consisted of 100% mature forest cover. The reach lacked in-stream habitat elements and did not have any channel alterations.

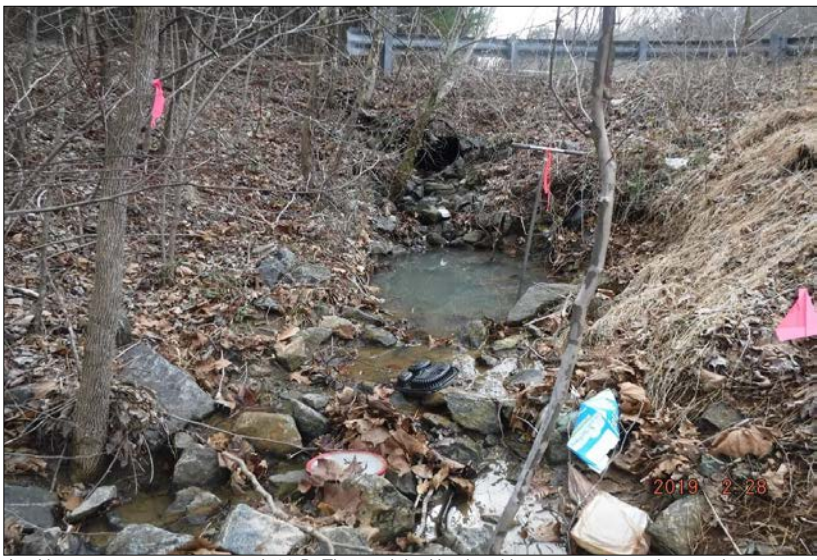
Looking upstream at stream reach 92-D. The reach had banks with some erosion and vegetation present. The right riparian buffer consisted of 20% mature forest cover, 75% mature forest with 30-60% cover containing shrub and herb layers, and 5% impervious surface. The left buffer consisted of 50% mature forest cover and 50% impervious surface. The in-stream habitat was marginal with stable elements in 10-30% of the reach. Channel alterations include rip-rap throughout the length of the reach and culverts.

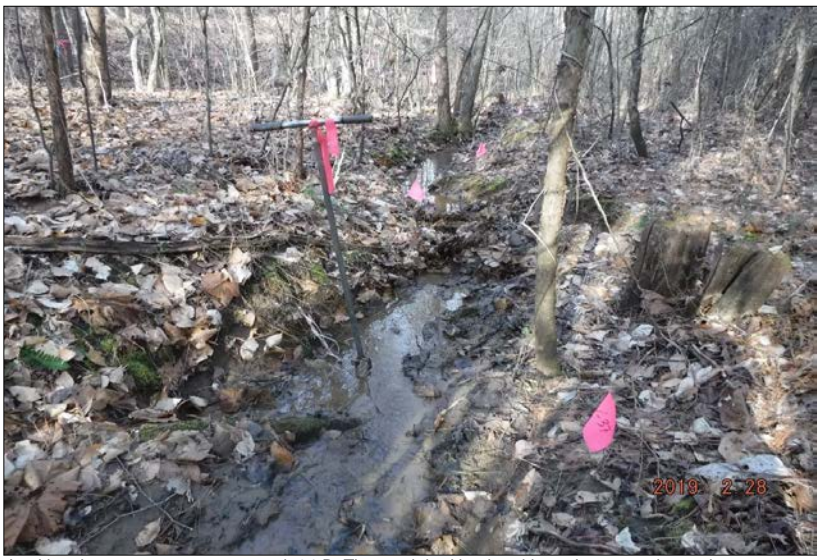
Looking downstream at stream reach 94-B. The reach had banks with moderate erosion and some vegetative protection present. The right riparian buffer consisted of 100% mature forest with 30-60% canopy cover. The left riparian buffer consisted of 75% mature forest cover and 25% impervious surfaces associated with Soapstone Road. The reach lacked in-stream habitat elements and did not have any channel alterations.

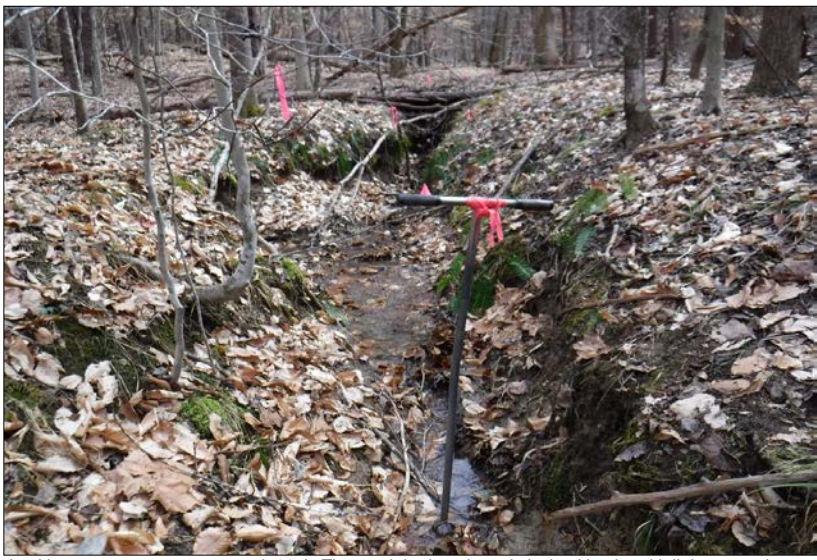
Looking upstream at stream reach 96-A. The reach had moderately incised banks with little vegetative protection. The right and left riparian buffers consisted of 100% mature forested cover. The in-stream habitat contained leaf packs, undercut banks, woody debris and shade. No channel alteration in reach.

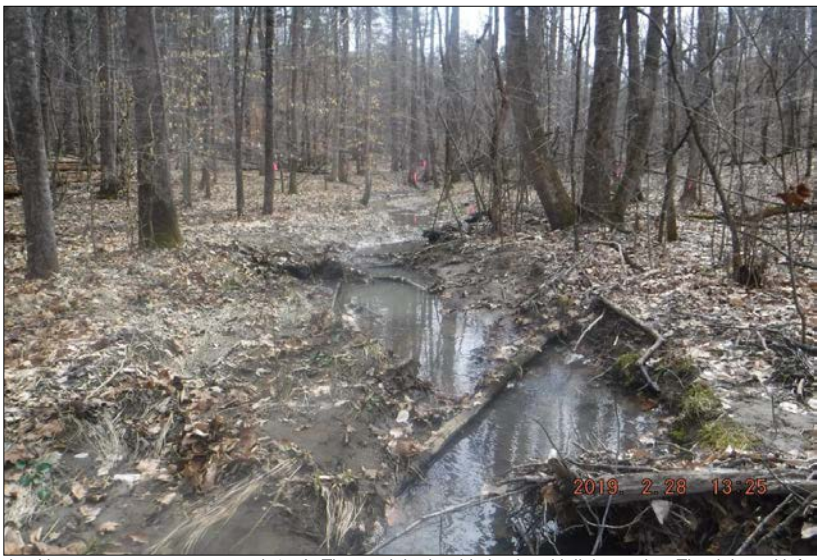
Looking upstream at stream reach 97-A. The reach had stable banks with little erosion. The right and left riparian buffers consisted of 100% mature forest cover containing wetlands. The in-stream habitat was suboptimal with stable elements in 30-50% of the reach, including contained leaf packs and woody debris. The reach lacked channel alterations.
