Stream Assessment Form (Form 1)

Unified Stream Methodology for use in Virginia

Project #	Project Name (Applicant)	Locality	Cowardin Class.	HUC	Date	SAR # / Data Point	Impact/SAR Length	Impact Factor	
	Martinsville Connector (VDOT)	Henry	R3	02070010	3/01/2019	A		N/A	
Name(s) of Evaluator(s)		Stream Name and Information					Stream Map		
SA, JB		Unnamed Tributary to Marrowbone Creek

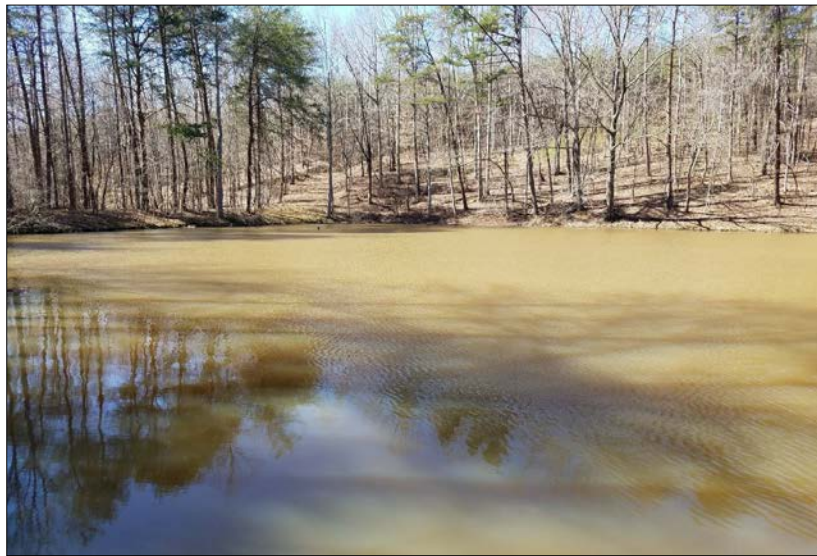
Open water pond with an inlet and outlet. Inline pond.

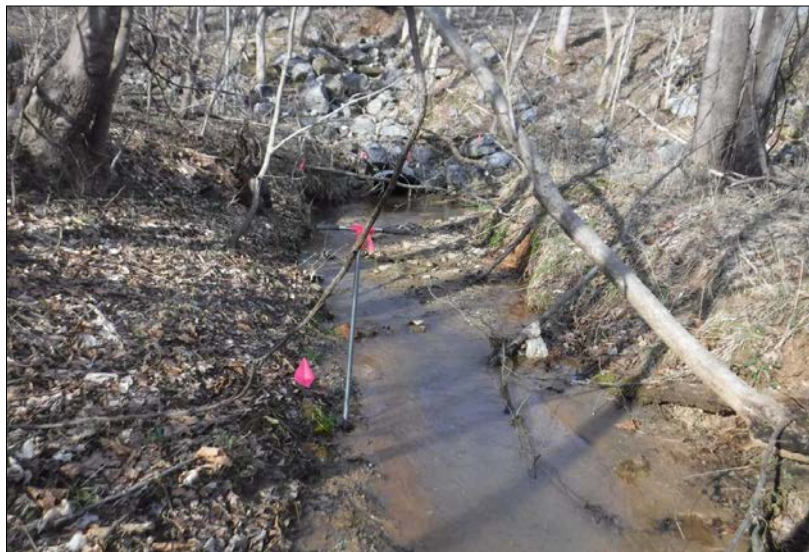
Looking upstream at Stream Reach 2-A. The reach was incised with active erosion at a culvert located at the top of the reach. The riparian buffers consist of 50% mature tree cover and 50% impervious surfaces associated with State Route 220. The in-stream habitat is present in 10%-30% of the reach and consisted of riffles, pools, leaf packs and substrate of various particle sizes. The channel was riprapped at the culvert.

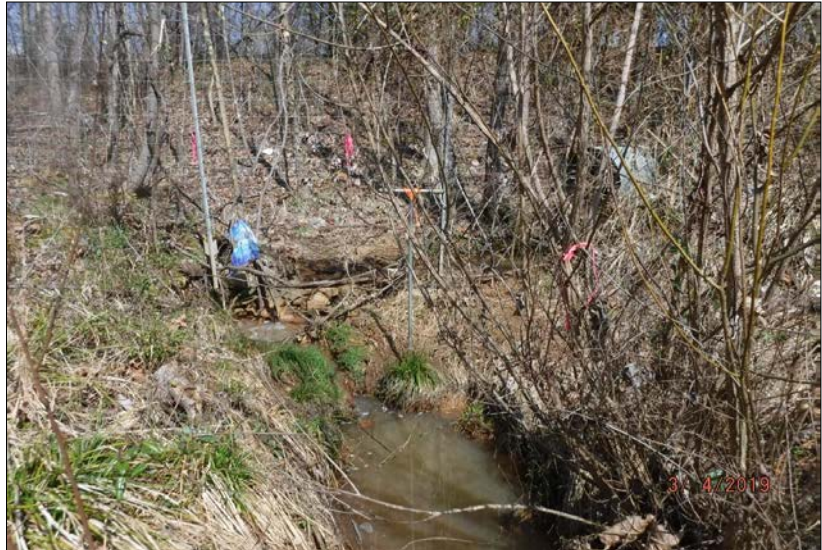
Looking upstream at Reach 7-A. The reach was incised with active erosion throughout the reach. The riparian buffers consisted of 50% mature tree cover and 50% impervious surfaces associated with State Route 220. In-stream habitat was present in 10-30% of the reach and consisted of shallow riffles, pools, and a few head-cuts. Greater than 80% of the channel was culverted under State Route 220.

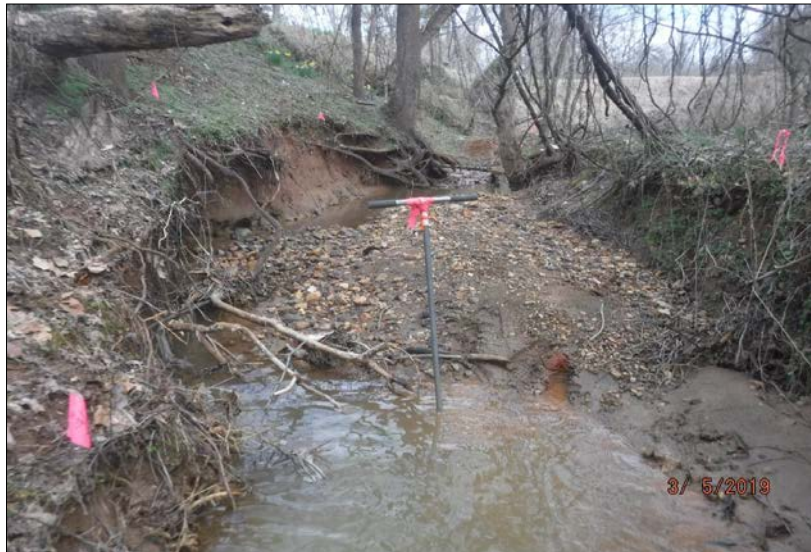
Looking downstream at Reach 7-C. The reach was frequently incised with active erosion throughout and near culverts at the top and bottom of the reach. The right riparian buffer consisted of a 90% tree cover with a maintained understory and 10% tree cover with a mature canopy. The left riparian buffer consisted of 60% tree cover with a mature canopy, 10% tree cover with a maintained understory, 10% maintained lawn, and 20% non-maintained herbaceous areas. The in-stream habitat throughout the reach consisted of riffles, pools, leaf packs and substrate of various particle sizes, however, the reach was degraded due to aggregation. The channel was riprapped and channelized at culverts.

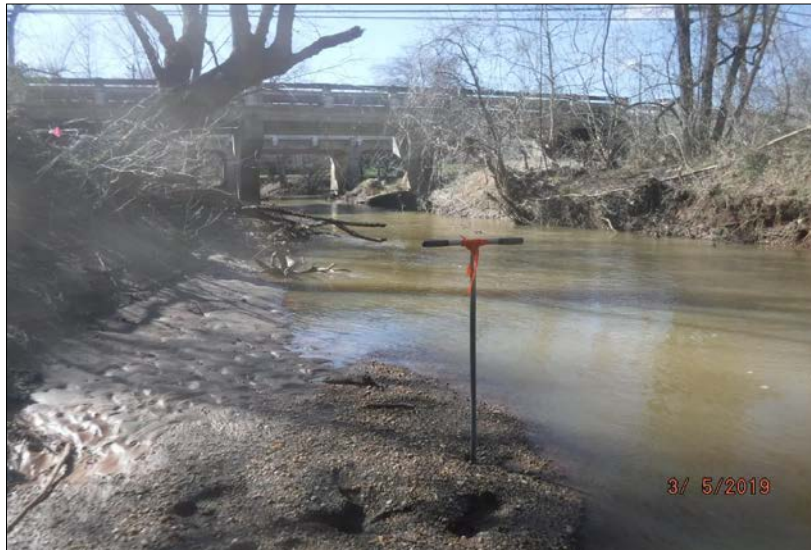
Looking downstream (west) at Stream Reach 10-B (Marrowbone Creek). The reach channel had active erosion throughout the stream. The riparian buffers consisted of 50% impervious surface associated with State Route 220 and 50% mature forest with wetlands. The in-stream habitat consisted of a deep-water with varying substrate. The channel was altered at the state route 220 bridge crossing Marrowbone Creek.

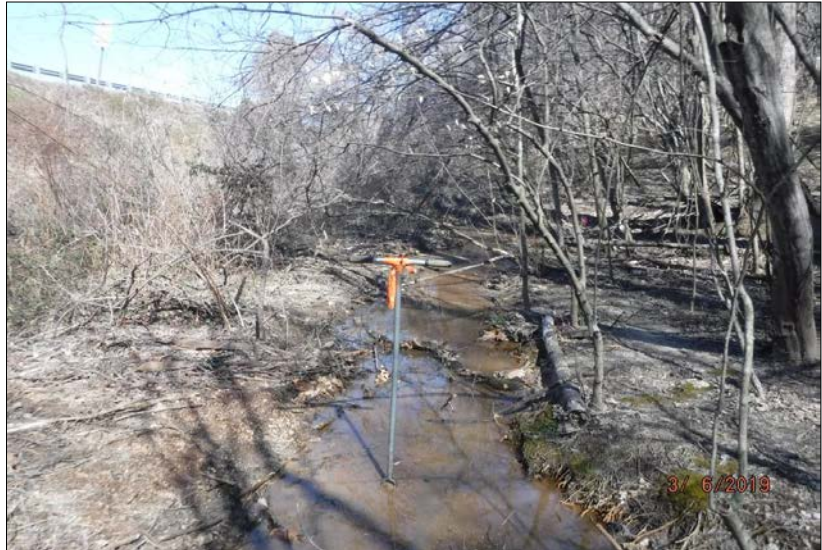
Looking downstream at Reach 12-A. The reach channel was marginal with stable and vegetated banks with some areas of erosion. The riparian buffers consisted of impervious surfaces associated with State Route 220 and forested areas with an immature forest/shrub canopy. The in-stream habitat was degraded by severe aggregation. The reach was channelized and riprapped at a culvert under State Route 220.

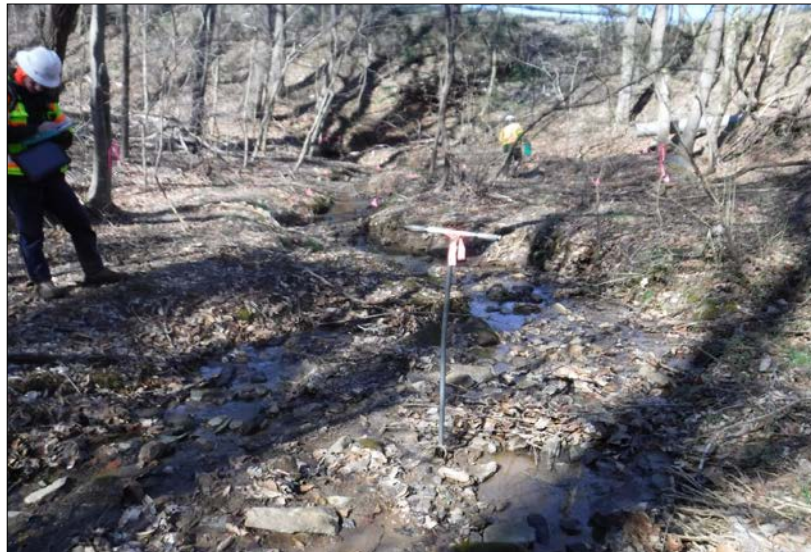
Looking downstream at Reach 13-A. The reach had active erosion in some areas. The right riparian buffer consisted of 40% mature forested areas and 60% impervious surfaces associated with parking lots and roads. The left riparian buffer consisted of 65% mature forested areas and 35% impervious surface associated with parking lots and roads. The in-stream habitat consisted of riffles, pools, leaf packs and substrate of various particle sizes. The stream was degraded by minor amounts of aggregation. The channel was riprapped and channelized through culverts.

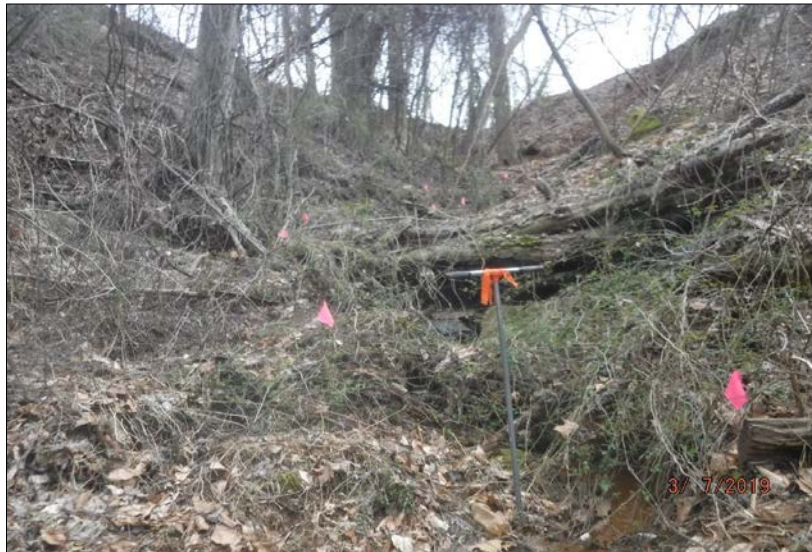
Looking upstream at Stream Reach 15-A. The reach was incised with active erosion throughout. The right riparian buffer consisted of 80% mature tree cover and 20% impervious surfaces associated with a stockyard. The left riparian buffer consisted of 20% high suboptimal tree cover and 80% impervious surfaces associated with State Route 220. The in-stream habitat was degraded by aggregation, erosion, and highway pollution. The reach was riprapped at the top.

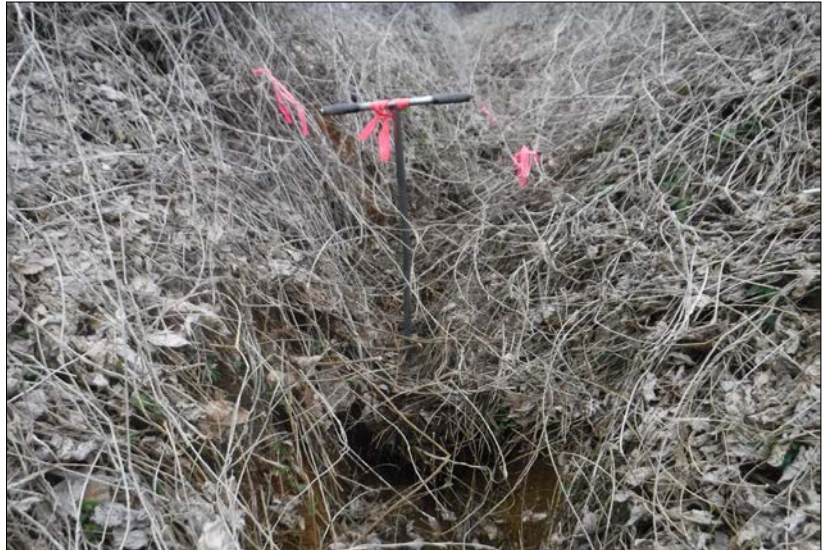
Looking upstream at Stream Reach 16-A. The reach was severely incised with frequent, active erosion throughout. The right riparian buffer consisted of 90% mature tree cover and 10% non-maintained herbaceous vegetation. The left riparian buffer consisted of 95% non-maintained herbaceous vegetation and 5% impervious surfaces associated with State Route 220. The in-stream habitat was degraded by severe erosion and lack of habitat elements. Greater than 80% of the reach was channelized into a concert culvert.

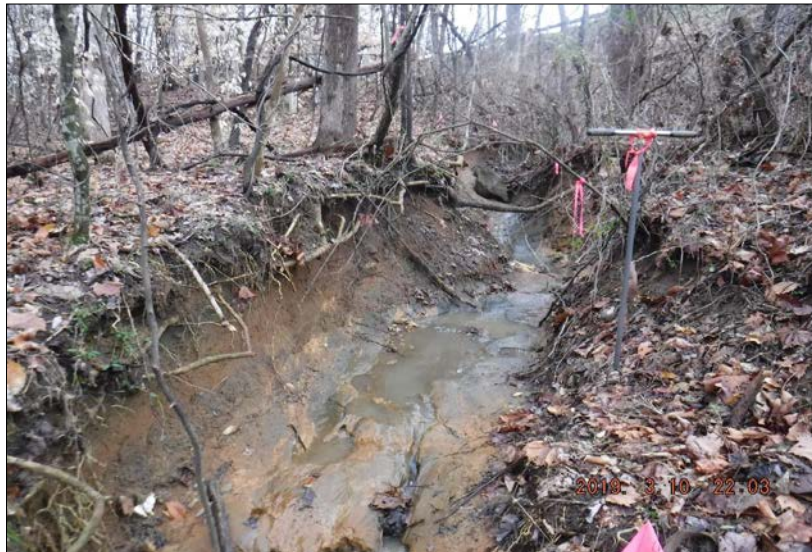
Looking upstream at Reach 19-B. The reach channel was rated severe with frequent areas of active erosion and acute aggregation. The riparian buffers consist of 10% maintained lawns and 90% mature forested areas. In-stream habitat was present in less than 10% of the reach. The reach was channelized through culvert and riprapped for stability at the top of the reach.

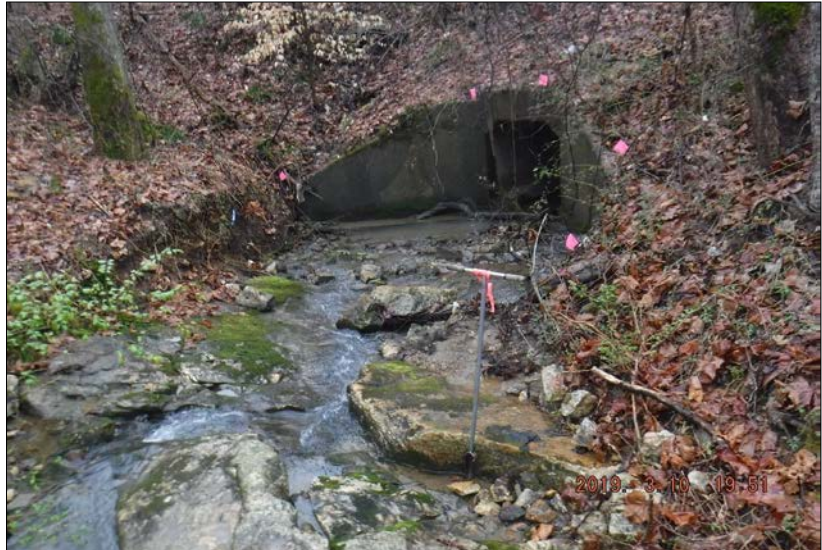
Looking downstream at 20-B. The reach was suboptimal with minor area of active erosion throughout with stable and vegetated banks. The right riparian buffer consisted of 100% mature tree cover. The left riparian buffer consisted of 70% mature tree cover and 30% densely non-maintained herbaceous area. Instream habitat was present in 30-50% of the reach and consisted of riffles, pools, head cuts, leaf packs and substrate of various particle sizes. The was channelized through culverts at the top and bottom of reach.

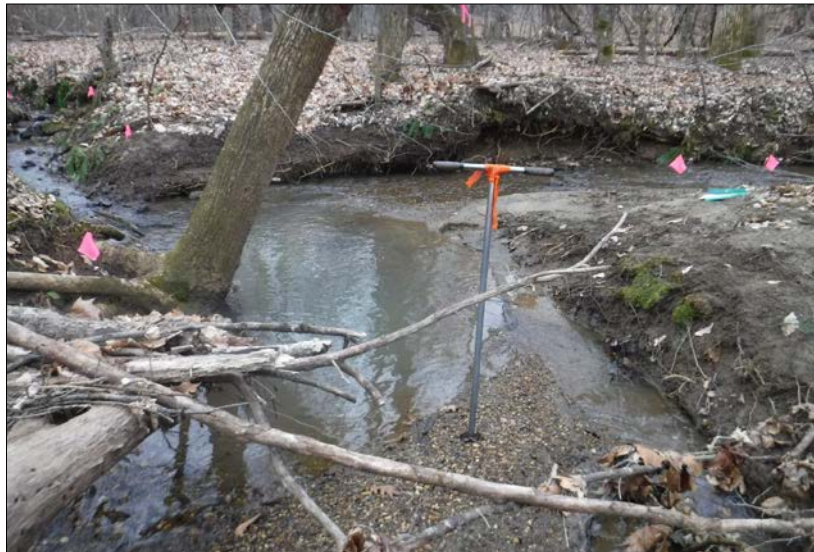
Looking upstream at stream reach 24-A. The reach had a few areas of active erosion throughout with stable and vegetated banks. The riparian buffers consisted of 90% mature tree cover and 10% maintained area associated with a gravel farm road. Istream habitat was present in 10-30% of the reach and consisted of riffles, pools, leaf packs and substrate of various particle sizes. The channel was channelized through a culvert under a gravel road.

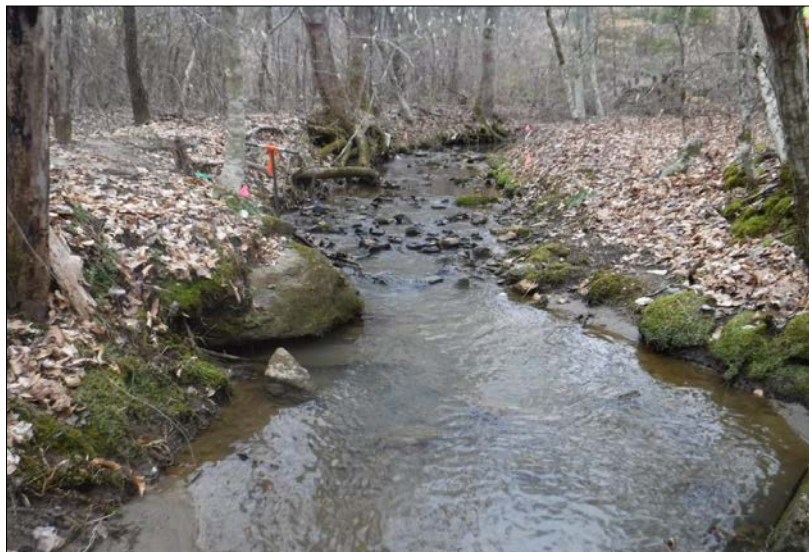
Looking upstream at stream reach 25-A. The reach had a minor area of active erosion throughout with stable and vegetated banks. The riparian buffers consisted of 100% mature tree cover. Instream habitat was present throughout the reach consisted of riffles, pools, head cuts, leaf packs and substrate of various particle sizes. The reach had no signs of alteration.

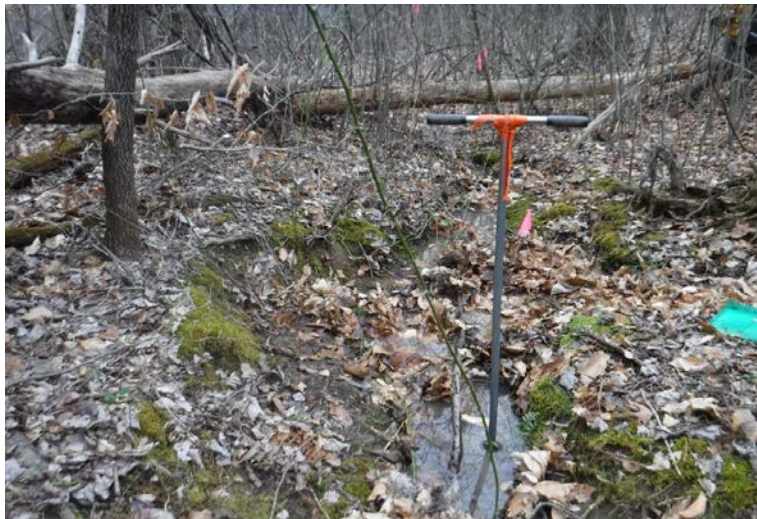
Looking upstream at stream reach 26-A. The riparian buffers consisted of 100% mature forested areas.

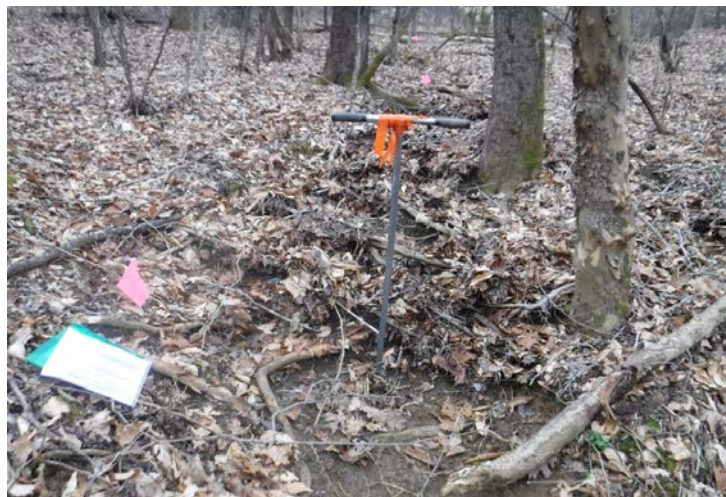
Looking upstream at stream reach 27-B. The riparian buffers consisted of 100% mature forested areas.

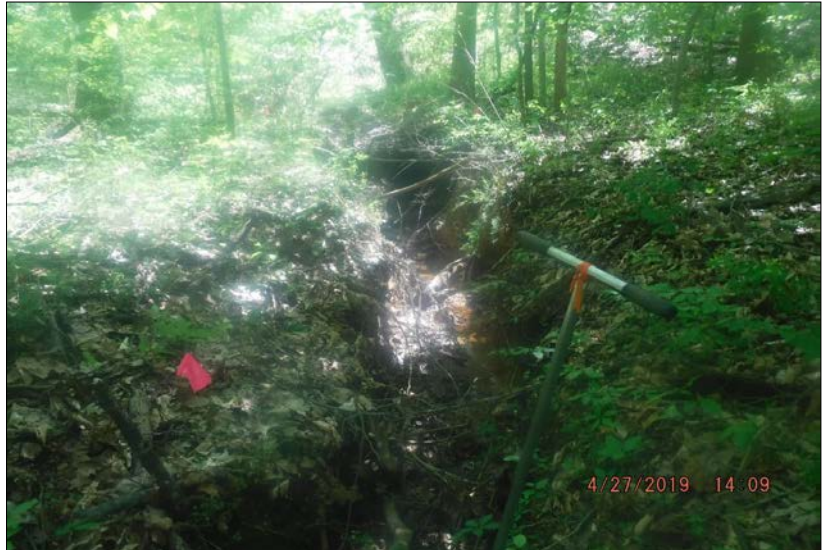
Looking upstream at Stream Reach 28-B. The stream is deeply incised with the streambed below the average majority of banks. The left bank riparian buffer consists of mature forest with greater than 60% tree canopy cover and impervious surfaces. The right bank riparian buffer consists of mature forest with greater than 60% tree canopy cover. Instream habitat is present in less than 10% of the stream. No channel alteration is present in the reach.

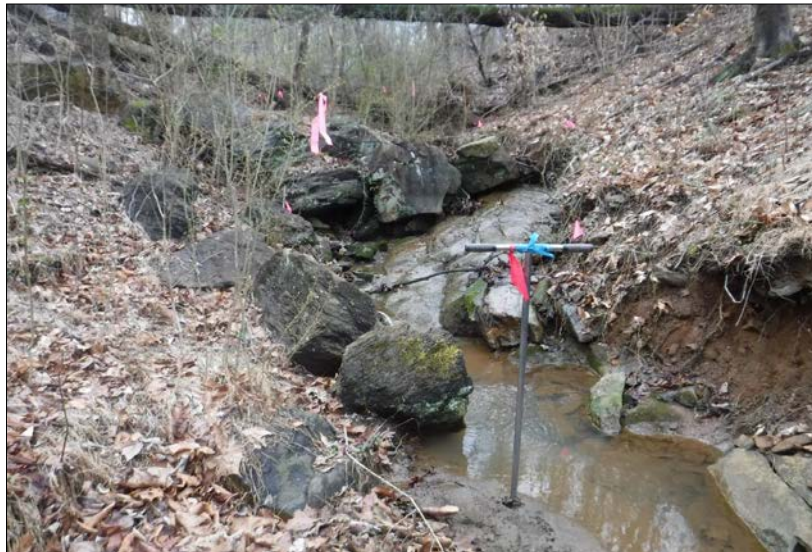
Looking upstream at stream reach 29-A. The reach channel was poor with frequent areas of active erosion throughout. The right riparian buffer consisted of 5% mature forested cover, 75% non-maintained shrub/tree layer, and 20% impervious surface associated with State Route 220. The left riparian buffer consisted of 90% non-maintained shrub/tree layer and 10% mature forested area. Instream habitat consisted of riffles, pools, leaf packs, substrate of varied particle sizes, and head-cuts, however, the reach was degraded by severe aggregation. The reach was filled in by sediment runoff associated with State Route 220.

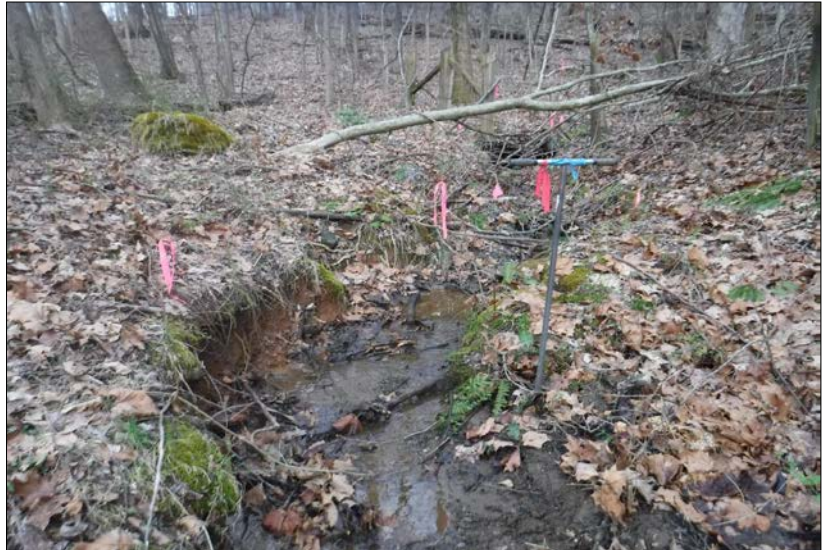
Looking upstream at stream reach 31-A. The reach was suboptimal with few areas of active erosion and level vegetated banks. The right riparian buffer consisted of 40% mature forested cover and 60% impervious surfaces associated with State Route 220. The right riparian buffer consisted of 100% mature forested cover. Instream habitat was present in 10-30% of the reach and consisted of riffles, pools, and head-cuts, however, the reach was degraded by aggregation throughout. The reach was channelized through a culvert at the top of reach.

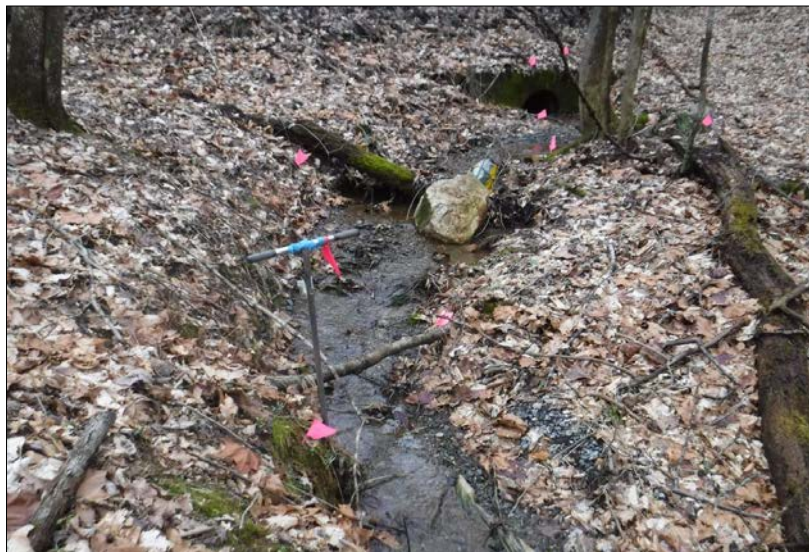
Looking upstream at stream reach 33-A. The reach was suboptimal with level and stabilized banks. The riparian buffer consisted of 80% mature forested cover and 20% impervious surfaces associated with State Route 220. Instream habitat was present in 10-30% of the reach and consisted of riffles, pools, and varied particle sizes. The reach was channelized through culverts.

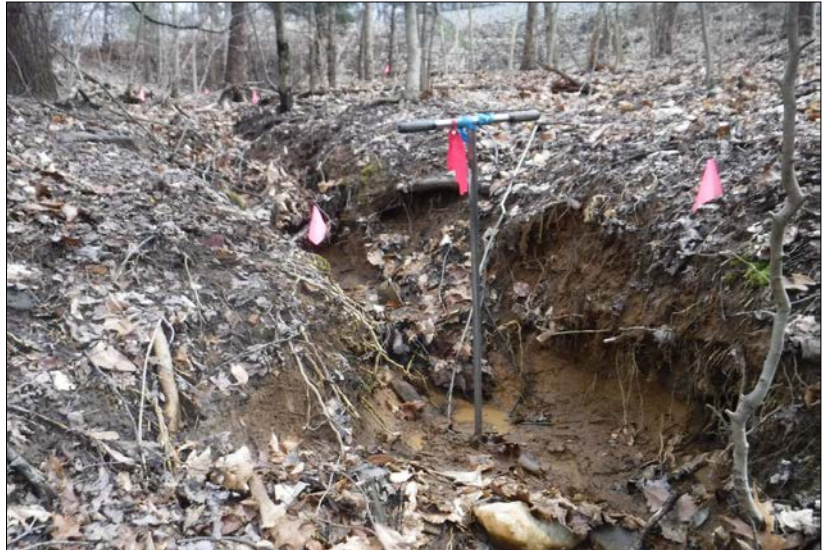
Looking upstream at stream reach 34-A. The reach was poor frequent areas of active erosion. The riparian buffers consisted of 75% mature forested cover and 25% impervious surfaces associated with State Route 220. Instream habitat was degraded by erosion and is present in less than 10% of the reach. The reach was channelized through culverts.

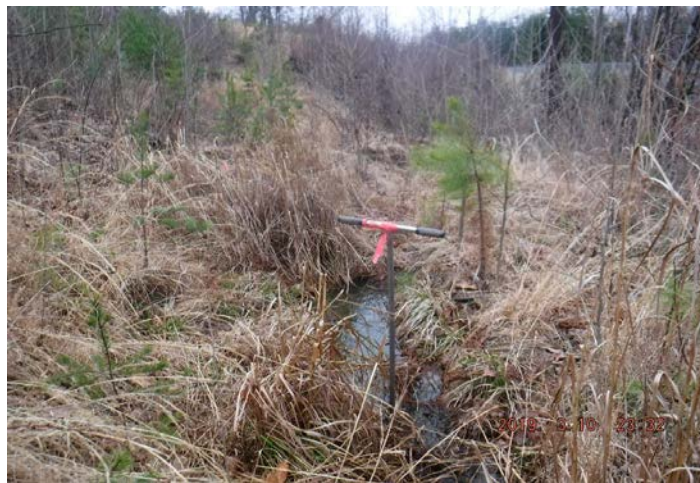
Looking downstream at stream reach 35-A. The riparian buffers consisted of 20% impervious surfaces associated with State Route 220 and 80% forested areas with wetlands.

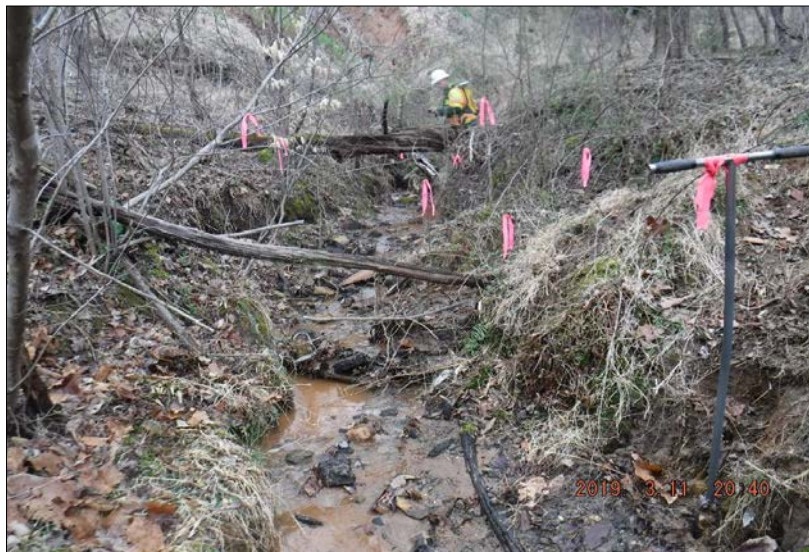
Looking upstream at stream reach 37-A. The reach was marginal with areas of active erosion and a large amount of sediment covering the stream bed. The right riparian buffers consisted of 85% mature forested areas and 15% non-maintained herbaceous areas. The left riparian buffer consisted of 85% mature forested with a maintained understory and 15% non-maintained herbaceous areas. Instream habitat was present 10-30% of the reach and consisted of riffles, pools, leaf packs, and head-cuts. The reach was channelized through a culvert.

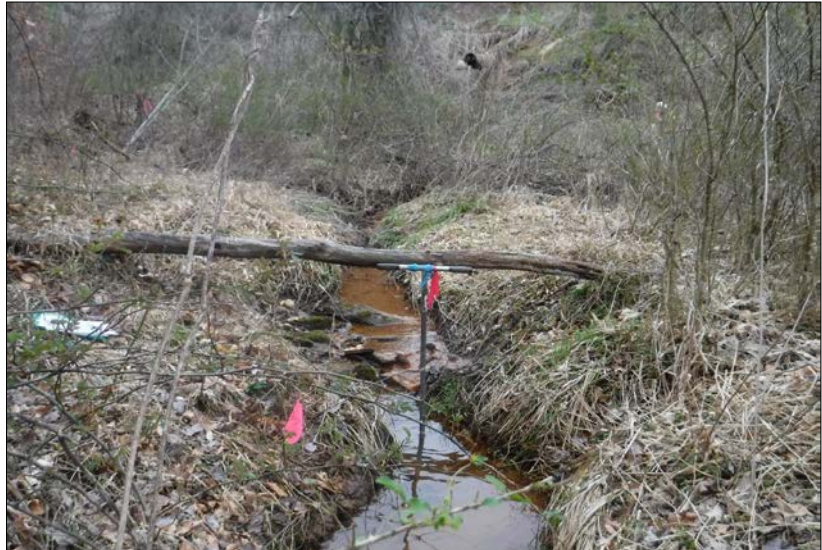
Looking upstream at stream reach 38-A. The reach was marginal with vegetated banks and some areas of active erosion. The right riparian buffers consisted of 40% mature forest with less than 60% canopy cover, 40% non-maintained densely vegetated herbaceous areas, and 20% impervious areas associated with State Route 220. Instream habitat was present in less than 10% of the reach. The reach was channelized through a culvert and stabilized with riprap at the top of the reach.

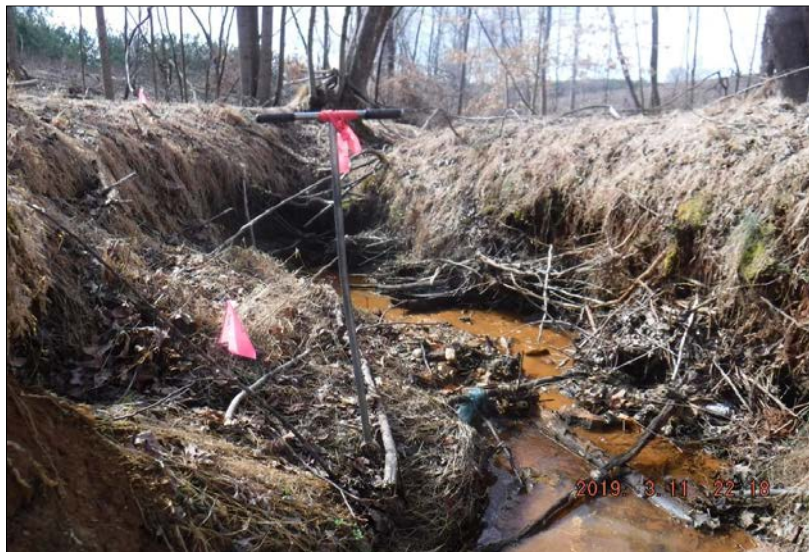
Looking downstream at stream reach 39-D. The reach was severely incised with frequent areas of active erosion. The right riparian buffers consisted of 90% mature forest and 10% impervious surfaces associated with State Route 220. The left riparian buffer consisted of 20% mature forest and 80% impervious surfaces associated with State Route 220. The in-stream habitat consisted of riffles, pools, leaf packs, and head-cuts, however, the reach was degraded by severe aggregation and active erosion. The reach was channelized through a culvert.

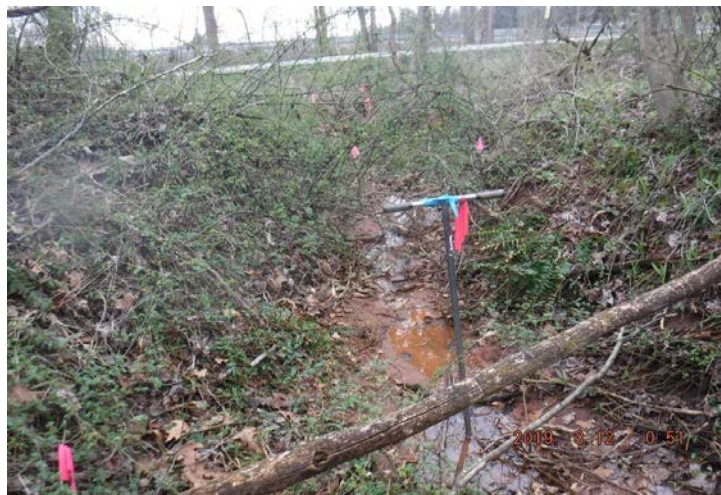
Looking upstream at stream reach 40-B. The right riparian buffer consisted of 90% mature forested areas and 10% maintained ride-of-way. The left riparian buffer consisted of 85% mature forested areas, 10% maintained ride-of-way, and 5% impervious surfaces.

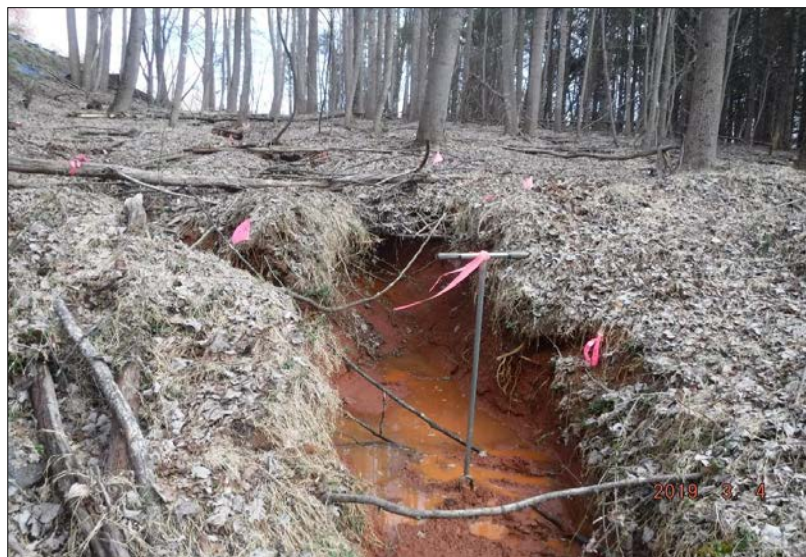
Looking upstream at stream reach 41-B. The right riparian buffer consisted of 100% mature tree cover. The left riparian buffer consisted of 50% mature tree cover and 50% impervious surface associated with State Route 220.

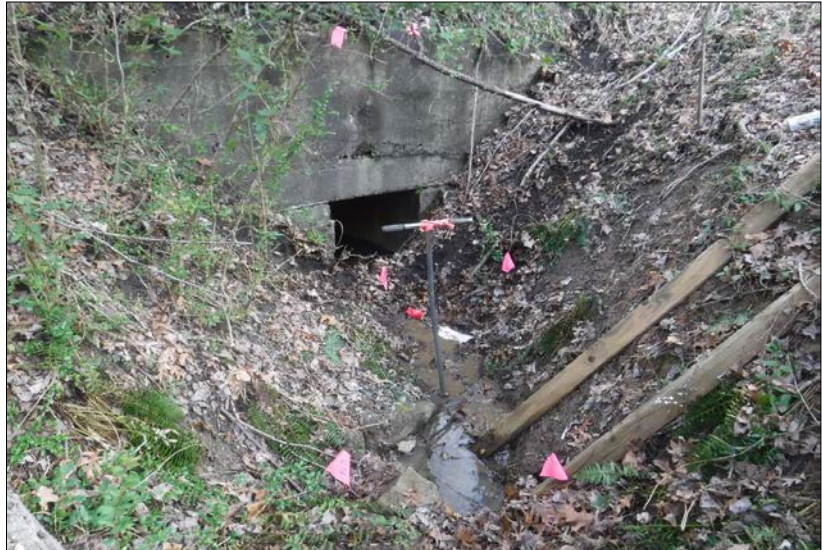
Looking downstream stream reach 42-A. The reach was marginal with areas of active erosion. The right riparian buffer consisted of 90% mature forested areas and 10% impervious surfaces associated with the railroad. The left riparian buffer consisted of 70% mature forested areas, 20% impervious surfaces associated with the railroad, and 10% maintained lawns. Instream habitat elements were less than 10% of the reach. The reach was channelized through a culvert.

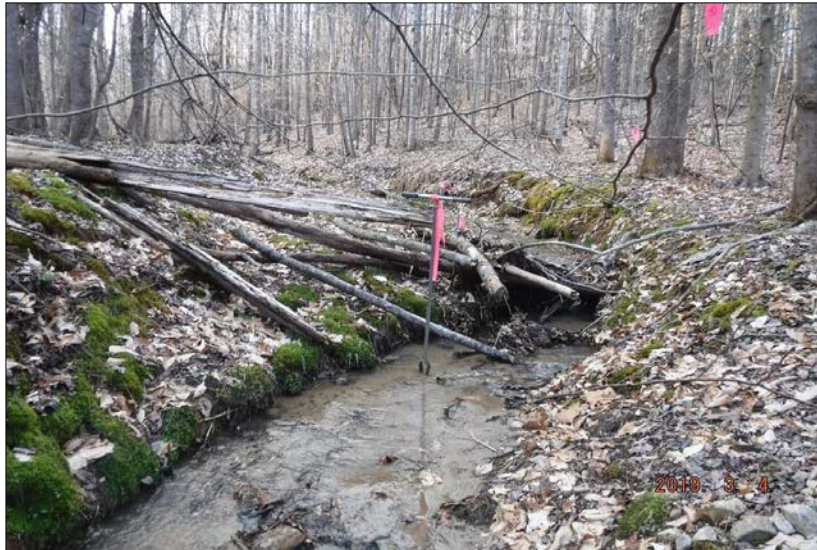
Looking upstream at stream reach 43-A. The reach had incised banks with moderate erosion present. The right and left riparian buffers consisted of 100% mature forest cover. The in-stream habitat was optimal and contained leaf packs, woody debris and various substrate sizes. Channel alterations include concrete installed along less than 20% of the reach.

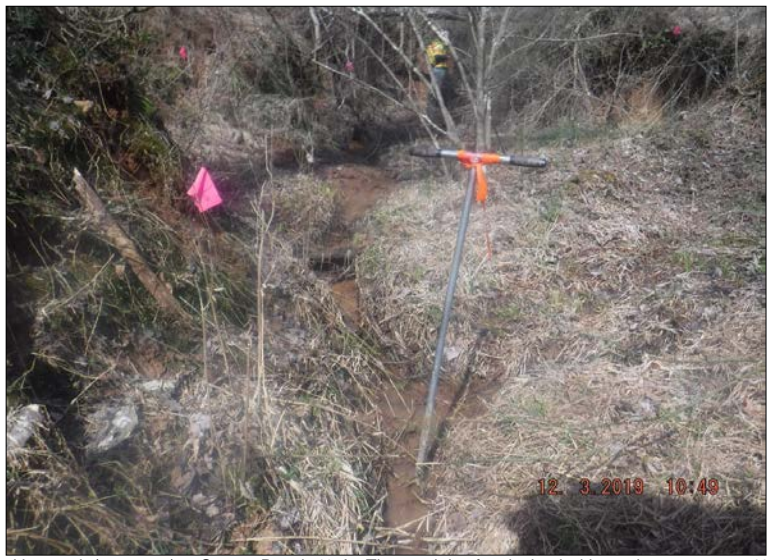
Looking north (upstream) at Stream Reach 43-A. The reach is often incised with erosion present on 40-60% of banks. The right and left riparian buffers are composed of sparse vegetation and are not maintained. Instream habitat elements are lacking and are present in less than 10% of the reach. The channel had no known alterations.

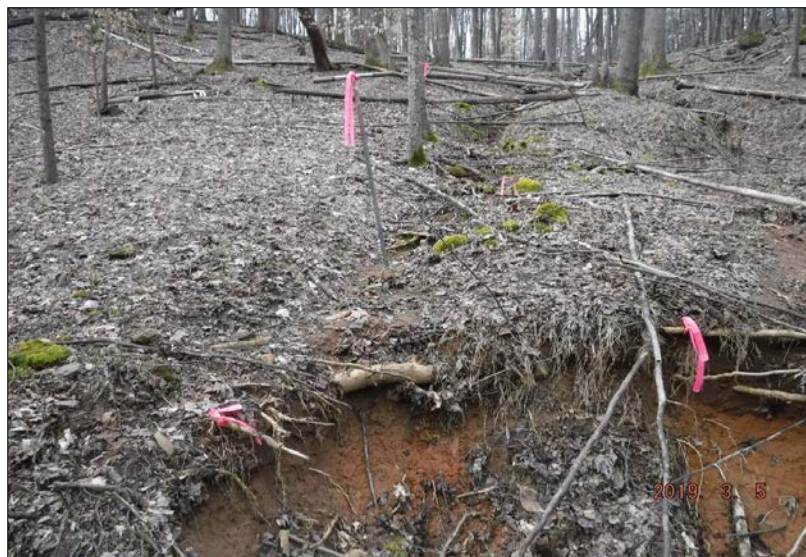
Looking upstream at stream reach 44-A. The right and left riparian buffers consisted of 100% mature forest cover.

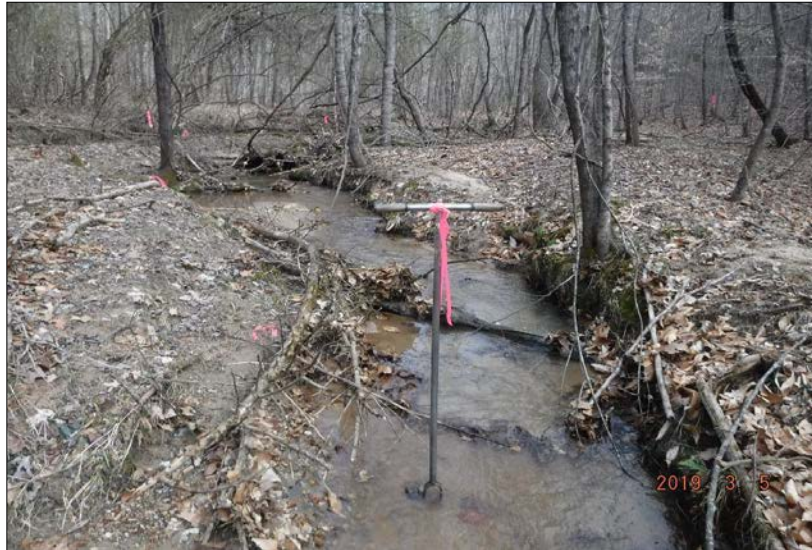
Looking upstream at stream reach 45-B. The reach had erosion present on 40-60% of banks. The right riparian buffer consisted of 98% mature forest cover containing wetlands, and 2% forest with 30-60% canopy cover containing a shrub and herbaceous layer. The left riparian buffer consisted of 100% mature tree cover containing wetlands. The in-stream habitat was optimal with stable elements in greater than 50% of the reach. No channel alterations were observed.

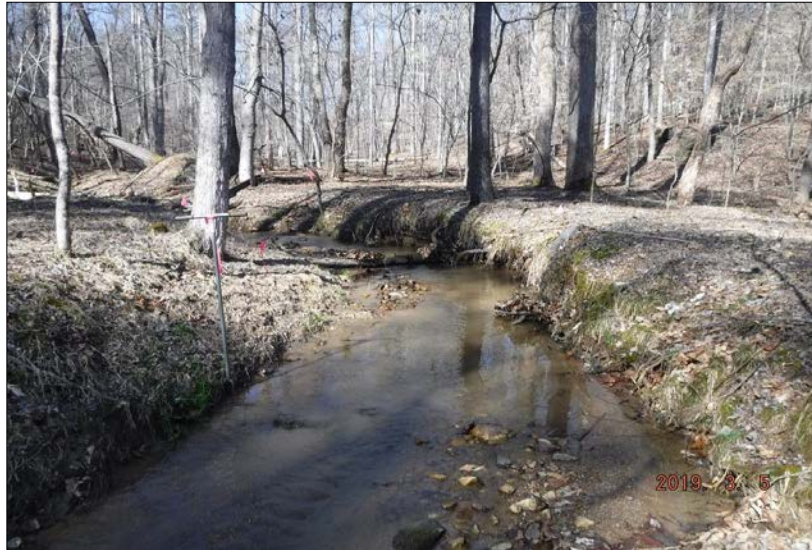
Looking upstream at stream reach 45-C. The reach had eroded banks with little vegetative protection present. The right and left riparian buffers consisted of 100% mature forest cover containing wetlands. In-stream habitat was optimal and contained leaf packs, woody debris and various substrate sizes. No channel alteration was present within this reach.

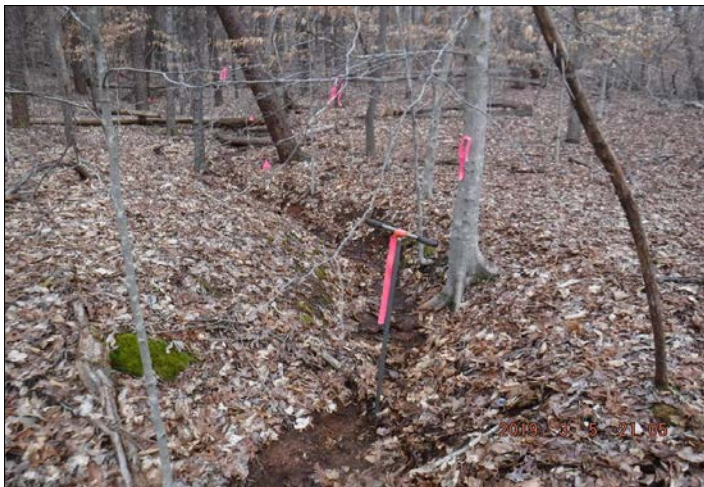
Looking upstream at stream reach 46-A. The right and left riparian buffers consisted of 100% mature forest cover.

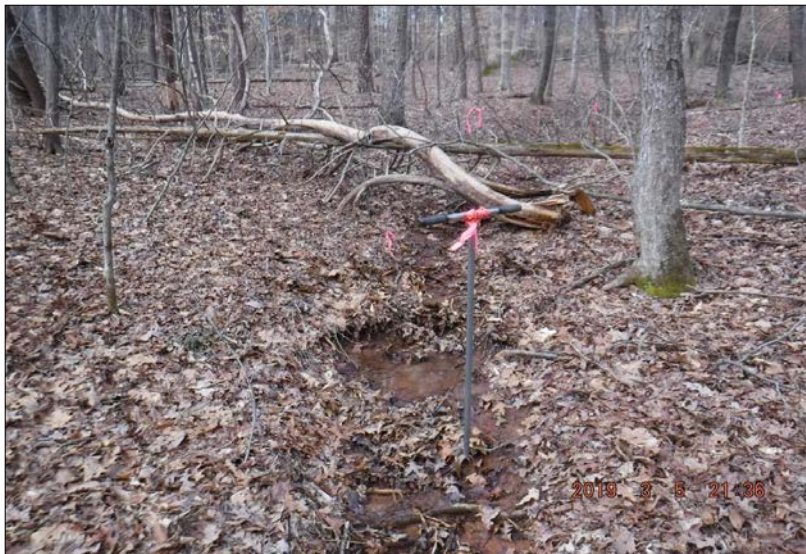
Looking upstream at stream reach 46-B. The right and left riparian buffers consisted of 100% mature forest cover.

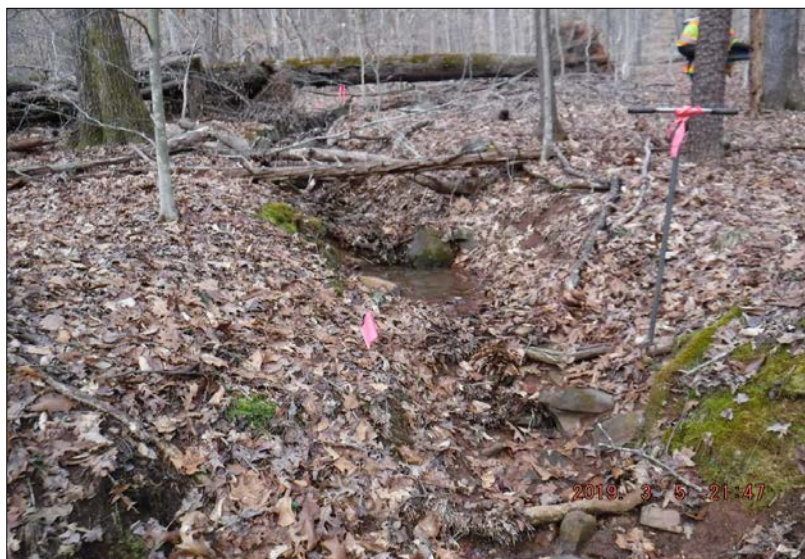
Looking upstream at stream reach 46-C. The right and left riparian buffers consisted of 100% mature forest cover.

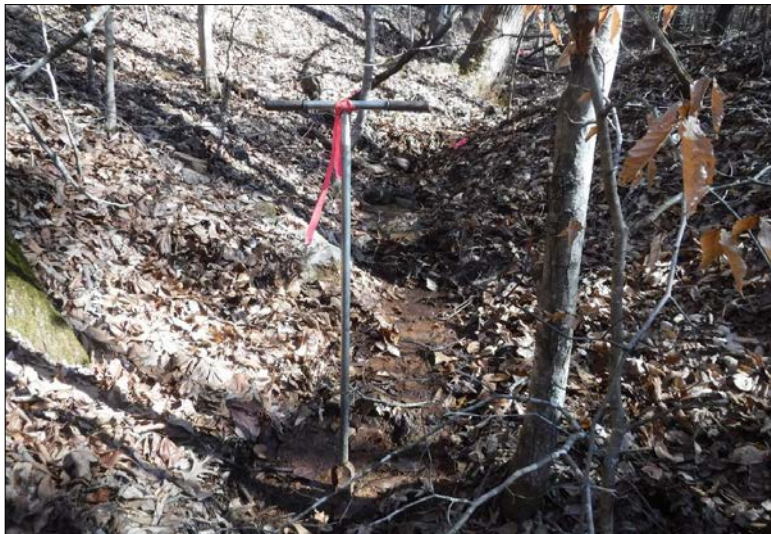
Looking upstream at stream reach 47-A. The right and left riparian buffers are forested with greater than 60% canopy cover.

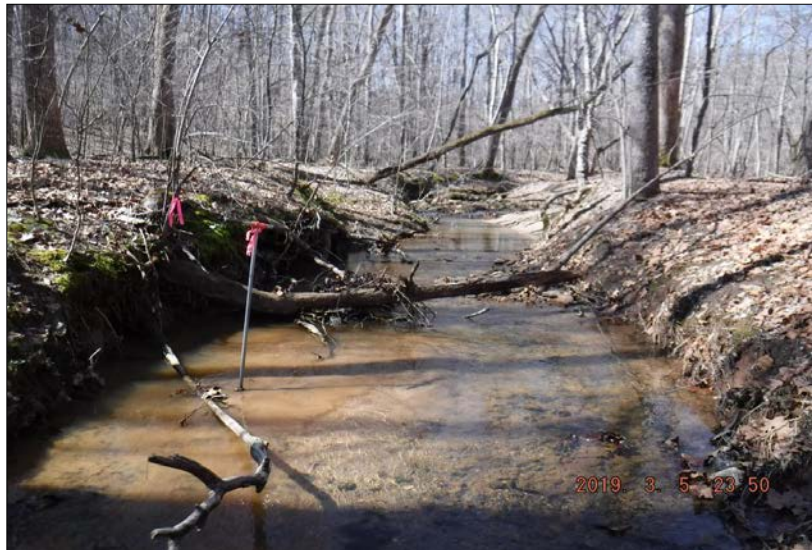
Looking upstream at stream reach 48-A. The reach had severely eroded, unstable banks. The right and left riparian buffers consisted of 100% mature forest cover. The in-stream habitat was optimal with stable elements in greater than 50% of the reach. There are no known channel alterations.

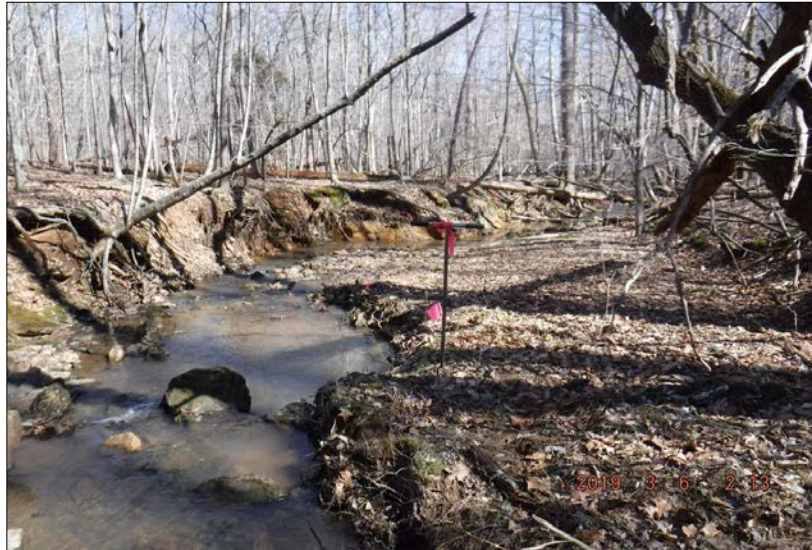
Looking downstream at stream reach 48-B. The reach was poor with eroded, unstable banks. The right and left riparian buffers consisted of 100% mature forest cover with wetlands present within the right riparian buffer. The in-stream habitat was suboptimal, with stable elements within 30-50% of the reach including various substrate sizes. There are no known channel alterations.

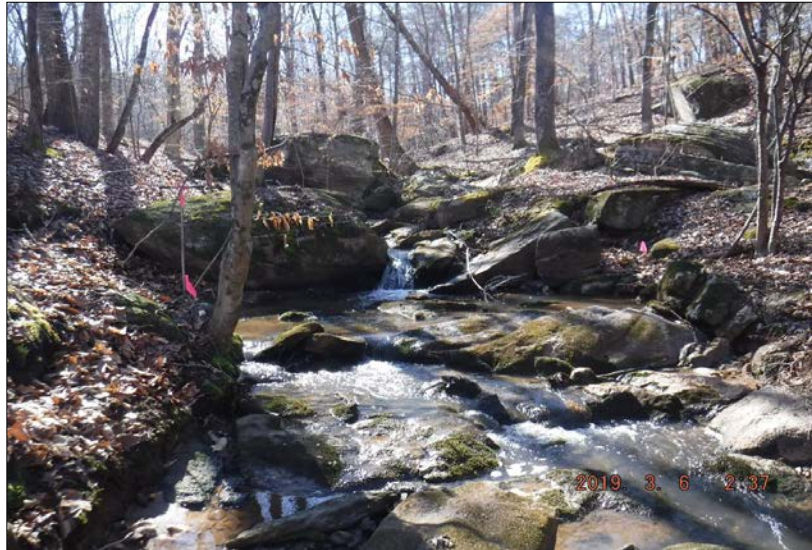
Looking upstream at stream reach 48-C. The reach had stable banks with bedrock present throughout. The right and left riparian buffers consisted of 100% mature forest cover. The in-stream habitat was optimal and contained leaf packs, shade, woody debris, and various water velocity and depths. There are no known channel alterations.

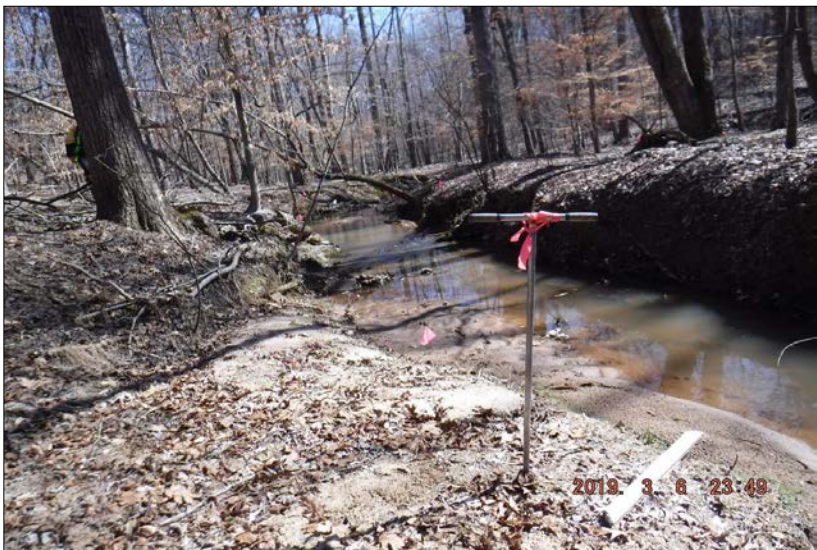
Looking upstream at stream reach 48-D. The reach had incised, eroded banks. The right and left riparian buffers consisted of 100% mature forest cover with wetlands within the right riparian buffer. The in-stream habitat was optimal with stable elements in greater than 50% of the reach. There are no known channel alterations.

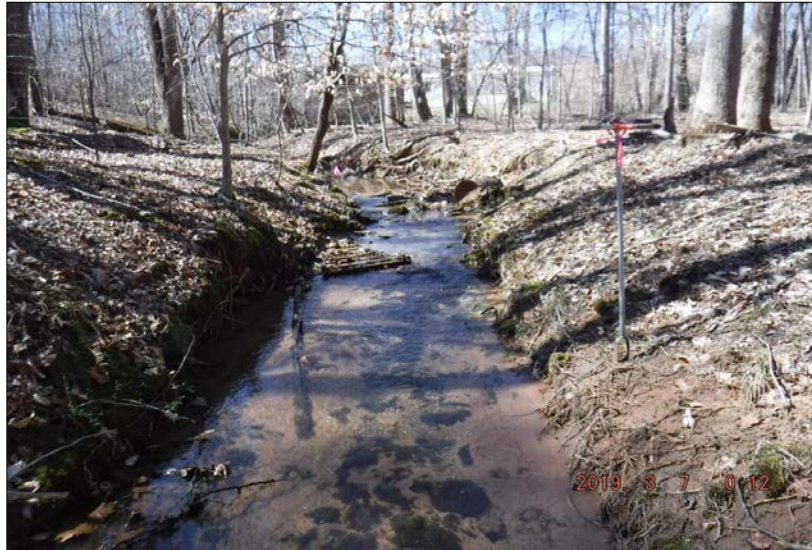
Looking upstream at stream reach 48-E. The reach had stable banks with areas of active erosion present. The right and left riparian buffers consisted of 100% mature forest cover. The in-stream habitat was optimal with stable elements in greater than 50% of the reach. There are no known channel alterations.

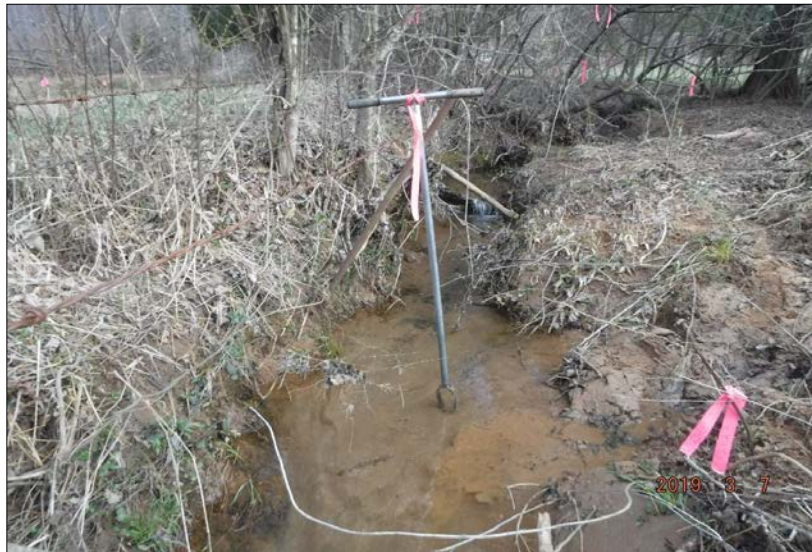
Looking upstream at stream reach 46-G. The reach had eroded banks with some vegetative protection present. The right riparian buffer consisted of 45% wetland, 10% dense shrubs and 45% maintained field. The left riparian buffer consisted of 5% wetland, 5% impervious surface including gravel lots and 80% maintained lawn. The in-stream habitat was suboptimal with stable elements in 30-50% of the reach. The channel alterations included a culvert.
