Stream Assessment Form (Form 1)

Unified Stream Methodology for use in Virginia

Project #	Project Name (Applicant)	Locality	Cowardin Class.	HUC	Date	SAR # / Data Point	Impact/SAR Length	Impact Factor	
	Martinsville Connector (VDOT)	Henry	R3	02070010	3/01/2019	A		N/A	
Name(s) of Evaluator(s)		Stream Name and Information					Stream Map		
SA, JB		Unnamed Tributary to Marrowbone Creek

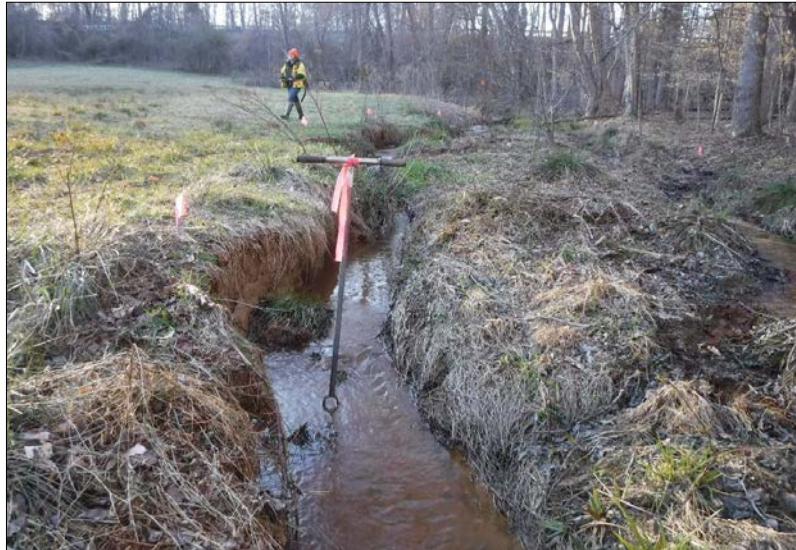
Looking upstream at stream reach 48-H. The reach had eroded banks with vegetation present. The right riparian buffer consisted of 50% wetland and 50% maintained field. The left buffer consisted of 100% mature forest cover containing wetlands. The in-stream habitat suboptimal with stable elements in 30-50% of the reach. The channel alterations included a culvert.

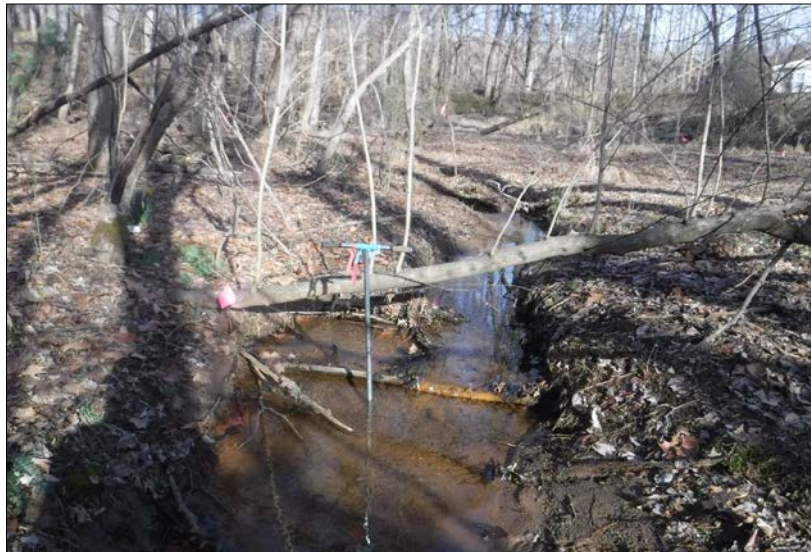
Looking upstream at stream reach 48-A. The reach was suboptimal with few areas of active erosion. The right riparian buffer consisted of 85% mature forested area with wetlands and 15% impervious surfaces associated with State Route 220. The left riparian buffer consisted of 70% mature forested areas, 15% impervious surfaces associated with the railroad, and 15% maintained lawns. Instream habitat was present in 30-50% of the reach and consisted of riffles, pools, and leaf packs, however, the reach was degraded by severe aggregation. The reach was channelized through a culvert.

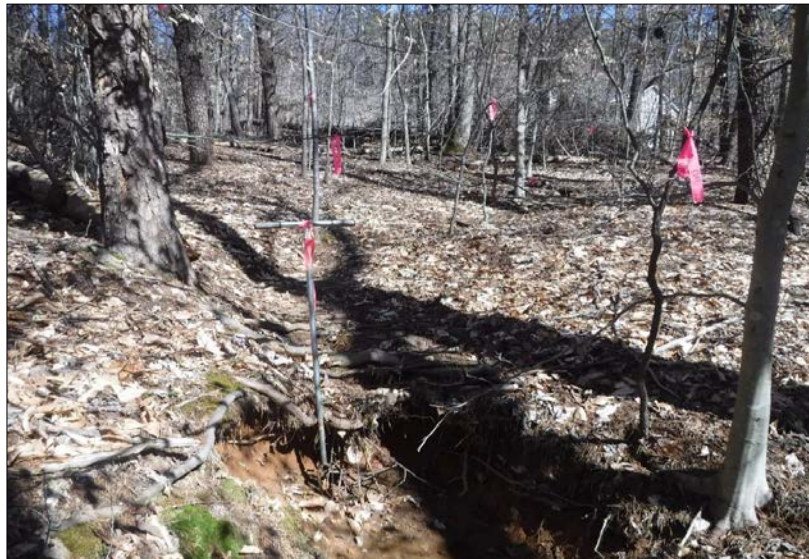
Looking upstream at stream reach 49-A. The right riparian buffer consisted of 75% forested with greater than 60% canopy cover, and 25% forested with 30-60% canopy cover that lacked an understory. The left buffer consisted of forest with greater than 60% canopy cover.

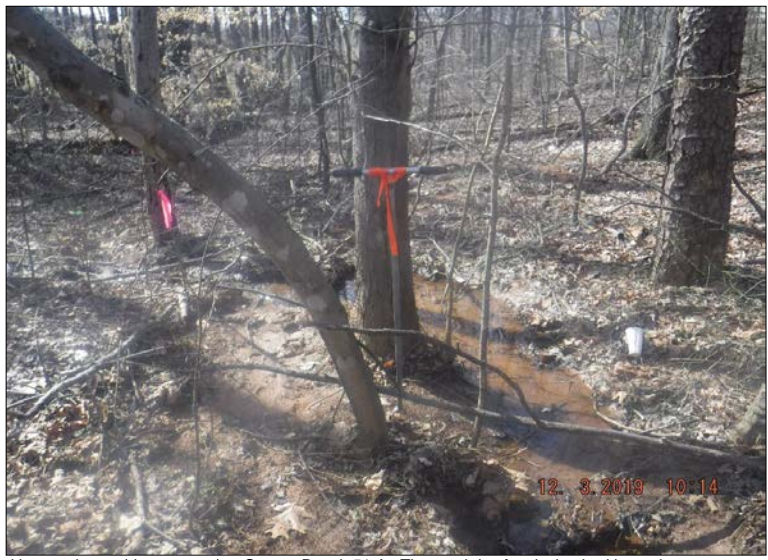
(WSSI Photo Location XXXX)

Looking southwest (downstream) at Stream Reach 51-A. The reach is often incised, with erosion present on 40-60% of banks. The right bank riparian buffer is composed almost entirely of impervious surfaces (road) and has a small portion of forest with greater than 60% canopy cover. The left buffer is composed largely of maintained grass and has a portion of forest with greater than 60% canopy cover. Habitat elements are lacking and are present in less than 10% of the reach. The upstream end of the reach is fed by a culvert, disrupting less than 20% of the reach.

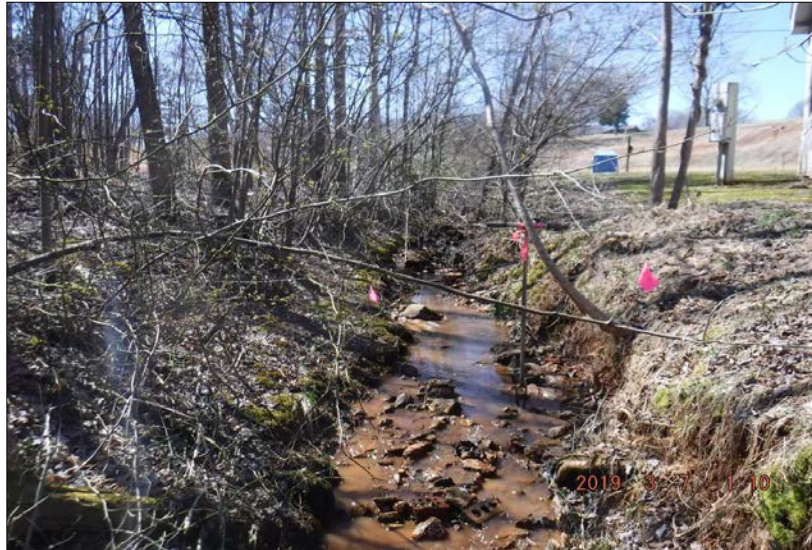
Looking upstream at stream reach 52-A. The reach had incised, eroded banks. The right riparian buffer consisted of 2% non-maintained, dense herbaceous vegetation and 98% forest with greater than 60% canopy cover. The left riparian buffer consisted of 50% forest with greater than 60% canopy cover and 50% maintained lawn. The in-stream habitat was marginal with stable elements in less than 30% of the reach. Channel alterations included a culvert and dumping of debris into the stream.

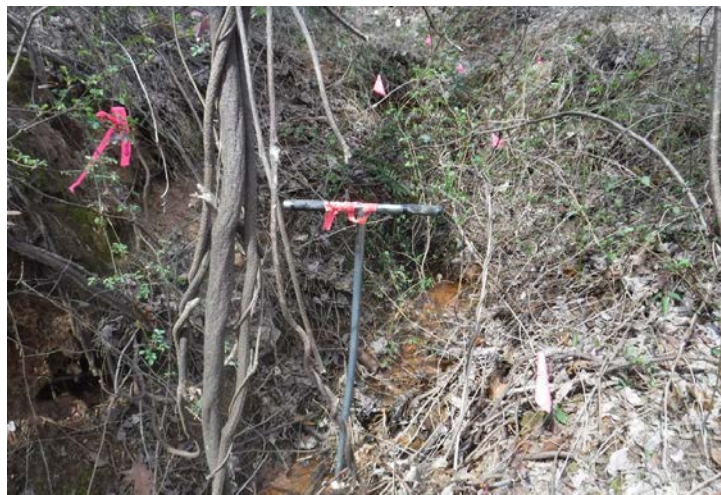
Looking upstream at stream reach 52-A. The right riparian buffer consisted of 80% mature forested area with canopy cover less than 60% and 20% non-maintained vegetation consisting of herbaceous and shrub layers. The left riparian buffer consisted of 100% mature forested area with a canopy cover less than 60%.

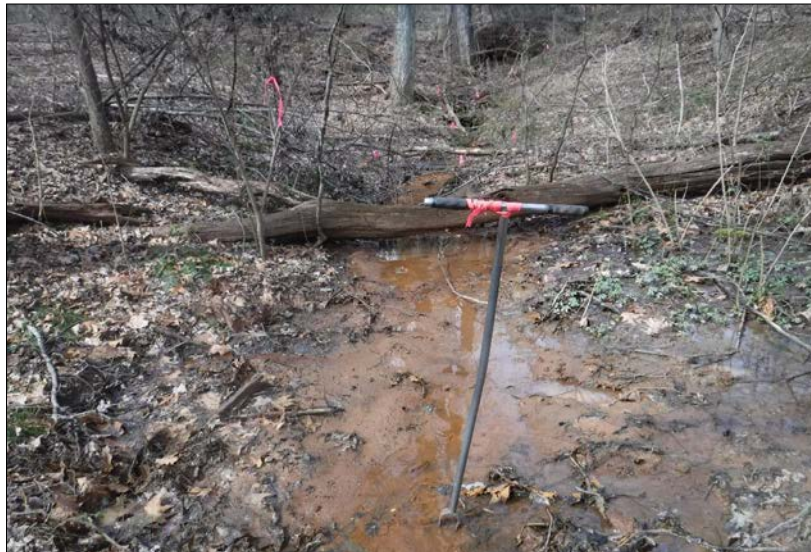
Looking upstream at stream reach 52-B. The reach was marginal with areas of active erosion. The right riparian buffer consisted of 75% mature forested area with less than 60% canopy cover, 15% impervious surfaces associated with State Route 220, and 10% densely vegetated herbaceous/shrub layer. The left riparian buffer consisted of 85% mature forested area and 15% impervious surfaces associated with State Route 220. Instream habitat was present in less than 10% of the reach. The reach was channelized through a culvert at the bottom of the reach.

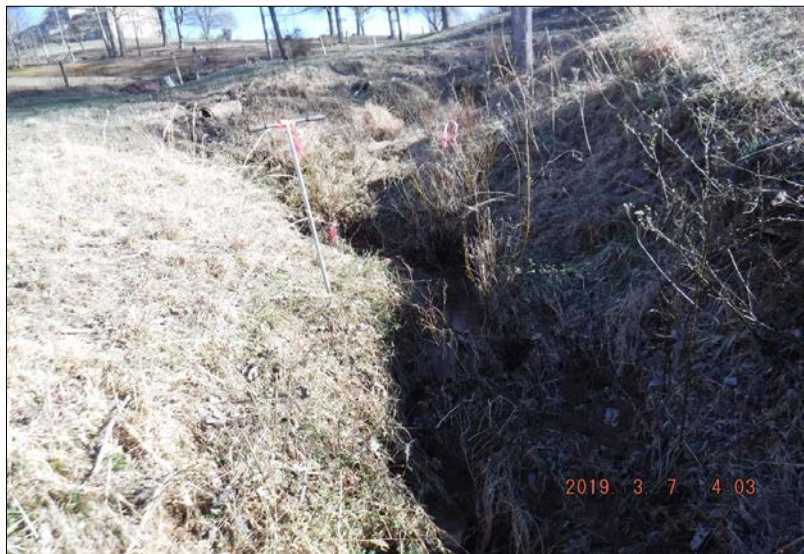
Looking upstream at stream reach 52-C. The reach had severely eroded, unstable banks. The right riparian buffer consisted of 5% wetland, 15% impervious surface and 80% actively grazed, maintained pasture. The left riparian buffer consisted of 40% forest with greater than 60% canopy cover and wetlands, 30% actively grazed, maintained pasture and 30% forest with 30-60% canopy cover. The in-stream habitat was poor and lacked stable elements. Channel alterations were severe and included multiple culverts, straightening of channel and impacts from livestock.

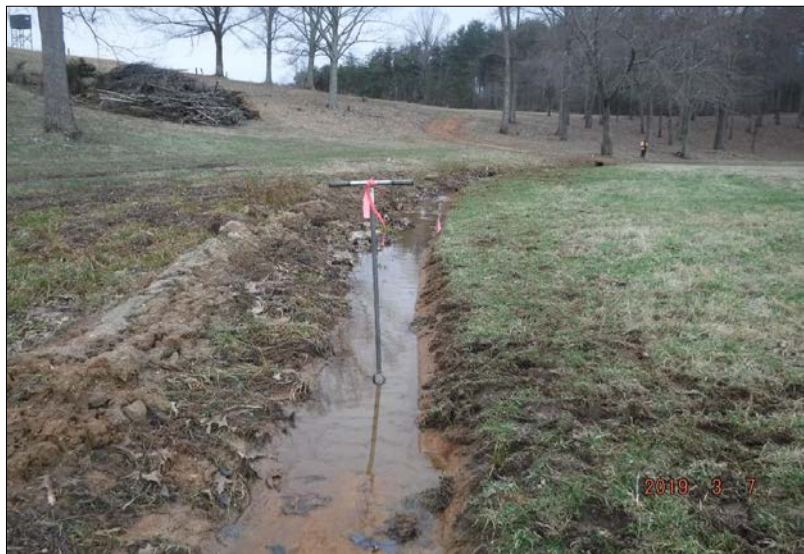
Looking upstream at stream reach 52-D. The reach was unstable and had been channelized. The right riparian buffer consisted of 45% wetland and forest with greater than 60% canopy cover, and 55% maintained pasture. The left buffer consisted of 20% wetlands and forest with greater than 60% canopy cover, and 80% maintained pasture. The in-stream habitat lacked stable features. The channel had been greatly altered through channelization, culvert installation and livestock access.

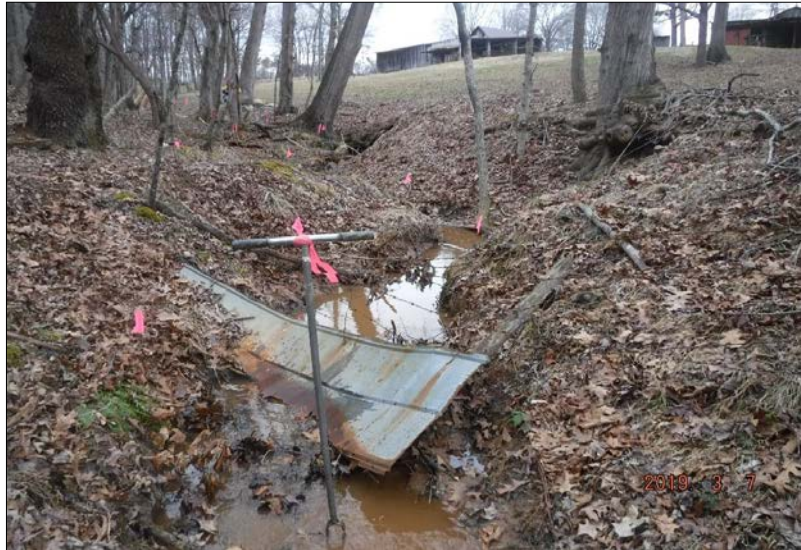
Looking upstream at stream reach 52-E. The reach had eroded banks with moderate vegetative protection. The right riparian buffer consisted of 25% maintained pasture and 75% forest cover with greater than 60% canopy cover and wetlands. The left riparian buffer consisted of 15% wetlands, 80% maintained pasture, and 5% forest with 30-60% canopy cover and a non-maintained understory. The in-stream habitat was marginal and contained stable features in less than 30% of the reach. Channel alterations included livestock access to the stream.

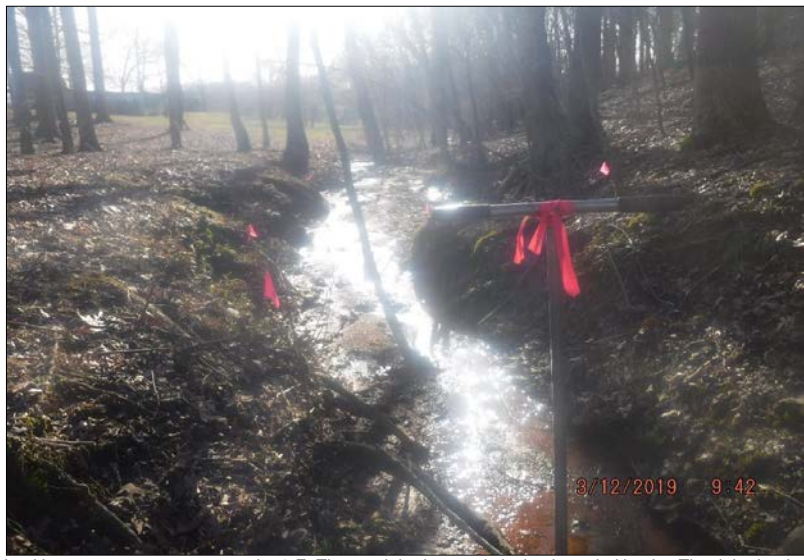
Looking upstream at stream reach 52-E. The reach had severely incised, eroded banks. The right riparian buffer consisted of 90% forest cover with greater than 60% canopy cover and 10% forest with 30-60% canopy cover and maintained understory. The left riparian buffer consisted of 55% forest cover with greater than 60% canopy cover and 45% forest with 30-60% canopy cover and maintained understory. The in-stream habitat was suboptimal with stable features throughout 30-50% of the reach. Channel alterations included a culvert.

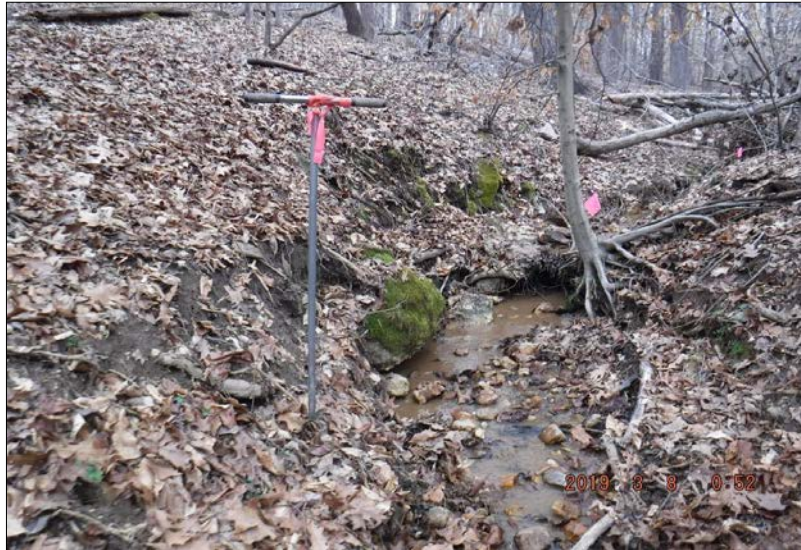
Looking upstream at stream reach 53-A. The reach had stable banks with some erosion present. The right riparian buffer was forested with greater than 60% canopy cover containing wetlands. The left riparian buffer contained 95% forest with greater than 60% canopy cover and wetlands, and and 5% spoil pile. The in-stream habitat was optimal and contained leaf packs, root wads and various substrate sizes. The channel had no known alterations.

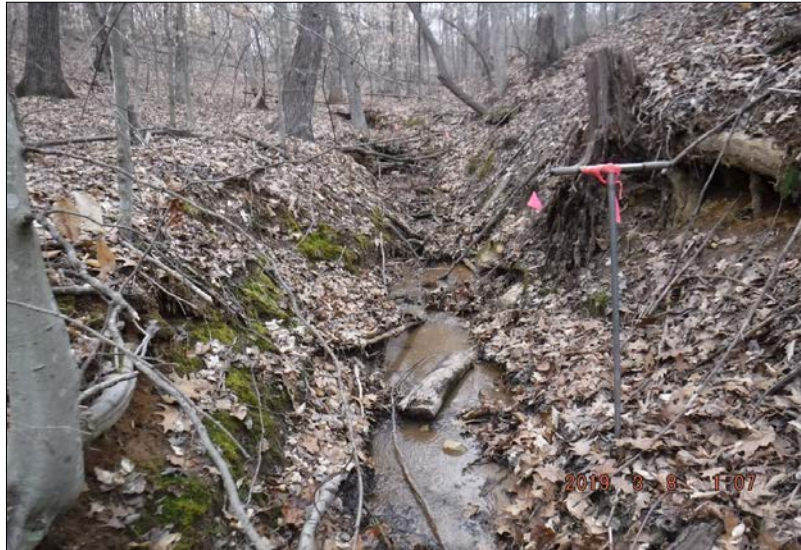
Looking upstream at stream reach 53-B. The reach had unstable, incised banks. The right and left riparian buffers were forested with greater than 60% canopy cover. The in-stream habitat was optimal with stable elements in greater than 50% of the reach. The channel had no known alterations.

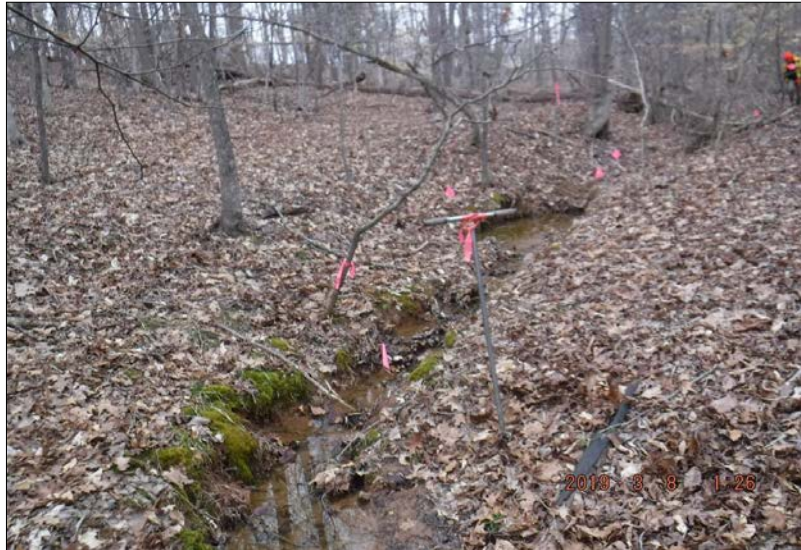
Looking upstream at stream reach 53-C. The reach had stable banks with little incision and active erosion. The right and left riparian buffers were forested with greater than 60% canopy cover, with a wetland located within the right riparian buffer. The in-stream habitat was marginal with 10-30% stable habitat elements within the reach. No channel alterations were observed.

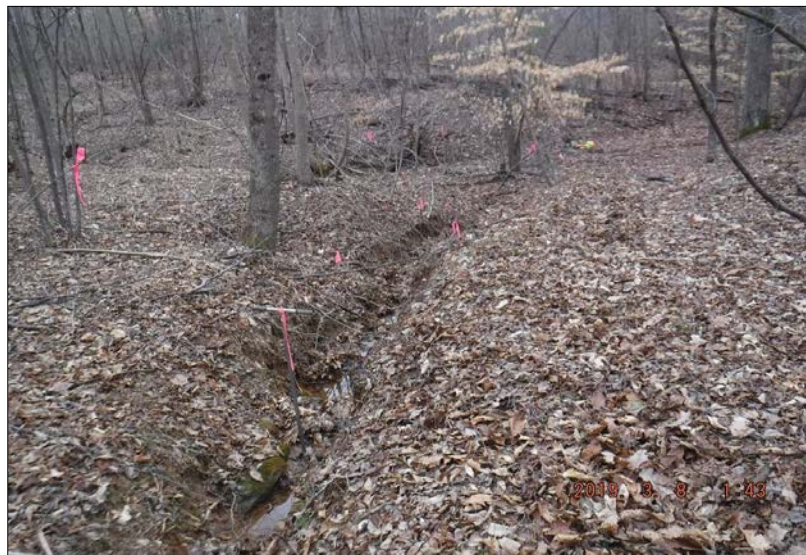
Looking downstream at stream reach 53-D. The right riparian buffer was forested with greater than 60% canopy cover. The left riparian buffer was of 65% forested with greater than 60% canopy cover, 15% non-maintained dense herbaceous vegetation and 20% impervious surface.

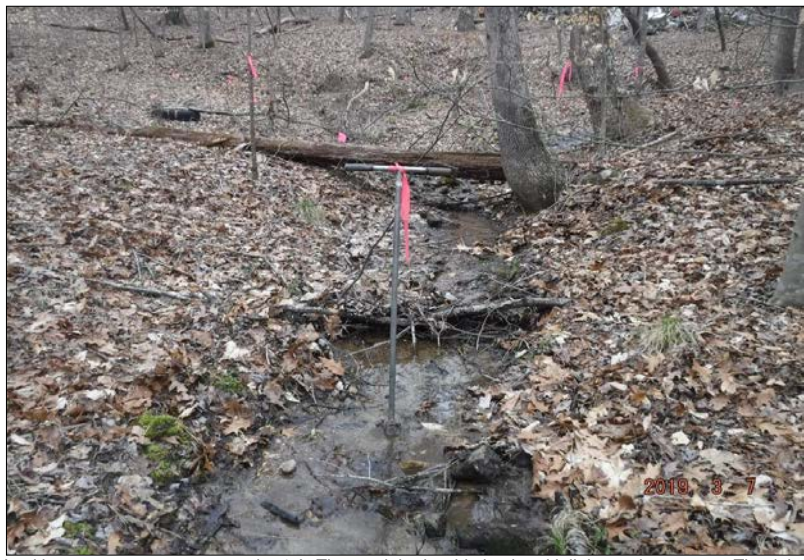
Looking upstream at stream reach 54-A. The reach had stable banks with little erosion present. The right and left riparian buffers consisted of 100% forest cover with greater than 60% canopy cover containing wetlands. The in-stream habitat was suboptimal and contained leaf packs and woody debris. The channel had no known alterations.

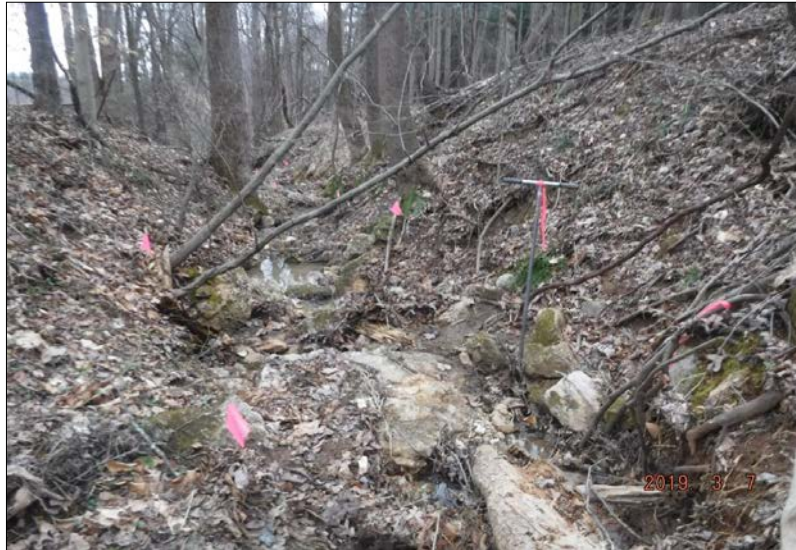
Looking upstream at stream reach 55-A. The reach had overwidened with incised, unstable banks. The right riparian buffer was forested with greater than 60% canopy cover. The left riparian buffer was 50% forested with greater than 60% canopy cover and 50% maintained lawn. The in-stream habitat was suboptimal, with stable elements in 30-50% of the reach. The channel had no known alterations.

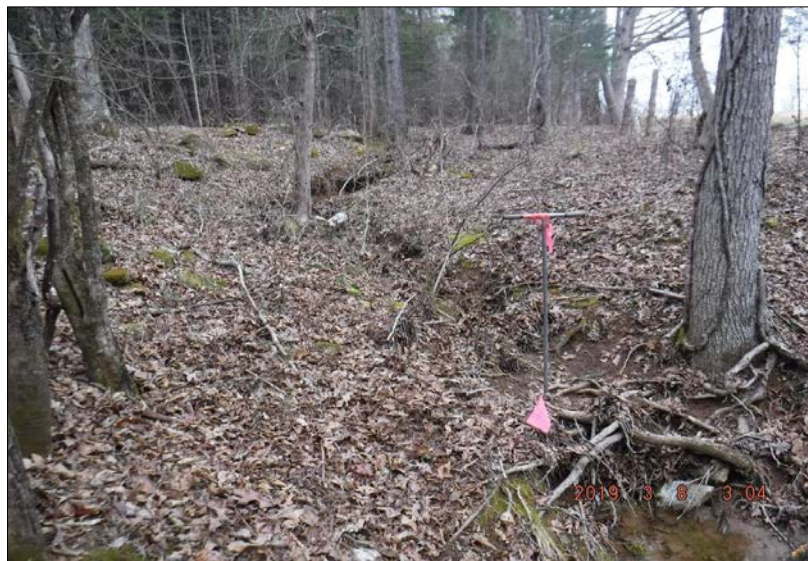
Looking upstream at stream reach 55-B. The right riparian buffer was forested with greater than 60% canopy cover. The left riparian buffer was 40% forested with greater than 60% canopy cover, and 60% mowed lawn.

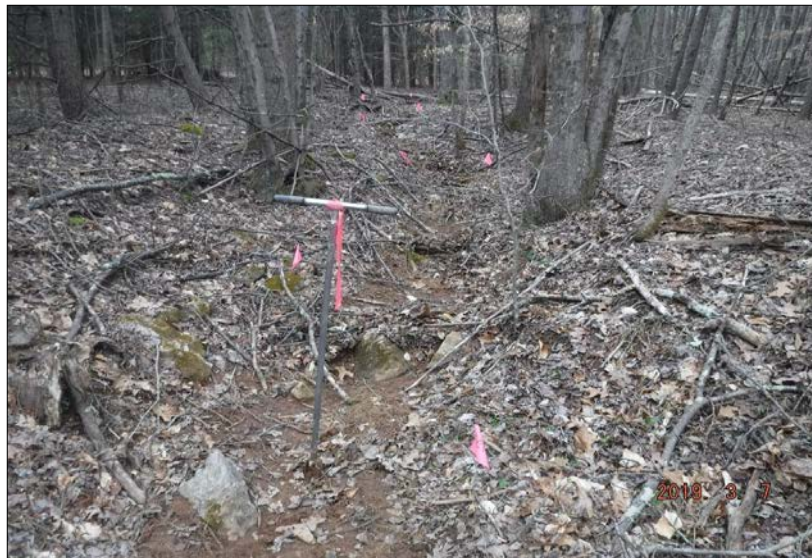
Looking upstream at stream reach 55-C. The right riparian buffer was forested with greater than 60% canopy cover. The left riparian buffer was 50% forested with greater than 60% canopy cover and 50% maintained lawn.

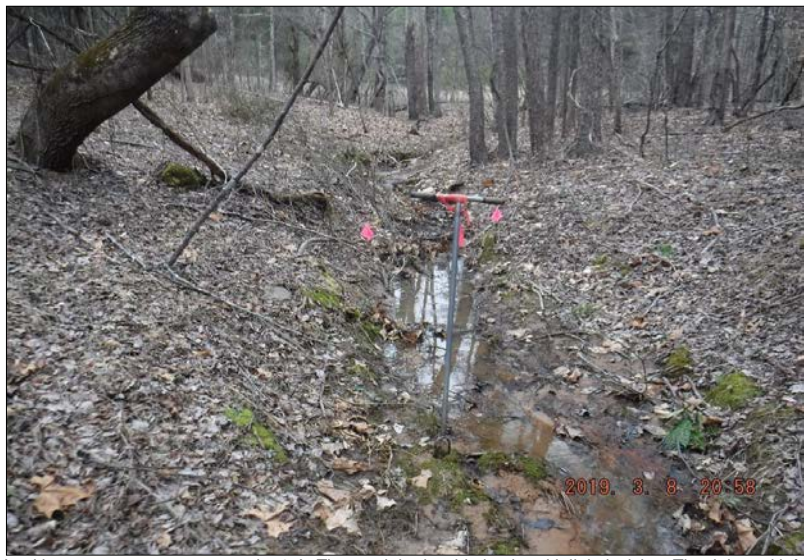
Looking upstream at stream reach 56-A. The reach had stable banks with little incision. The right and left riparian buffers were forested with greater than 60% canopy cover, with wetlands located within the left riparian buffer. The in-stream habitat was suboptimal with stable elements found within 30-50% of the reach. No channel alterations in reach.

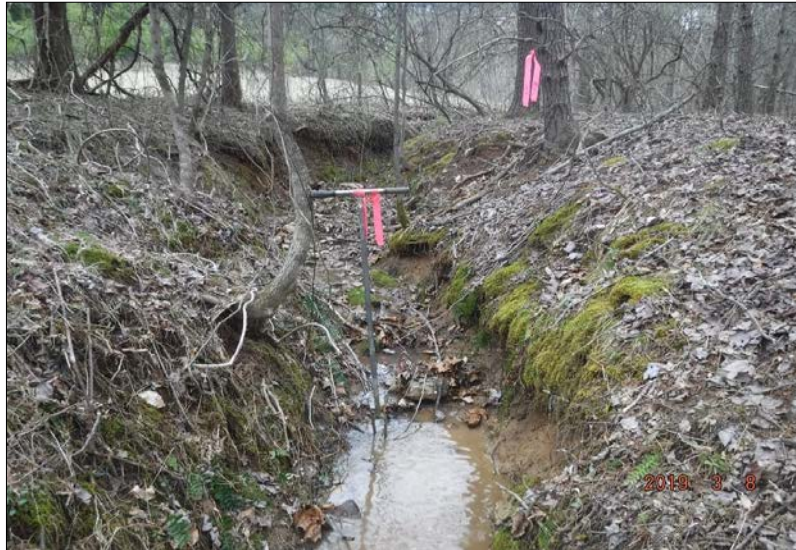
Looking upstream at stream reach 56-B. The reach had incised, unstable banks. The right riparian buffer was 80% forested with greater than 60% canopy cover and 5% maintained herbaceous vegetation. The left riparian buffer was forested with greater than 60% canopy cover. The in-stream habitat was optimal and contained stable elements in greater than 50% of the reach. The channel had no known alterations.

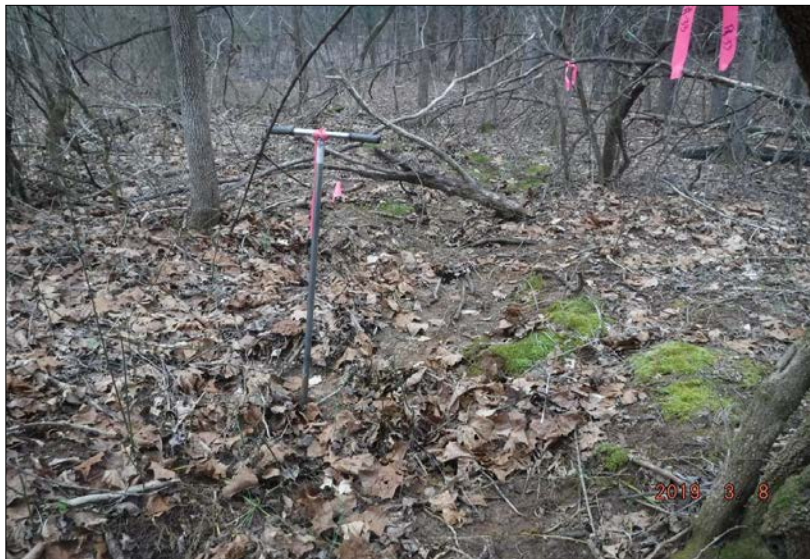
Looking upstream at stream reach 56-C. The right riparian buffer was forested with greater than 60% canopy cover. The left riparian buffer was 65% forested with greater than 60% canopy cover, and 20% non-maintained, dense herbaceous vegetation with a shrub layer present.

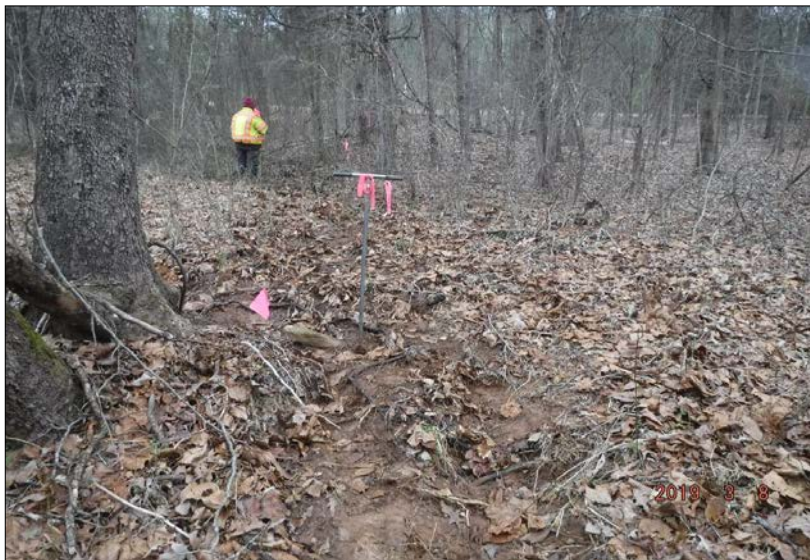
Looking upstream at stream reach 56-D. The right riparian buffer was 90% forested with greater than 60% canopy cover and 10% herbaceous vegetation. The left riparian buffer was forested with greater than 60% canopy cover.

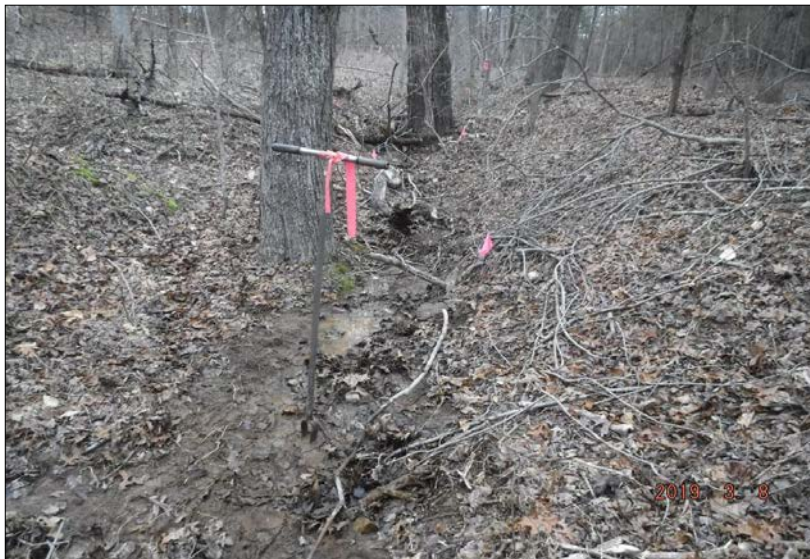
Looking upstream at stream reach 56-E. The right riparian buffer was forested with greater than 60% canopy cover. The left buffer was 50% forested with greater than 60% canopy cover, and had 50% cover of non-maintained, dense herbaceous vegetation with a shrub layer.

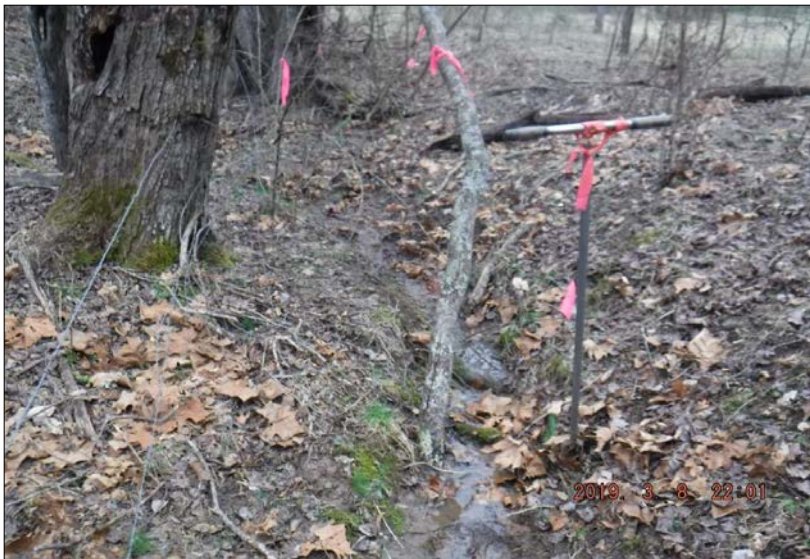
Looking upstream at stream reach 57-A. The right riparian buffer consisted of 100% mature forest cover. The left buffer consisted of 40% mature trees, 60% dense herbaceous and shrub layer. The right riparian buffer was forested with greater than 60% canopy cover. The left buffer was 30% forested with greater than 60% canopy cover, and had 70% cover of tree stratum with 30-60% canopy cover and a maintained understory.

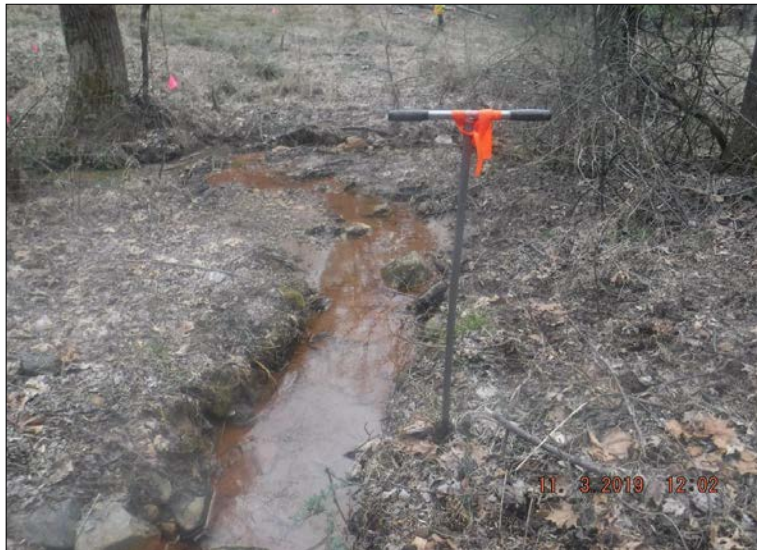
Looking south (downstream) at Stream Reach 58-A. The stream exhibits very little incision with 80-100% stable banks. The right bank's riparian buffer is encroached upon by impervious road surfaces but is also partly forested (>60% canopy cover). The left bank's riparian buffer is composed of maintained grass associated with the existing overhead electric easement, as well as, forest providing greater than 60% canopy cover. Instream habitat elements are present in 30-50% of the stream. The upstream end of the reach is fed by a culvert, disrupting less than 20% of the reach.

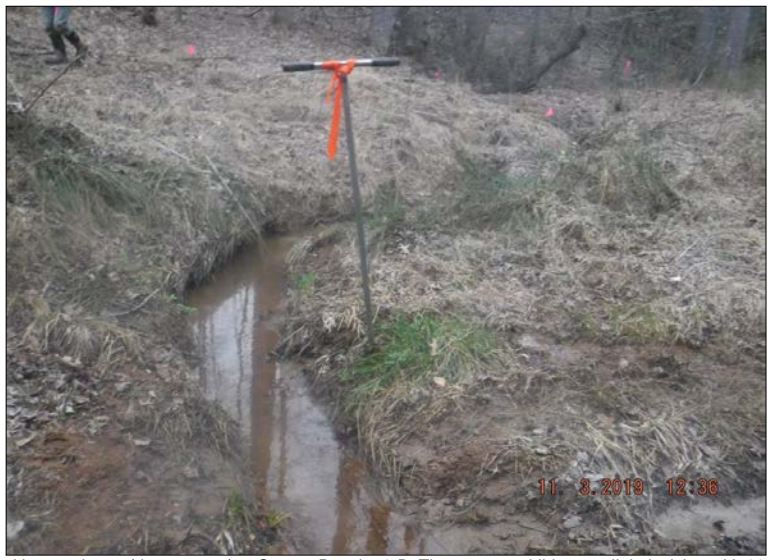
Looking southeast (downstream) at Stream Reach 58-B. The stream exhibits very little incision with 80-100% stable banks. The right and left banks' riparian buffers are composed of maintained grass associated with the existing overhead electric easement. Instream habitat elements are present in 30-50% of the stream. The channel had no known alterations.

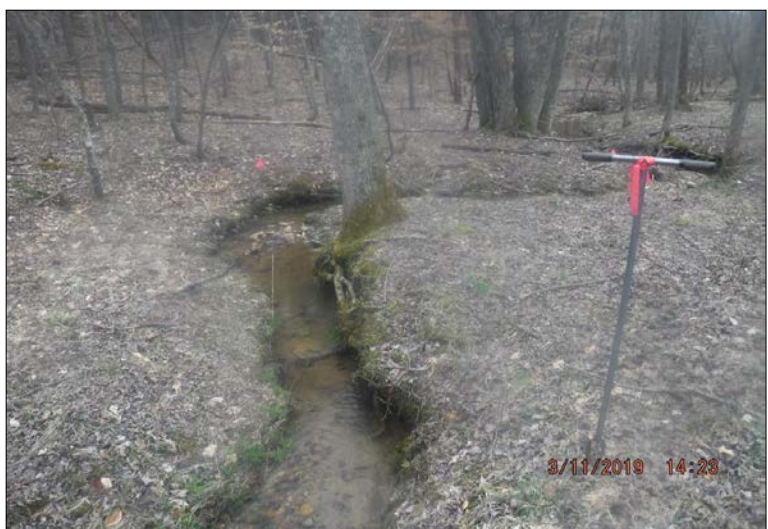
Looking southeast (downstream) at Stream Reach 58-C. The stream exhibits very little incision with 60-80% stable banks. The right and left banks' riparian buffers are composed of greater than 60% tree canopy cover. Instream habitat elements are present in 30-50% of the stream. The channel had no known alterations.

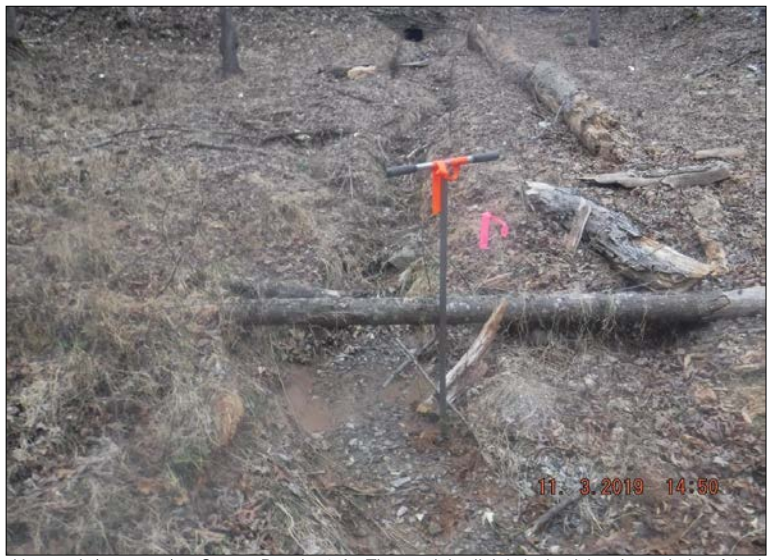
Looking north (upstream) at Stream Reach 59-A. The reach is slightly incised, but the majority of the banks are stable (60-80%). The right and left riparian buffers are composed of tree canopy cover between 30-60% and a non-maintained understory. Stable habitat elements are present in 10-30% of the reach. The upstream end of the reach is fed by a culvert, disrupting less than 20% of the reach.

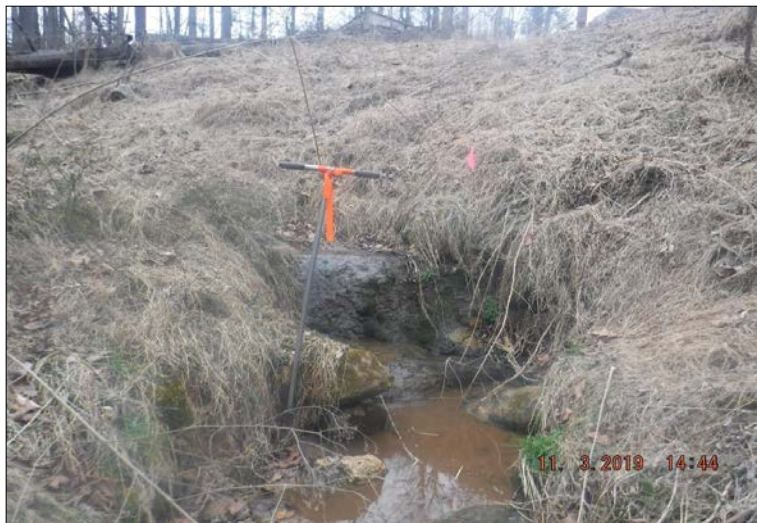
Looking northwest (upstream) at Stream Reach 59-B. The reach is slightly incised, but the majority of the banks are stable (60-80%). The right and left riparian buffers consist of a herbaceous, maintained right-of-way. Stable habitat elements are present in 10-30% of the reach. The upstream end of the reach is fed by a culvert, disrupting less than 20% of the reach.

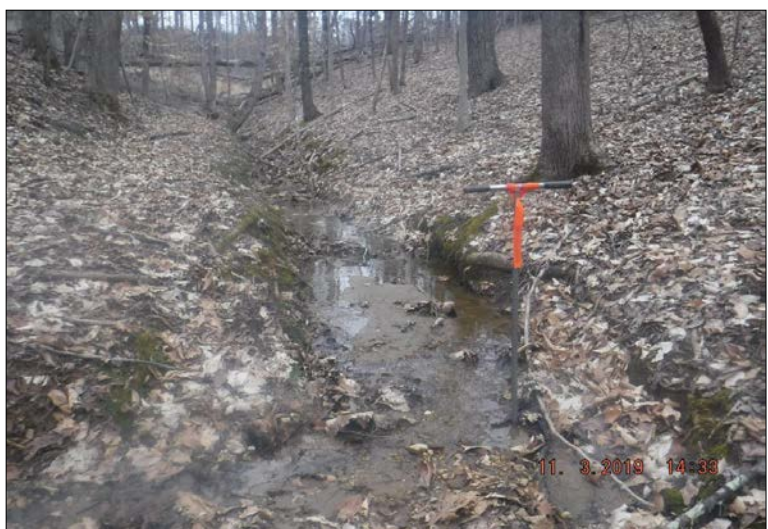
Looking upstream at Stream Reach 59-C. The reach is slightly incised, but the majority of the banks are stable (60-80%). The right and left riparian buffers are composed of tree stratum with greater than 60% tree canopy cover. Stable habitat elements are present in 30-50% of the reach. No channel alteration is present within the reach.

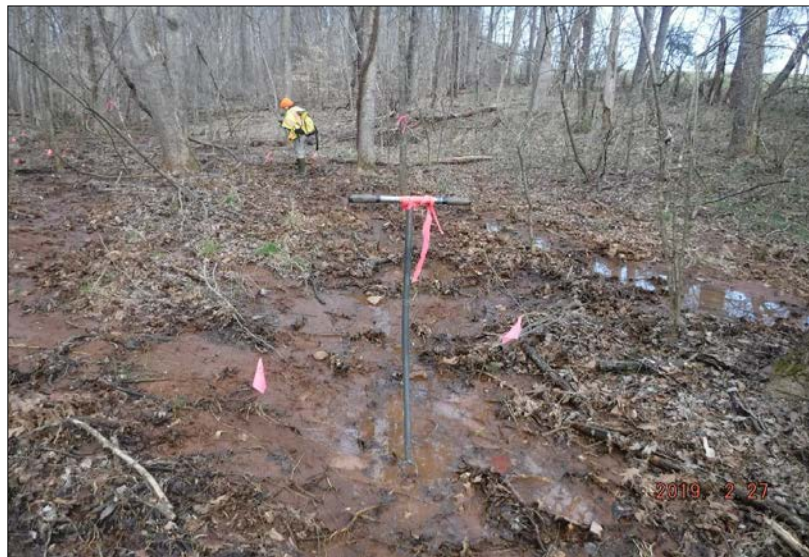
Looking upstream at stream reach 60-A. The right riparian buffer consisted of 100% mature forest cover, and the left riparian buffer consisted of 50% mature forest cover and 50% field containing herbaceous vegetation.

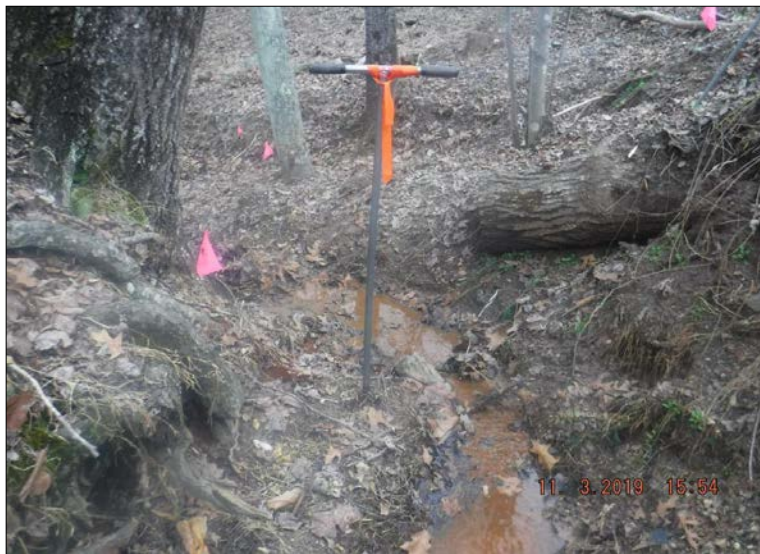
Looking southwest (downstream) at Stream Reach 60-C. The reach is often incised with erosion present on 40-60% of banks. The left bank riparian buffer is heavily encroached upon by impervious surfaces (road) and has some forested areas with 30-60% canopy cover; the right bank riparian buffer is entirely forested and exhibits greater than 60% canopy cover. Habitat elements are unstable and are present in less than 10% of the reach. The reach has been significantly altered (60-80%) by the presence of a culvert at bottom of stream.

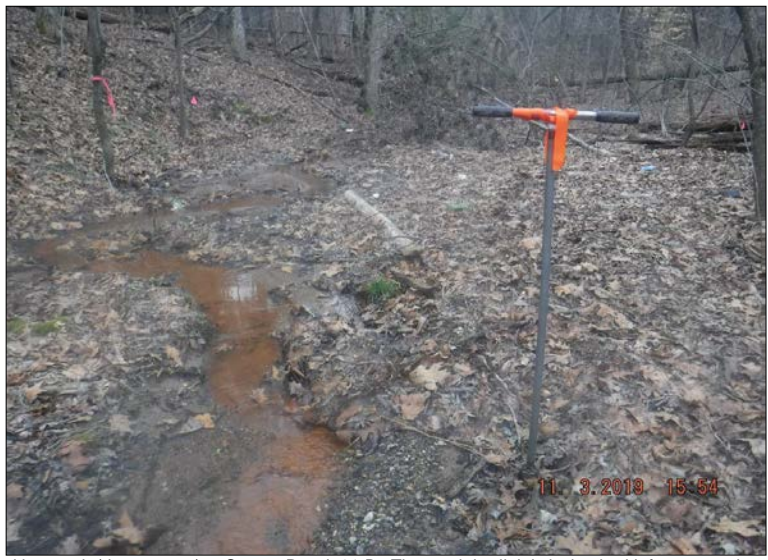
Looking south (downstream) at Stream Reach 61-B. The reach is slightly incised, with few areas showing signs of active erosion. The right and left riparian buffers consists of greater than 60% tree canopy cover. Stable habitat elements are present in 30-50% of the reach. The reach shows no signs of alteration.

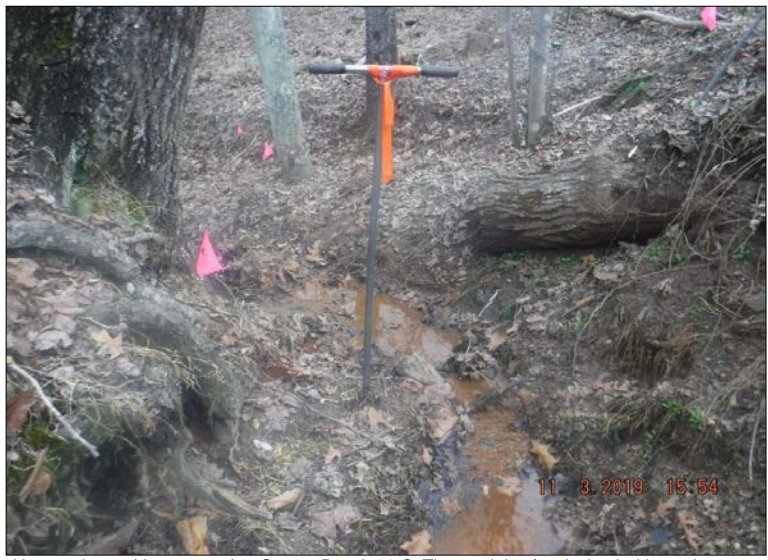
Looking southwest (downstream) at Stream Reach 61-C. The reach is often incised with erosion present on 40-60% of banks. The left bank riparian buffer is heavily encroached upon by impervious surfaces (road) and has some forested areas with 30-60% canopy cover. The right bank riparian buffer is entirely forested and exhibits greater than 60% canopy cover. Habitat elements are unstable and are present in less than 10% of the reach. The reach has been significantly altered (60-80%) by the presence of a culvert and the adjacent road.

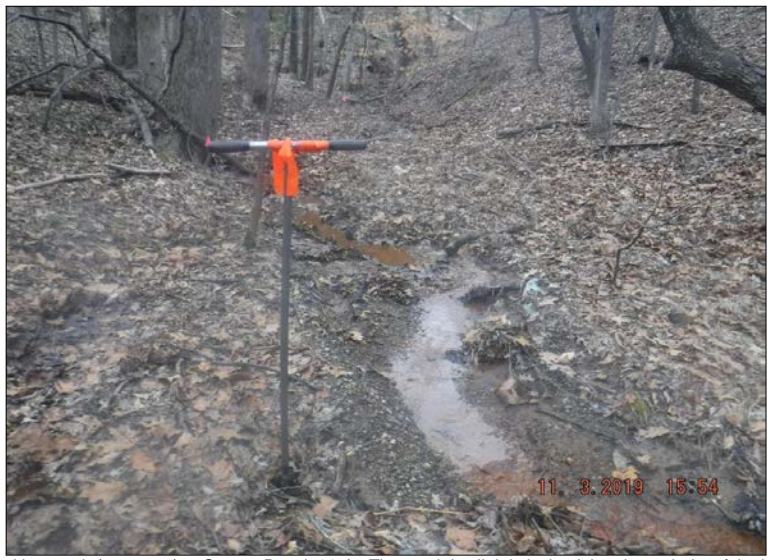
Looking south (upstream) at Stream Reach 62-A. The reach is slightly incised, but the majority of the banks are stable (60-80%). The right and left riparian buffers are composed largely of forest canopy cover greater than 60%, with a small area on both banks composed of maintained grass. Stable habitat elements are present in 10-30% of the reach. The upstream end of the reach is fed by a culvert, disrupting less than 20% of the reach.

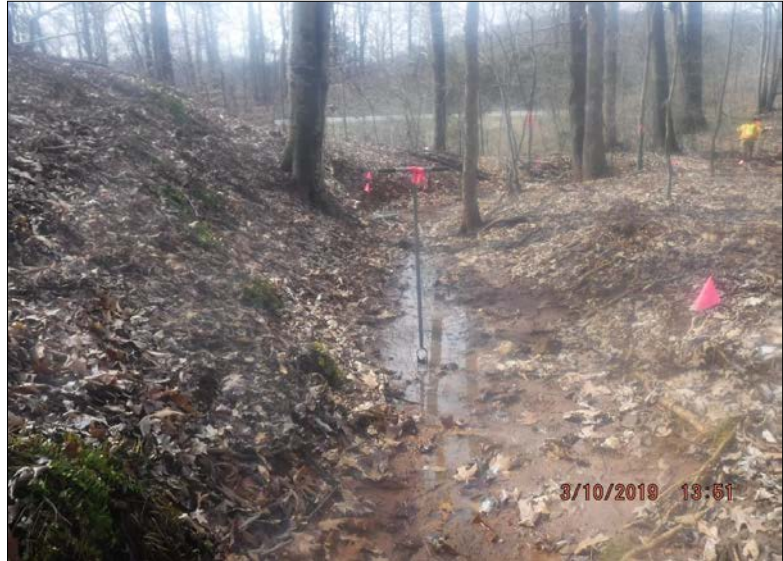
Looking southwest (downstream) at Stream Reach 63-A. The banks are slightly incised with mostly stable banks (60-80%). The right bank's riparian buffer is predominantly forested, with an area of dense herbaceous vegetation and shrubs providing less than 30% tree canopy cover. The left bank's riparian buffer is composed of forest with greater than 60% tree canopy cover. Instream habitat elements are stable and present in 30-50% of the reach. The downstream end of the reach is culverted, disrupting 20-40% of the reach.

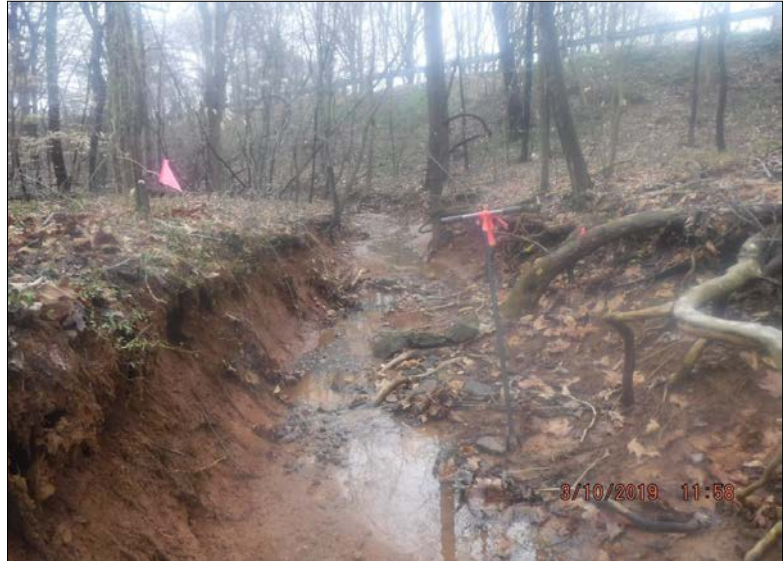
Looking southwest (downstream) at Stream Reach 63-B. The majority of the banks are incised and overwidened (60-80%). The left and right riparian buffers are occupied by forest with greater than 60% tree canopy cover and an impervious road. Instream habitat elements are present in 10-30% of the reach. Both the downstream and upstream ends of the reach are culverted, disrupting 20-40% of the reach.

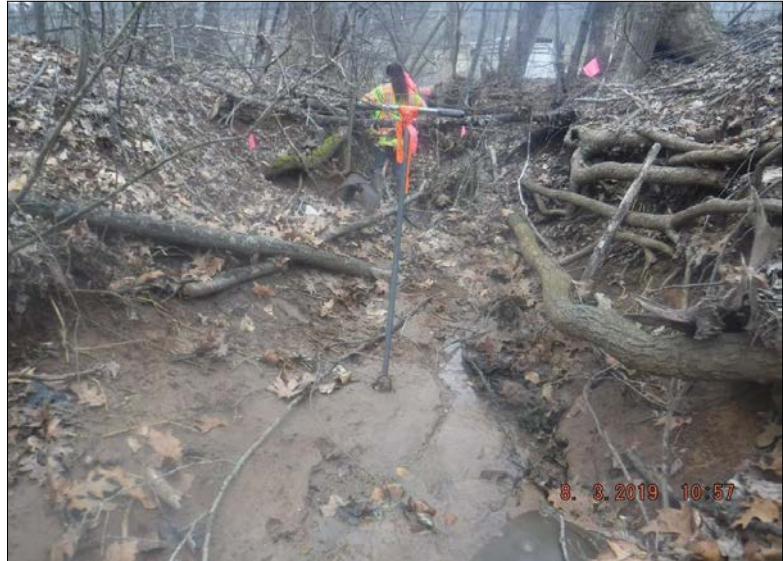
Looking southwest (downstream) at Stream Reach 63-B. Erosion is present along both banks as a result of stormwater surges, but the majority of banks are stable. Both banks' riparian buffers are primarily forested with greater than 60% tree canopy cover but contain canopy gaps dominated by dense herbaceous vegetation. Stable habitat elements are present in 10-30% of the reach. The upstream end of the reach is fed by a culvert, disrupting less than 20% of the reach.

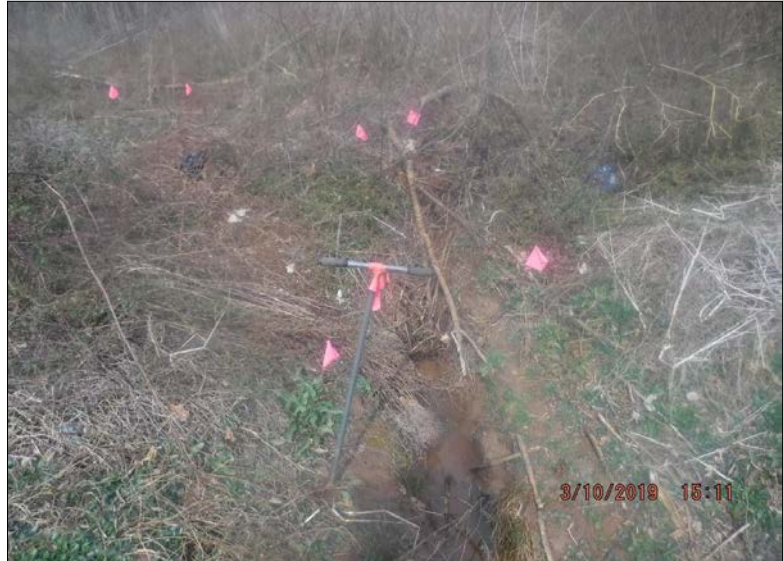
Looking northeast (upstream) at Stream Reach 64-A. The banks are often incised with relatively low bank slopes. Both banks' riparian buffers are dominated by dense herbaceous vegetation and tree and shrub layers occupying less than 30% of the canopy. Impervious surfaces are present on the outer third of each bank's riparian area. Instream habitat elements are unstable and occupy less than 10% of the reach. This stream reach flows into a culvert, disrupting less than 20% of the total reach.

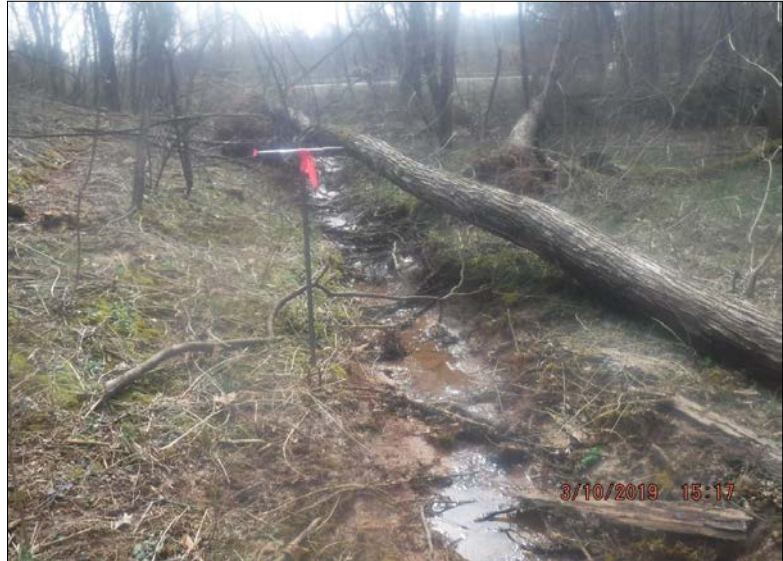
Looking southwest (downstream) at Stream Reach 64-B. The channel is slightly incised with mostly stable banks (60-80%). Both the left and right banks' riparian buffers are composed of forest providing greater than 60% tree canopy cover. Instream habitat elements are present in 10-30% of the reach. The downstream and upstream ends of the reach are culverted, disrupting less than 20% of the reach.
