Stream Assessment Form (Form 1)

Unified Stream Methodology for use in Virginia

Project #	Project Name (Applicant)	Locality	Cowardin Class.	HUC	Date	SAR # / Data Point	Impact/SAR Length	Impact Factor	
	Martinsville Connector (VDOT)	Henry	R3	02070010	3/01/2019	A		N/A	
Name(s) of Evaluator(s)		Stream Name and Information					Stream Map		
SA, JB		Unnamed Tributary to Marrowbone Creek

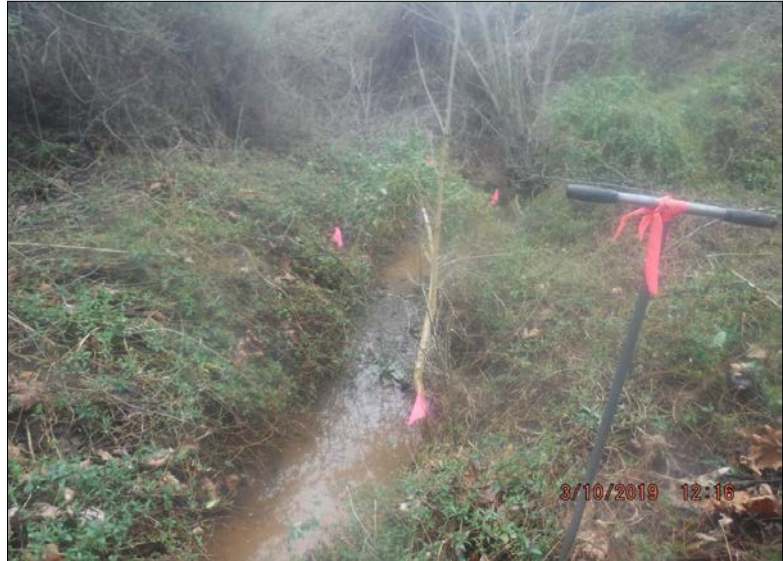
Looking southwest (downstream) at Stream Reach 64-C. The channel is often incised with relatively low bank slopes. Impervious surfaces are in the immediate vicinity of both banks; non-impervious areas are dominated by dense herbaceous vegetation, with shrub and tree cover providing less than 30% tree canopy. Instream habitat elements are unstable and are present in less than 10% of the reach. The downstream and upstream ends of the reach are fed by a culvert, disrupting 20-40% of the reach.

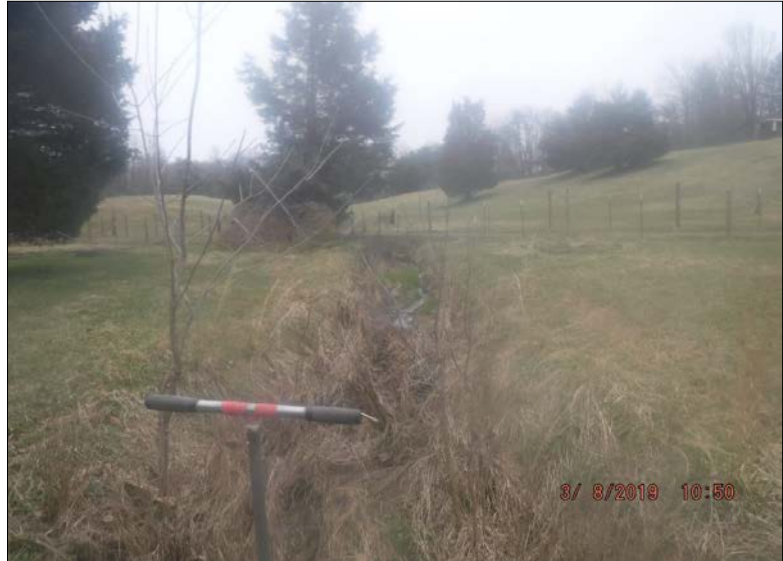
Looking south (downstream) at Stream Reach 64-D. Both banks' riparian buffers consist of actively grazed pasture. Instream habitat elements are lacking, and are present in less than 10% of the reach. The upstream end of the reach is fed by a culvert, disrupting less than 20% of the reach.

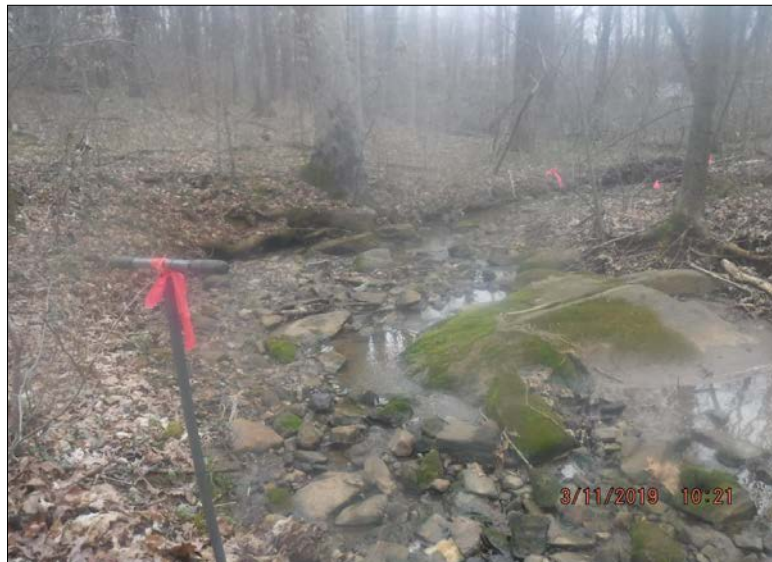
Looking southeast (downstream) at Stream Reach 65-A. The channel is slightly incised with mostly stable banks (60-80%). Both riparian buffers are composed of forest providing greater than 60% tree canopy cover. Stable habitat elements are present in 30-50% of the reach. There is no evidence of channel alteration within the reach.

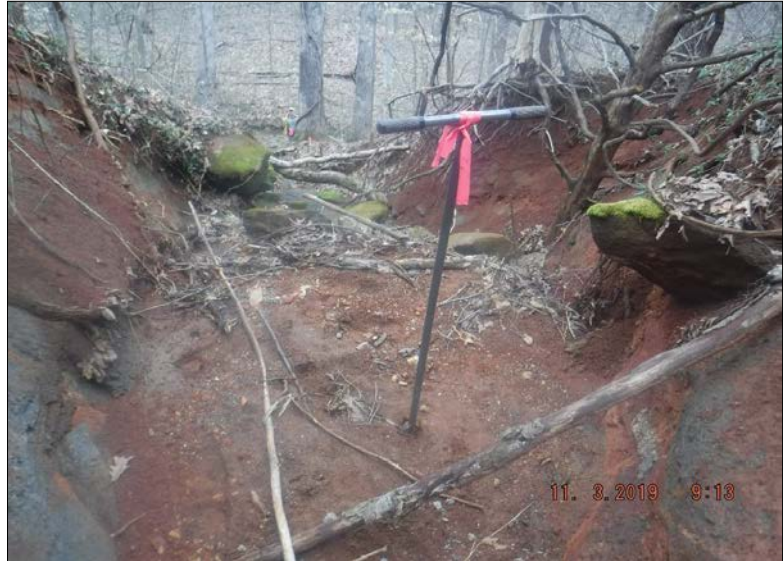
Looking east (downstream) at Stream Reach 66-A. The channel is deeply incised, restricting flow to within the banks. Both riparian buffers are composed of forest providing greater than 60% tree canopy cover. Habitat elements are unstable and are present in less than 10% of the reach. A culvert is disrupting less than 20% of the reach.

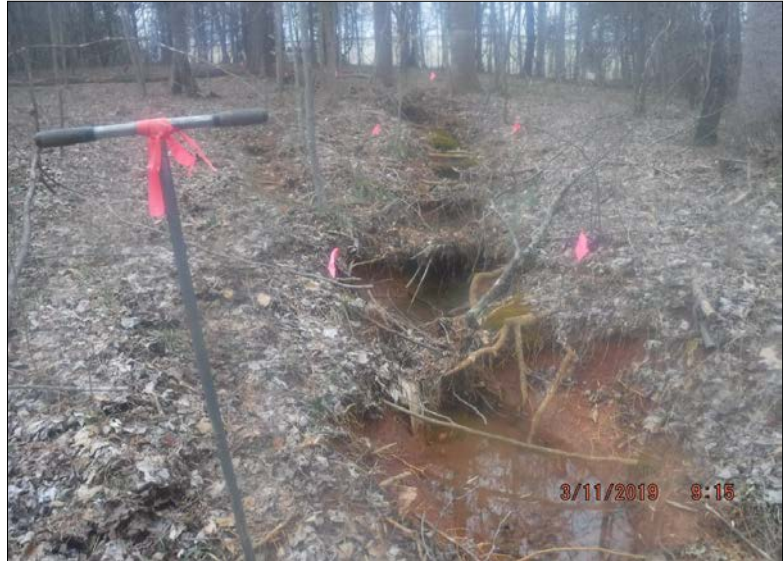
Looking northwest (upstream) at Stream Reach 67-A. The channel is often incised, with erosion present on both banks. The right bank's riparian buffer is composed largely of forest providing greater than 60% tree canopy cover, with a bit of encroachment by impervious roadway and maintained grass. The left bank's riparian buffer is composed entirely of forest providing greater than 60% canopy cover. Habitat elements are present in less than 10% of the reach. There is a culvert at the upstream end of the reach is disrupting less than 20% of the reach.

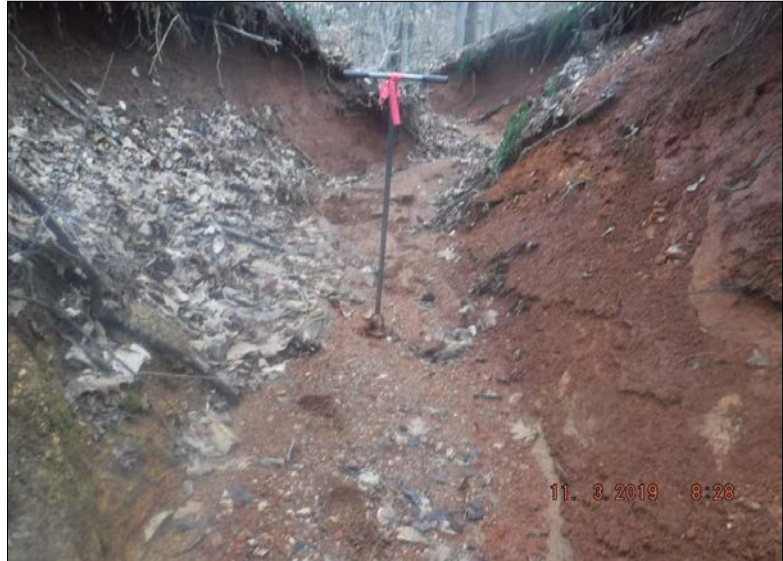
Looking northeast (downstream) at Stream Reach 67-B. The channel is incised and the majority of both banks are nearly vertical. The right bank's riparian buffer is largely composed of forest providing greater than 60% canopy cover, with some encroachment by maintained grass. The left bank's riparian buffer is composed entirely of forest providing greater than 60% tree canopy cover. Habitat elements are present in less than 10% of the reach. There is no evidence of channel alteration within the reach.

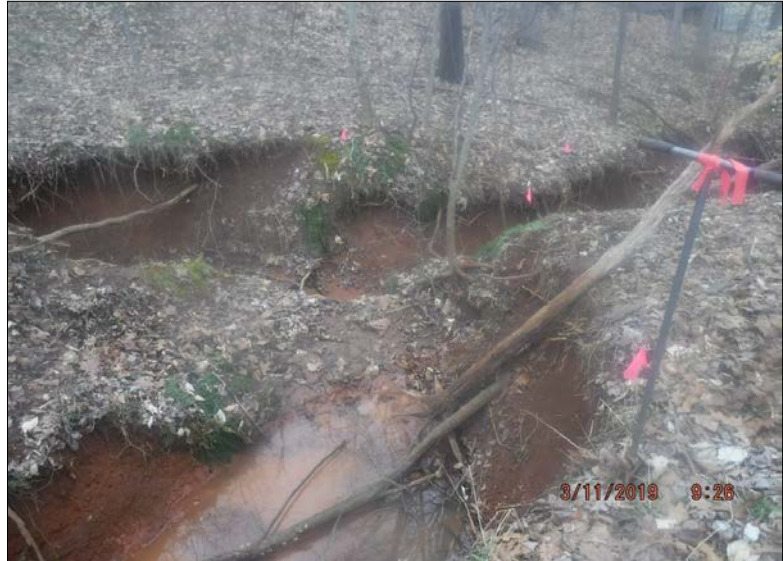
Looking east (downstream) at Stream Reach 67-C. The channel is deeply incised, restricting flow to within the banks. The right bank's riparian buffer is composed of impervious surface, maintained grass associated with the impervious surface, and forest with greater than 60% tree canopy cover. The left bank's riparian buffer is composed entirely of forest with greater than 60% tree canopy cover. Habitat elements are present in less than 10% of the reach. There is no evidence of channel alteration within the reach.

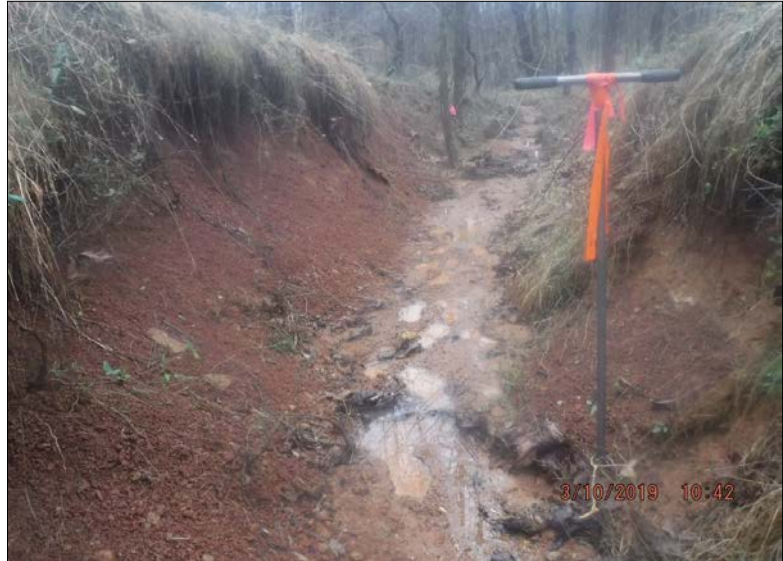
Looking east (downstream) at Stream Reach 68-A. Severe incision restricts flow to within the banks. The right bank's riparian buffer is occupied by impervious surfaces, mowed lawns associated with the impervious area, and non-maintained herbaceous vegetation with less than 30% tree canopy cover. The left bank's riparian is forested with greater than 60% tree canopy cover. Habitat elements are present in less than 10% of the reach. The upstream end of the reach is fed by a culvert, disrupting less than 20% of the reach.

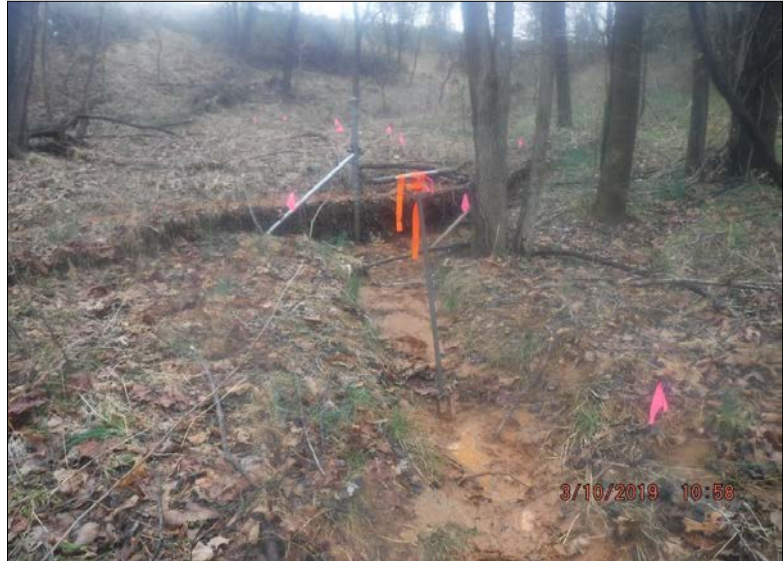
Looking northeast (upstream) at Stream Reach 69-A. The banks show areas of erosion, but vegetative protection is present along 60-80% of the reach. Both banks' riparian buffers are fully forested (>60% tree canopy cover). Habitat elements are unstable and are present in less than 10% of the reach. No channel alteration present within the reach.

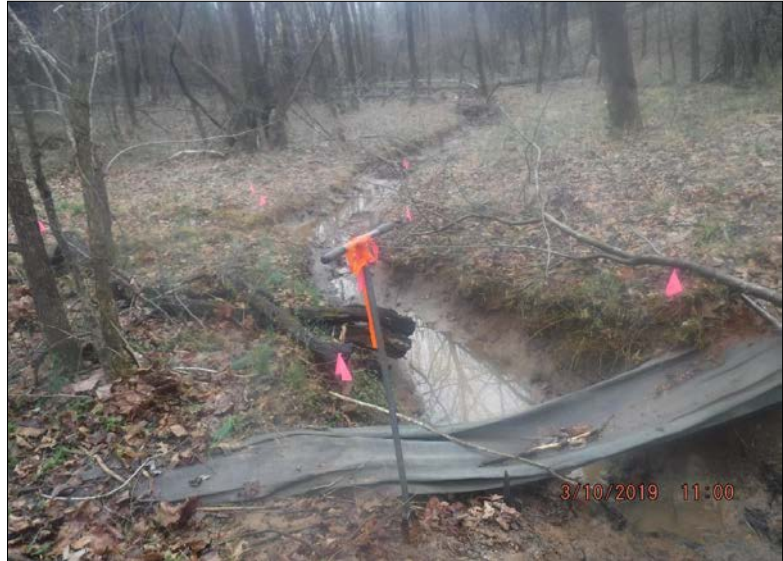
Looking south (downstream) at Stream Reach 70-A. The stream shows signs of erosion but the banks are mostly stable (60-80%). Both banks' riparian buffers are fully forested (>60% canopy cover). Instream habitat elements are present in 10-30% of the reach. The upstream end of the reach is fed by a culvert and rip rap is present immediately below; channel alteration effects 40-60% of the stream reach.

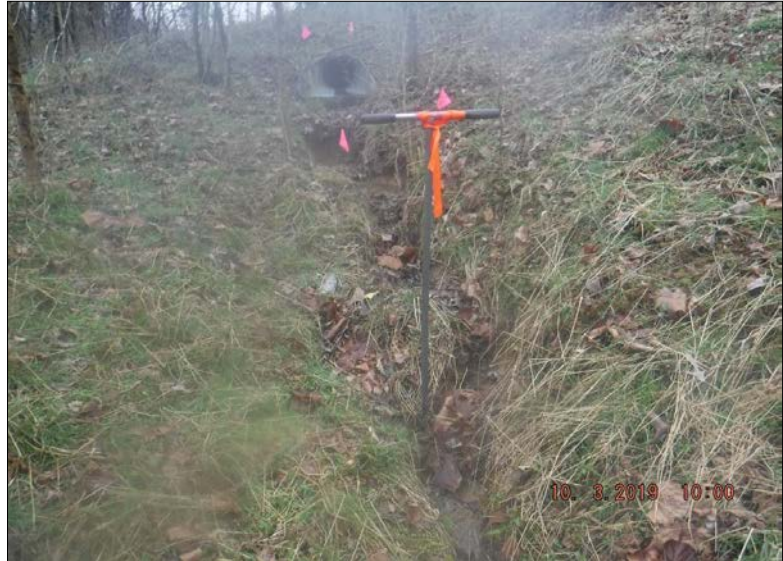
Looking northwest (upstream) at Stream Reach 71-A. The stream is slightly incised but the majority of banks are stable (60-80%). The left bank riparian buffer has impervious surface, mowed grass associated with the impervious surface, riparian areas lacking shrub and tree cover, and minimal tree canopy cover. The right bank's riparian buffer is fully forested (>60% canopy cover). Instream habitat is present in less than 10% of the reach. The upstream end of the reach is fed by a culvert, disrupting less than 20% of the reach.

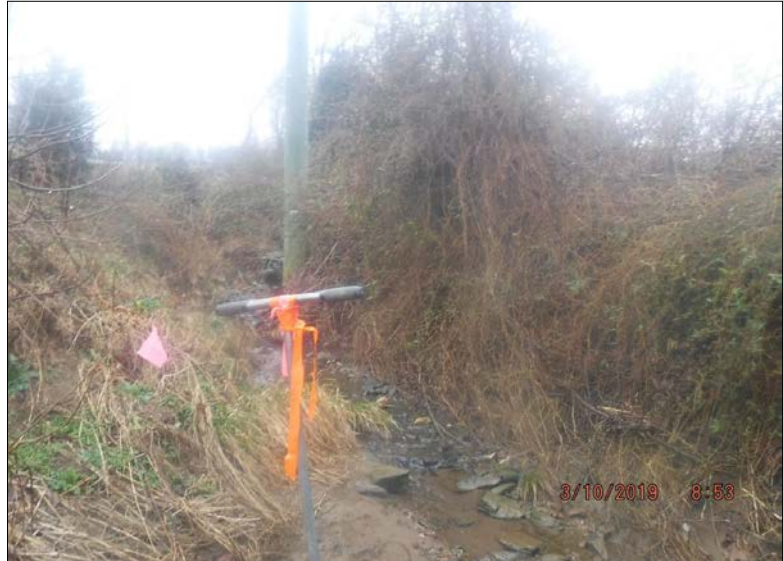
Looking north (upstream) at Stream Reach 72-A. Active erosion is occurring, with vegetative protection on 40-60% of the banks within the reach. Both riparian buffers are encroached upon by paved asphalt, with dense herbaceous vegetation occupying the space between the stream and pavement. Stable habitat elements are present in 10-30% of the reach. The reach is culverted across Joseph Martin Highway (Rt. 641) and the upstream end of the reach is fed by a culvert, disrupting 20-40% of the reach.

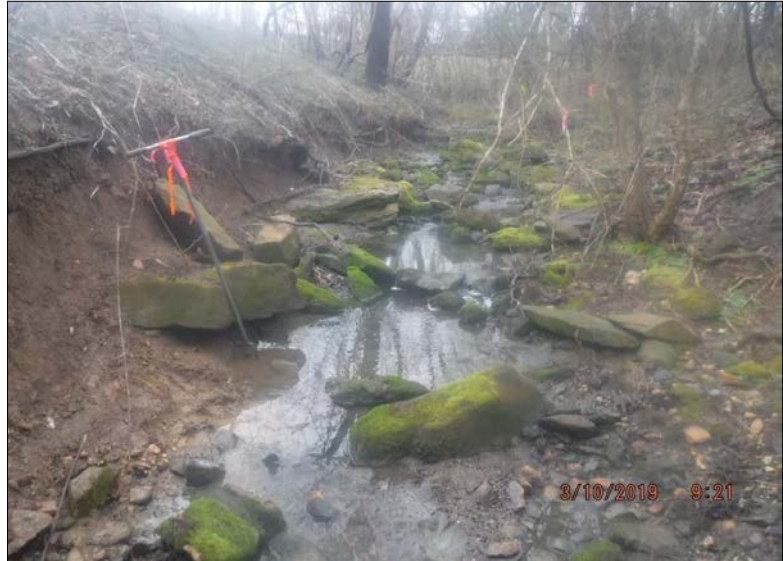
Looking north (upstream) at Stream Reach 72-B. The right bank's riparian buffer contains impervious surfaces, maintained grass associated with the impervious surfaces, non-maintained herbaceous vegetation, and a minimal amount of tree canopy cover. The left bank's riparian buffer is occupied by mowed grass and areas of forest with greater than 60% tree canopy cover. Stable habitat elements are present in 10-30% of the reach. The downstream and upstream ends of the reach are culverted, disrupting less than 20% of the reach.

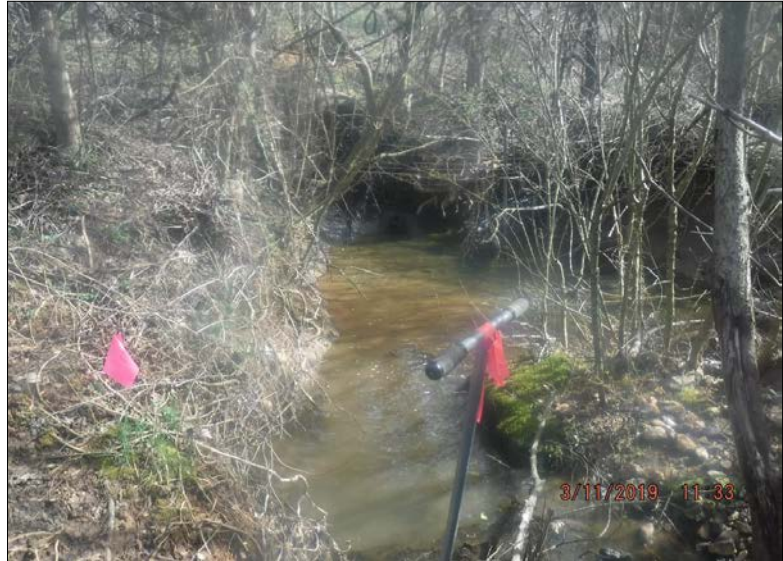
Looking east (upstream) at Stream Reach 72-C. The channel exhibits vertical banks and is overwidened. The left and right banks' riparian buffers are composed of forest providing greater than 60% tree canopy cover. Habitat elements are lacking and are present in less than 10% of the reach. The reach has culverts at both ends, disrupting 40-60% of the reach.

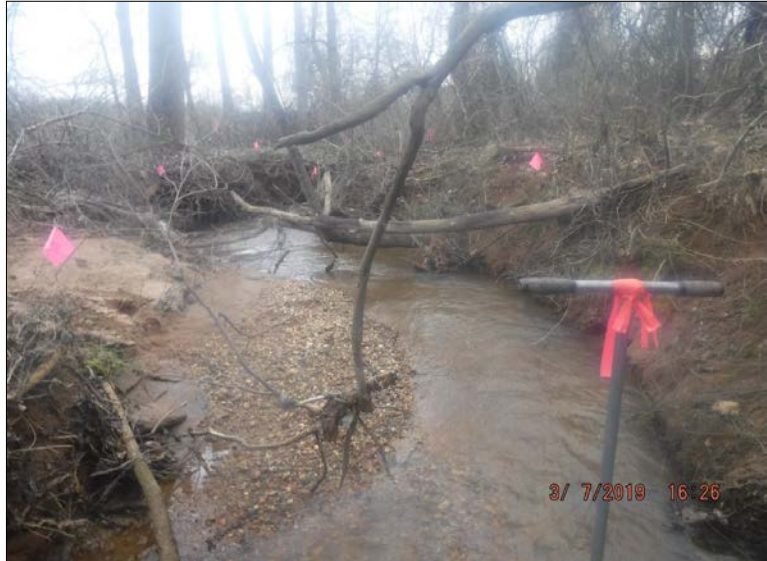
Looking south (downstream) at Stream Reach 73-A. The banks are often incised and there erosion is present on 40-60% of both banks. The left bank's riparian buffer is forested with greater than 60% tree canopy cover; the right bank's riparian buffer is covered largely by dense shrubbery, with maintained lawn encroaching the riparian buffer in some areas. Stable habitat elements are present in 30-50% of the reach. A road exists at the downstream end of the reach, disrupting less than 20% of the reach.

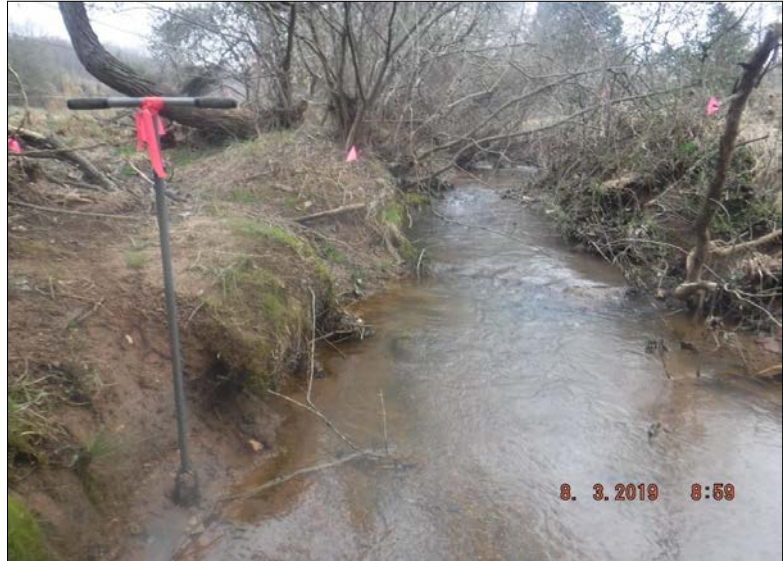
Looking north (upstream) at Stream Reach 73-B. There are a few areas of erosion within the reach but the majority of the banks are stable. The riparian buffers are largely lacking tree and shrub strata and consists of maintained lawn. The right bank riparian buffer contains a wetland. Stable habitat elements are present within 30-50% of the reach. The downstream end of the reach contains a culvert, disrupting less than 20% of the stream.

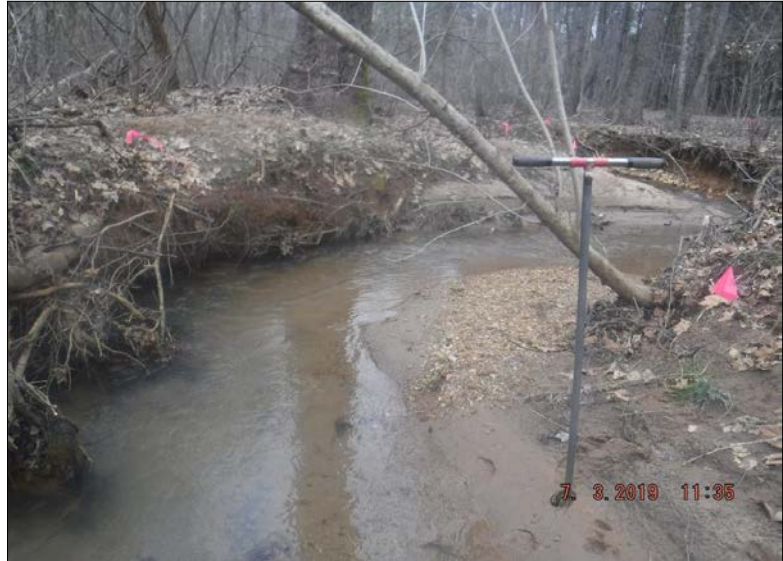
Looking southeast (downstream) at Stream Reach 74-A. The reach exhibits a few incised and/or undercut banks but the majority of the streambank is stable. Both banks' riparian buffers are forested with greater than 60% tree canopy cover. Stable habitat elements are present and occupy 30-50% of the reach. The stream shows no signs of alteration.

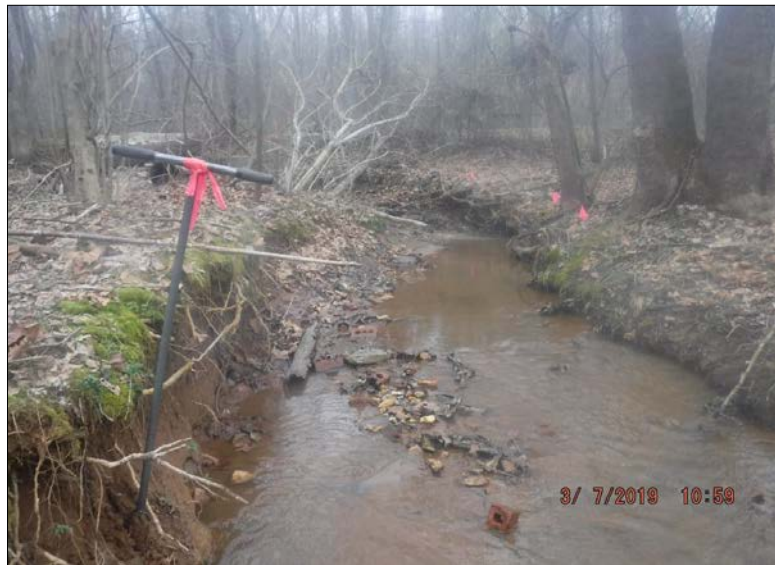
Looking west (downstream) at Stream Reach 75-A. The majority of the banks are stable (>80%). Both banks' riparian buffers are fully forested. Stable habitat elements are present in greater than 50% of the reach. A road exists at the downstream end of the reach, disrupting less than 20% of the reach.

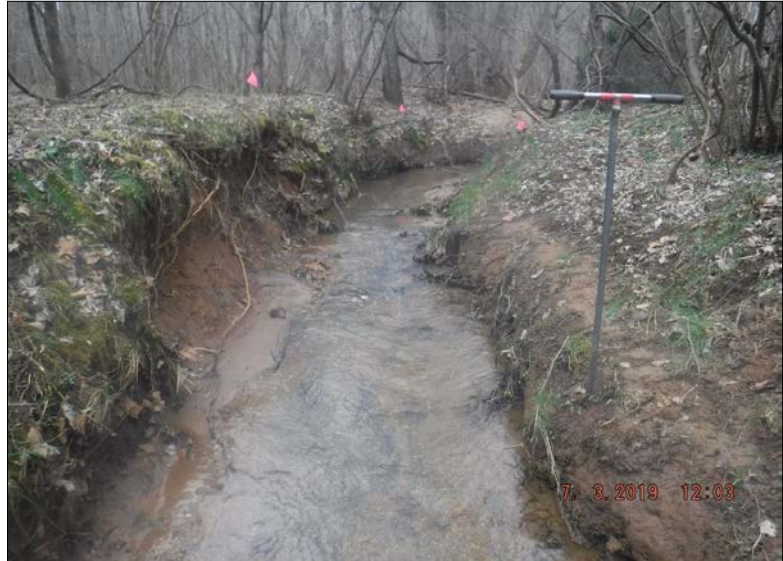
Looking southwest (upstream) at Stream Reach 75-B. The banks are slightly incised but mostly stable. Both banks' riparian buffers are forested (>60% canopy cover); a canopy gap on the right bank is occupied by dense herbaceous vegetation. Stable habitat elements are present in 30-50% of the reach. The upstream end of the reach is fed by a culvert, disrupting less than 20% of the reach.

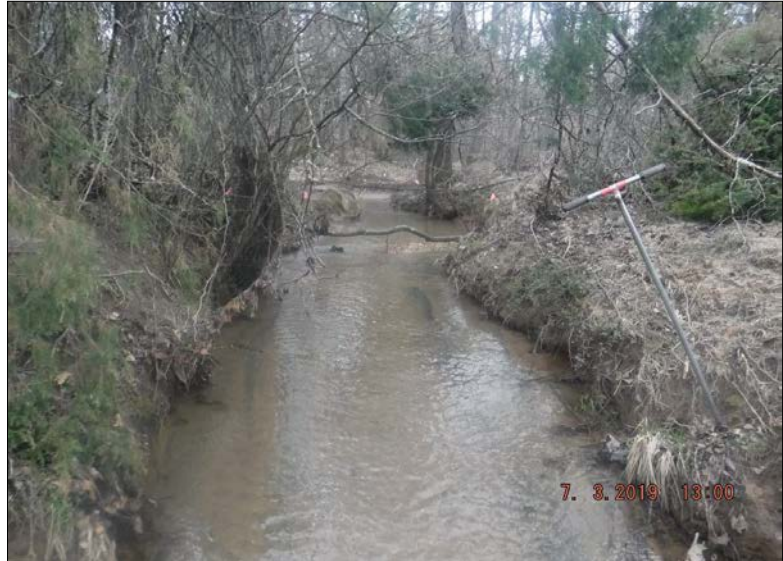
Looking southwest (upstream) at Stream Reach 75-C. The banks are slightly incised but largely stable. The right bank's riparian buffer is predominantly forested (>60% canopy cover), though there are areas of dense herbaceous vegetation and maintained lawn. The left bank's riparian buffer is predominantly forested (>60% canopy cover) but contains some maintained lawn. Stable habitat elements are present in 30-50% of the reach. The stream shows no signs of alteration.

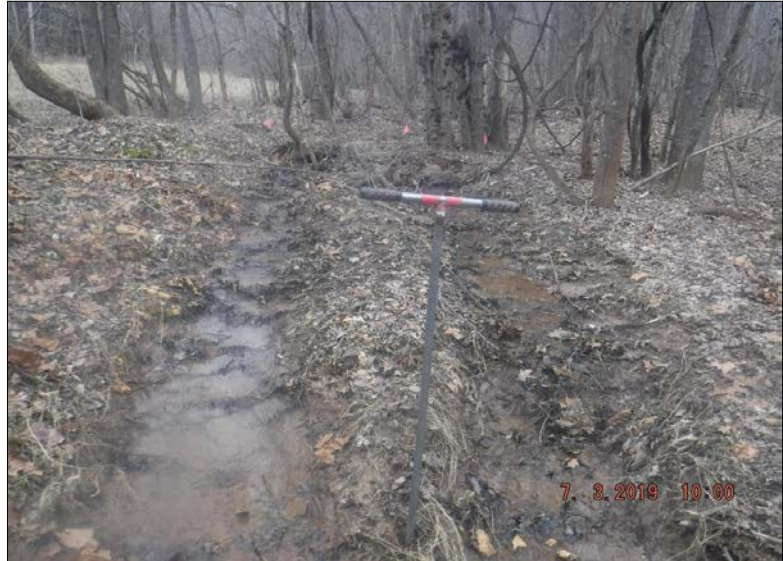
Looking southwest (upstream) at Stream Reach 76-A. The reach has some areas of erosion but the majority of the banks are stable. The right bank's riparian buffer has greater than 60% canopy cover with maintained herbaceous vegetation, while the left bank's riparian buffer is entirely forested with greater than 60% canopy cover. Stable habitat elements are present in 30-50% of the reach. The stream shows no signs of channel alteration.

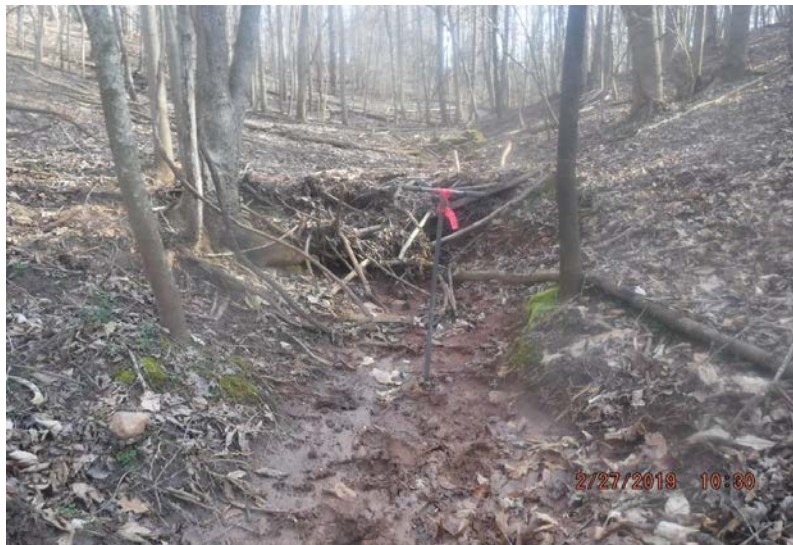
Looking upstream at Stream Reach 77-A. The right and left riparian buffers consist of 100% optimal canopy cover.

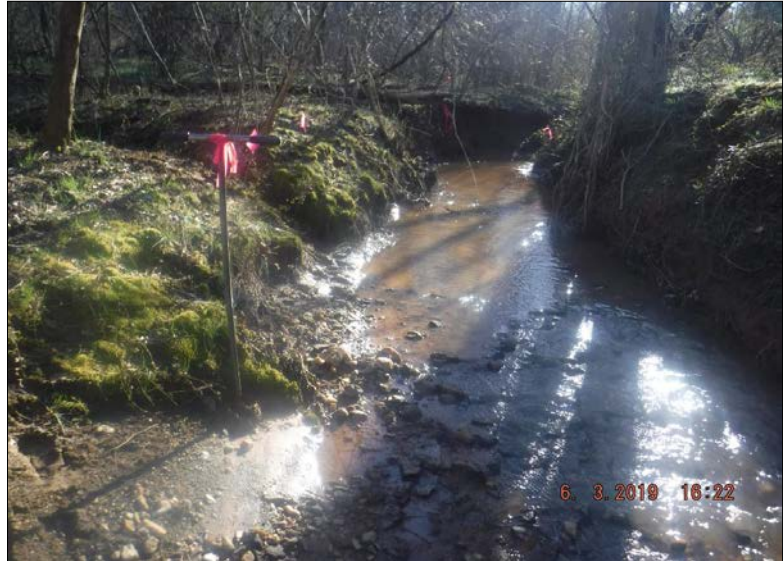
Looking southwest (downstream) at Stream Reach 78-A. Active erosion is present on both banks; vegetative protection is present on 40-60% of the reach. There is some maintained lawn in the vicinity of the left bank, but both banks' riparian buffers are largely forested with greater than 60% tree canopy cover. Stable habitat elements are present and occupies 30-50% of the stream. There is no evidence of channel alteration.

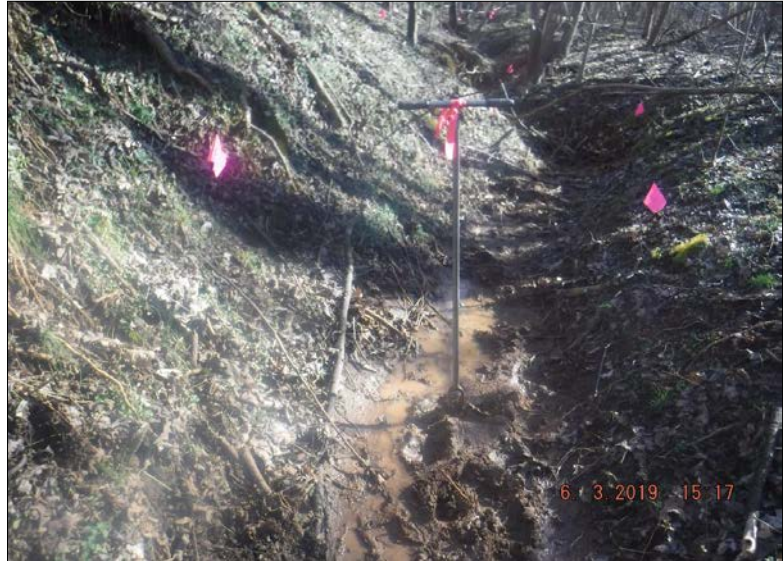
Looking north (downstream) at Stream Reach 79-A, an intermittent tributary of Marrowbone Creek. The stream is slightly incised but banks are stable. The right bank's riparian buffer is made up of forest providing greater than 60% tree canopy cover and maintained lawn, while the left bank's riparian buffer is entirely forested with greater than 60% tree canopy cover. Habitat elements are unstable and are present in less than 10% of the reach. The upstream end of the reach is fed by a culvert, disrupting less than 20% of the reach.

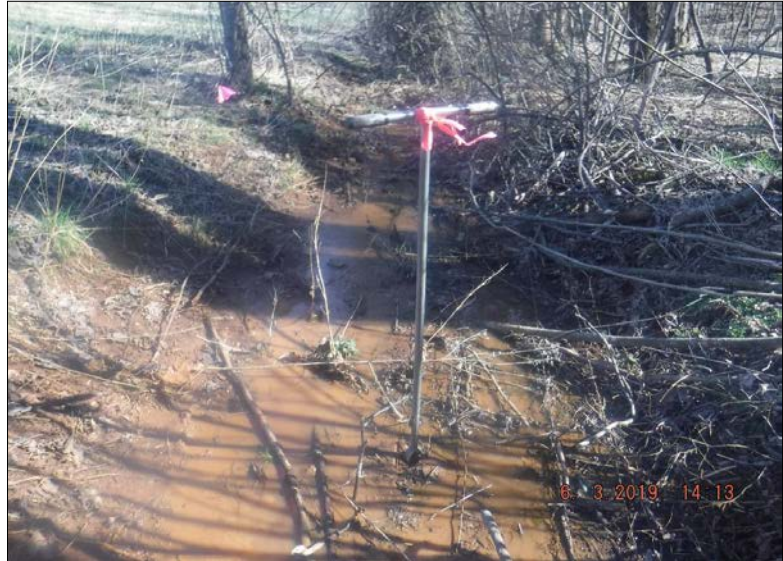
Looking southeast (downstream) at Stream Reach 80-A. There are a few areas of active erosion but the banks are generally stable. The left bank's riparian buffer is composed entirely of maintained lawn while the right bank's buffer is composed entirely of forest providing greater than 60% tree canopy cover. Habitat elements are stable and are present in 10-30% of the reach. The stream reach shows no signs of channel alteration.

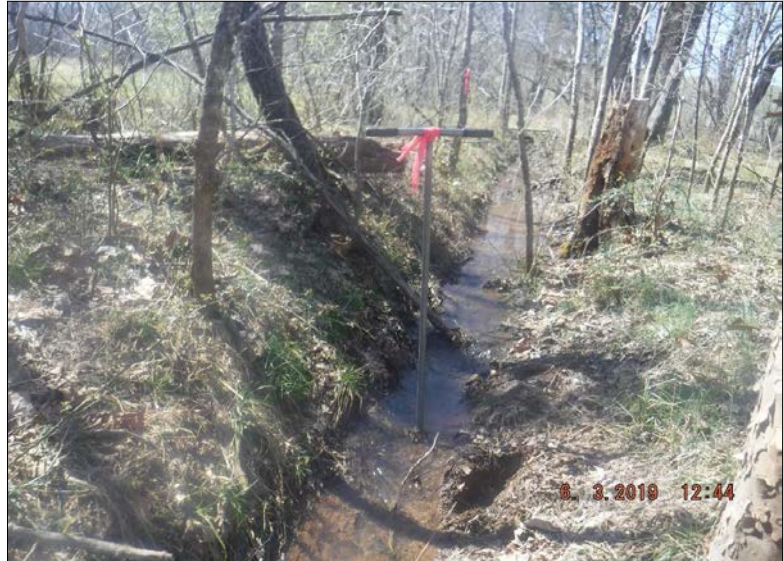
Looking southwest (upstream) at Stream Reach 81-A. Vegetative protection is prominent within the reach and the stream has access to bankfull benches. Both the right and left bank riparian buffers are partly forested (>60% tree canopy cover) and partly composed of maintained lawn. Instream habitat elements are present within 30-50% of the reach. The upstream end of the reach is fed by a culvert, disrupting less than 20% of the reach.

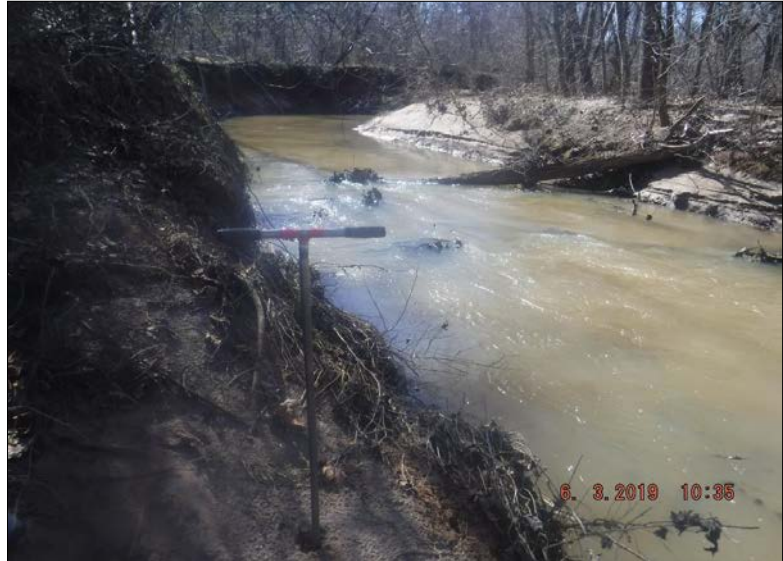
Looking south (upstream) at Stream Reach 82-A. Erosion is present on both banks with some areas being undercut. The right bank's riparian buffer is fully forested (>60% canopy cover). The left bank's riparian buffer is forested adjacent to the stream but then gives way to herbaceous ground cover. Instream habitat elements are adequate for the maintenance of populations and are present in 30-50% of the reach. The stream shows no evidence of channel alteration.

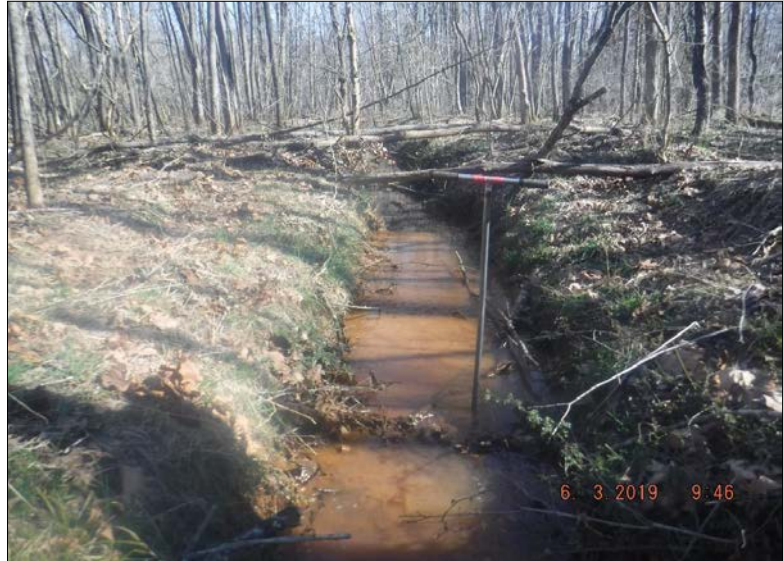
Looking northeast (upstream) at Stream Reach 83-A. The stream is slightly incised but the banks are generally stable. The left and right bank riparian buffers have greater than 60% tree canopy cover. Habitat elements are present in 10-30% of the reach. The stream shows no signs of alteration.

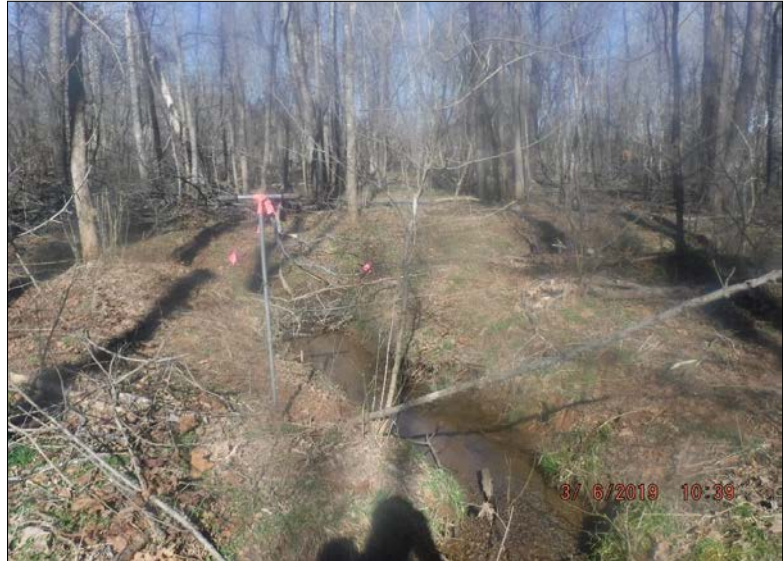
Looking northwest (downstream) at Stream Reach 84-A. There are a few areas of active erosion but the banks are generally stable. The left and right bank riparian buffer have greater than 60% tree canopy cover. Instream habitat elements are present in greater than 50% of the reach. This reach shows no signs of channel alteration.

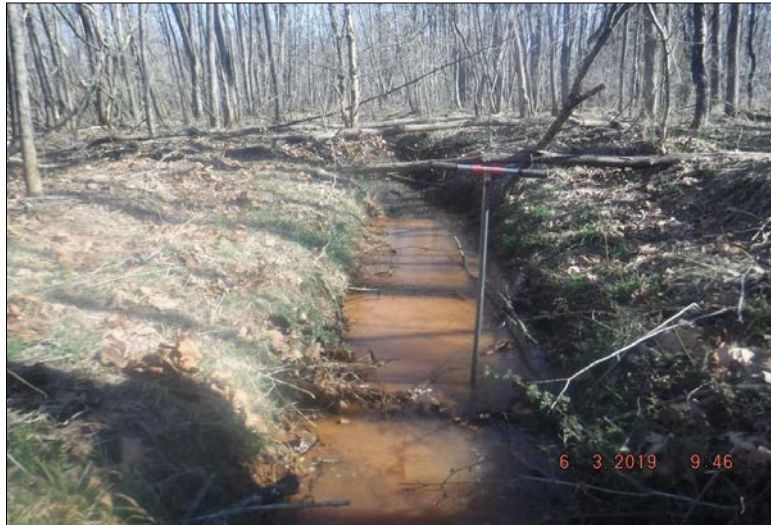
Looking northwest (downstream) at Stream Reach 84-A. The reach had vegetation cover on 60 to 80% of the banks and the stream has access to bankfull benches. The left and right bank riparian buffer have greater than 60% tree canopy cover. Instream habitat elements are present in 30 to 50% of the reach. This reach shows no signs of channel alteration.

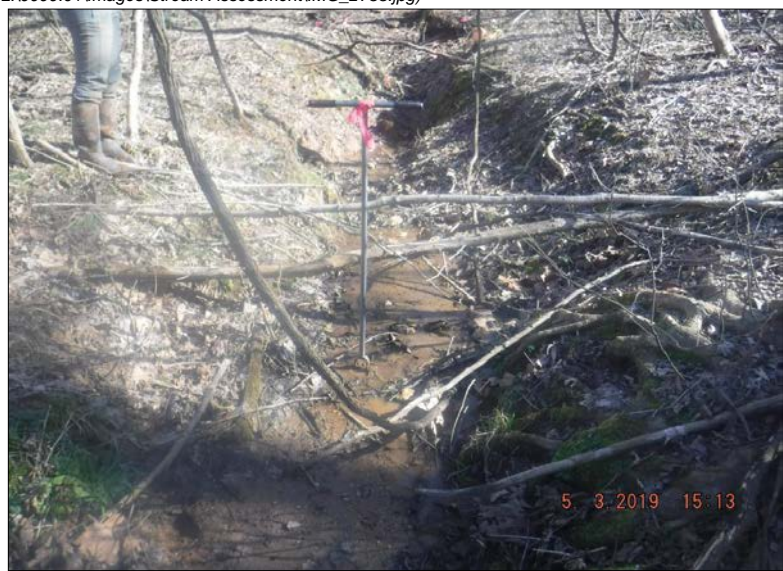
Looking southeast (upstream) at Stream Reach 86-A. Both left and right banks' riparian buffers have greater than 60% tree canopy cover and contain minimal maintained lawn. Habitat elements are present in 10-30% of the reach. There are no signs of channel alteration.

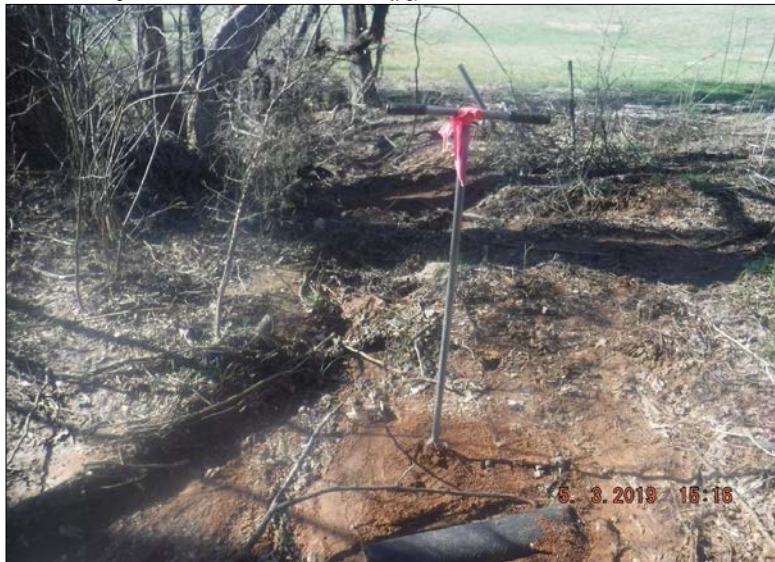
Looking northwest (downstream) at Stream Reach 86-B. This reach exhibits heavy sedimentation and is overwidened. The left and right banks' riparian buffers are forested (>60% canopy cover) and contain minimal maintained lawn. Habitat elements are generally lacking and are present in less than 10% of the reach. The channel is slightly altered in less than 20% of the reach by the presence of an erosional storm water feature.

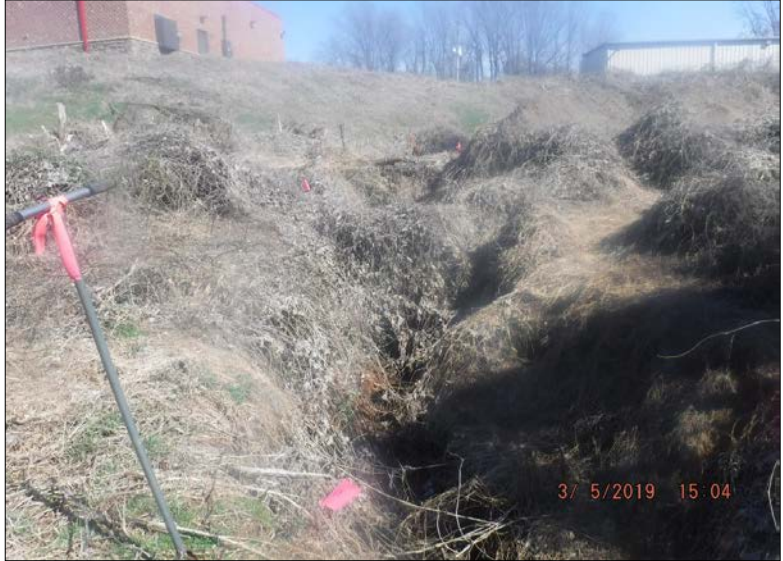
Looking east (upstream) at Stream Reach 87-A. The channel is often incised and much of the streambank is undercut. The left and right riparian buffers are covered by non-maintained herbaceous vegetation; a parking lot is adjacent to the right bank and sparse tree cover (<30% canopy cover) is present on the left bank. Instream habitat is present in less than 10% of the reach. A culvert is present at the upstream end of the reach, disrupting less than 20% of the reach.

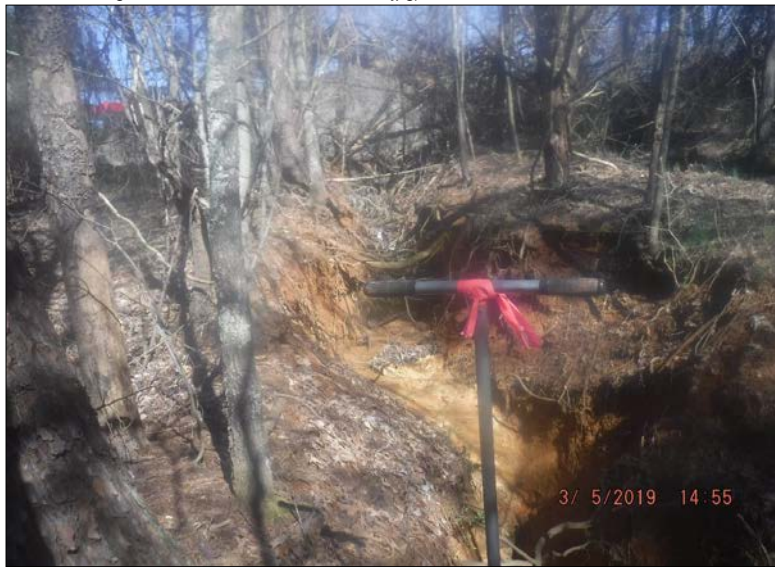
Looking east (upstream) at Stream Reach 87-B. The channel is deeply incised and flow is contained within the banks. The left bank riparian buffer is entirely forested with greater than 60% tree canopy cover; the right bank riparian buffer is largely forested with greater than 60% tree canopy cover and has some canopy gaps occupied by dense herbaceous vegetation and shrubs. Instream habitat elements are unstable and are present in less than 10% of the reach. This stream reach shows no signs of alteration.

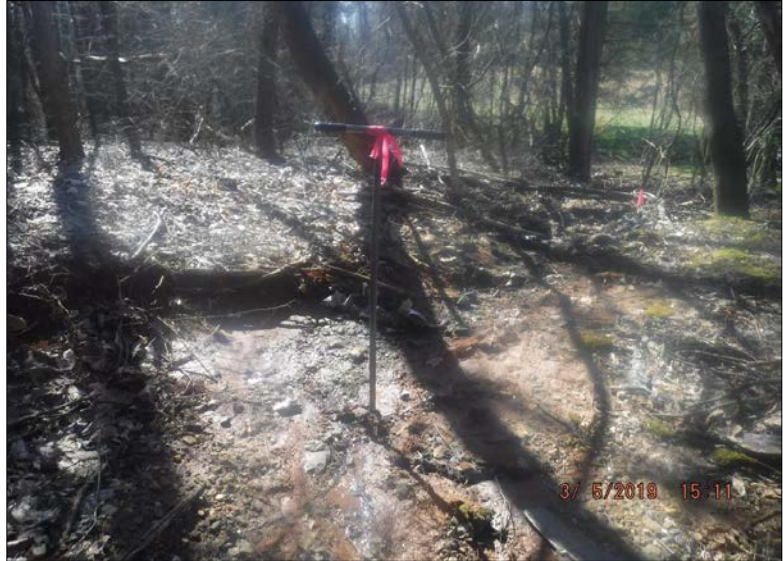
Looking west (downstream) at Stream Reach 87-C. The stream banks are relatively stable and exhibit lower bank slopes than other reaches within this stream. The left bank riparian buffer is entirely forested with greater than 60% canopy cover. The right bank riparian buffer has a forested riparian buffer but is mostly comprised of maintained lawn. Instream habitat elements are present in less than 10% of the reach. There are no signs of channel alteration within this reach.

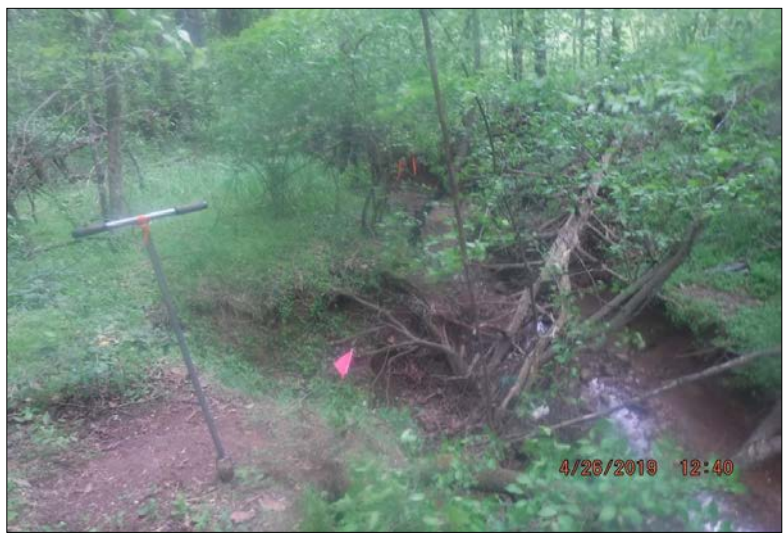
Looking downstream at Stream Reach 87-D. The stream is mostly incised and likely to widen further. The left bank riparian buffer consists of mature forest with greater than 60% tree canopy cover. The right bank riparian buffer consists of mature forest with greater than 60% tree canopy cover and maintained lawn. Instream habitat is present in less than 10% of the stream. Channel alteration is not present in this reach.

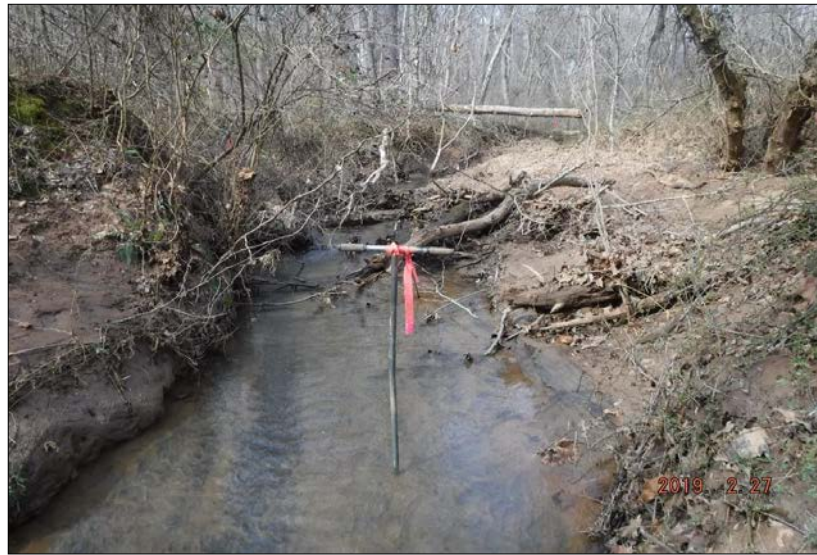
Looking upstream at stream reach 88-A. The reach was slightly incised with majority of banks stable. The right riparian buffer consisted of 98% mature forest cover and 2% herbaceous field. The left riparian buffer contained 88% mature forest cover, 2% non-maintained dense vegetation, and 10% herbaceous field. The in-stream habitat was suboptimal with stable elements in 30-50% of the reach, and the channel had no alterations.

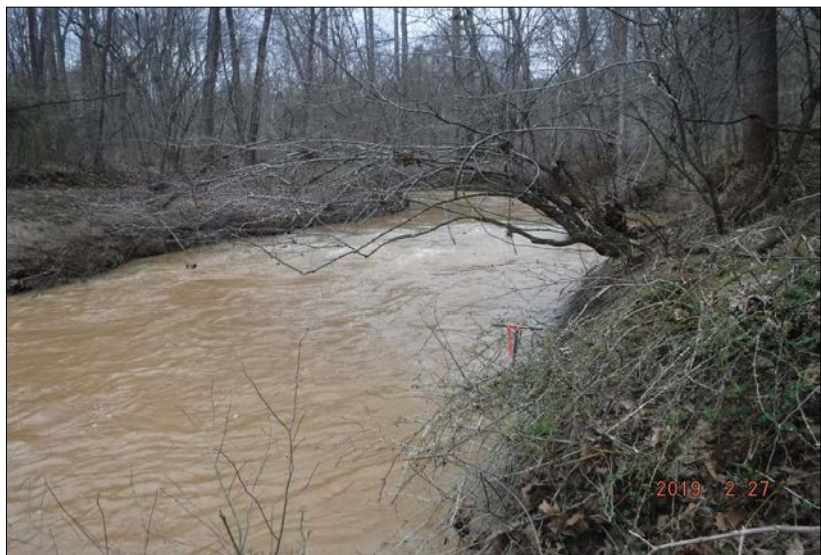
Looking upstream at stream reach 89-A. The reach had stable bed and banks with vegetative protection and some erosion. The right riparian buffer consisted of 100% mature forest cover. The left riparian buffer consisted of 95% mature forest cover and 5% sparsely vegetated area. The in-stream habitat was suboptimal with stable elements in 30-50% of the reach. There are no channel alterations within the evaluated reach.

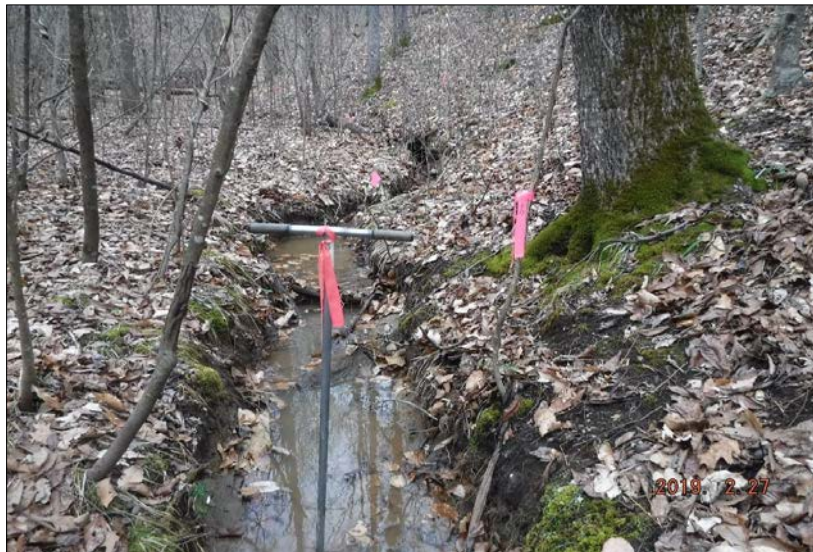
Looking upstream at stream reach 90-A. The reach had 40-60% vegetative protection on both banks with transient sediment. The right riparian buffer consisted of 50% mature forest cover and 50% mature forest cover with 30 to 60% canopy cover. The left buffer consisted of 75% mature forest cover and 25% mature forest cover with 30 to 60% canopy cover. In-stream habitat elements were lacking, and no channel alterations were observed.

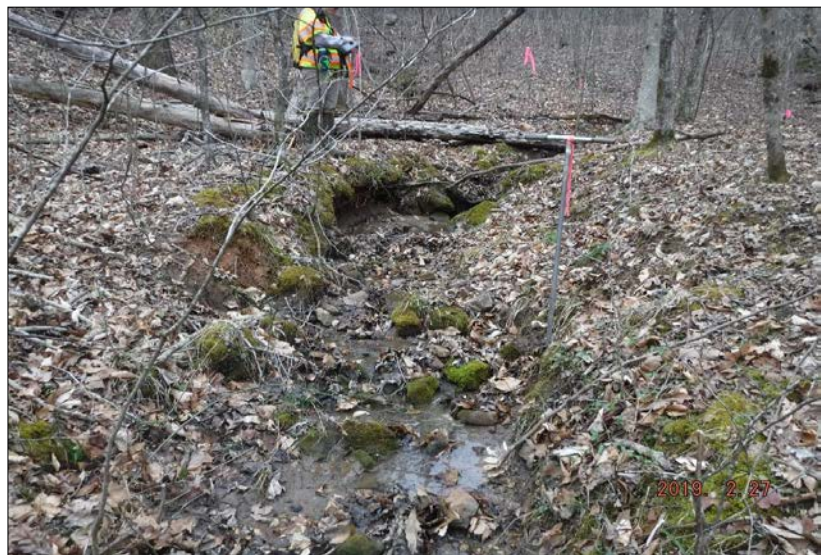
Looking upstream at stream reach 90-B. The reach had 40-60% vegetative protection on both banks with transient sediment and moderate erosion. The right riparian buffer consisted of 75% mature forest with 60% or greater canopy cover and 25% mature forest cover with 30 to 60% canopy cover. The left buffer consisted of 90% mature forest cover and 10% mature forest cover with 30 to 60% canopy cover. In-stream habitat elements were lacking, and no channel alterations were observed.
