Stream Assessment Form (Form 1)

Unified Stream Methodology for use in Virginia

Project #	Project Name (Applicant)	Locality	Cowardin Class.	HUC	Date	SAR # / Data Point	Impact/SAR Length	Impact Factor	
	Martinsville Connector (VDOT)	Henry	R3	02070010	3/01/2019	A		N/A	
Name(s) of Evaluator(s)		Stream Name and Information					Stream Map		
SA, JB		Unnamed Tributary to Marrowbone Creek

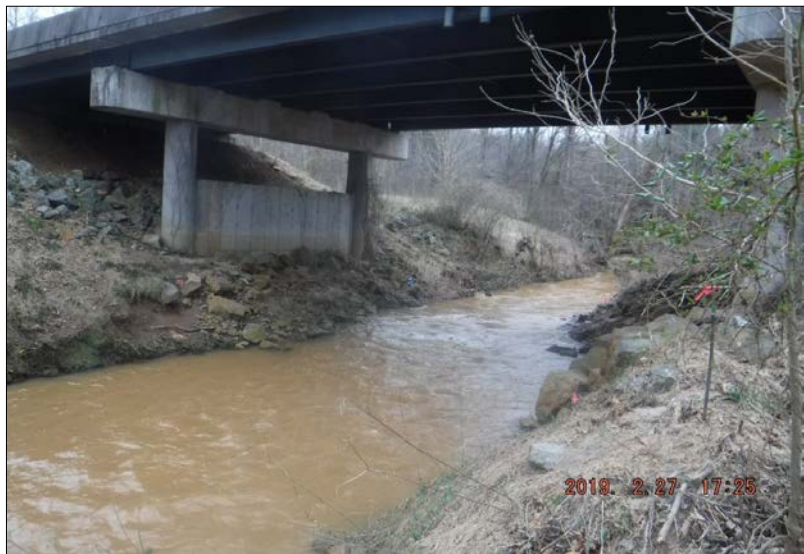
Looking upstream at stream reach 91-A. The reach had eroded banks and was overwidened, with little vegetative protection present. The right and left riparian buffers consisted of 60% mature forest cover and 40% impervious surfaces associated with Soapstone Road. The in-stream habitat was suboptimal with stable elements in 30-50% of the reach, and channel alterations included road and brige installation.

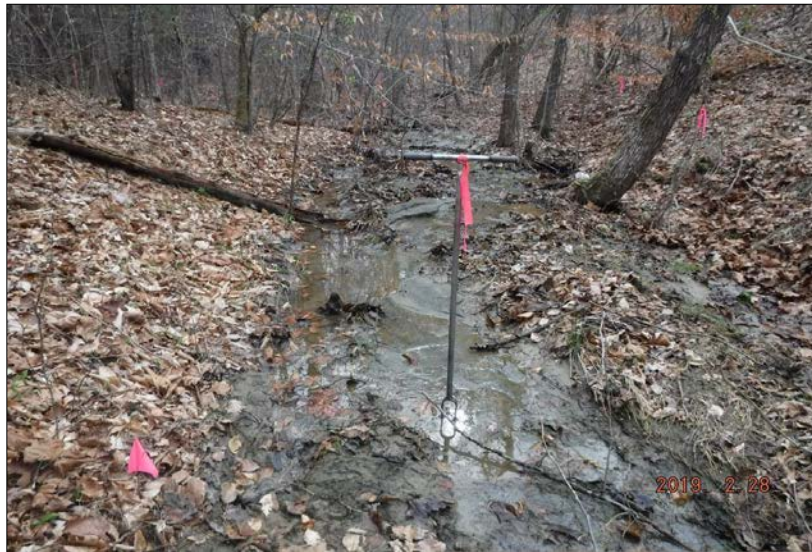
Looking upstream at stream reach 92-C. The reach had moderate erosion along the banks with some vegetative protection present. The right riparian buffer consisted of 100% mature forest cover. The left buffer consisted of 25% mature forest cover and 75% impervious surface associated with Soapstone Road. The reach lacked in-stream habitat elements and did not have any channel alterations.

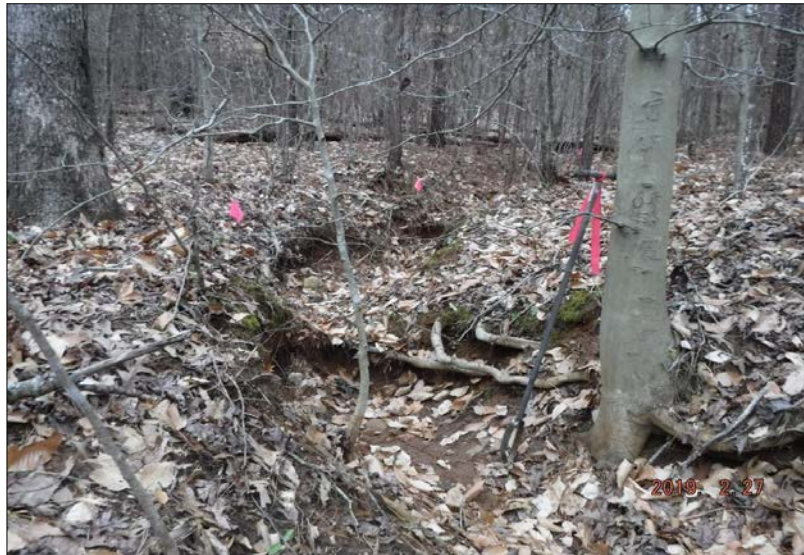
Looking upstream at stream reach 93-A. The right and left riparian buffers consisted of 10% mature forest cover and 90% mature forest cover with 30 to 60% canopy cover.

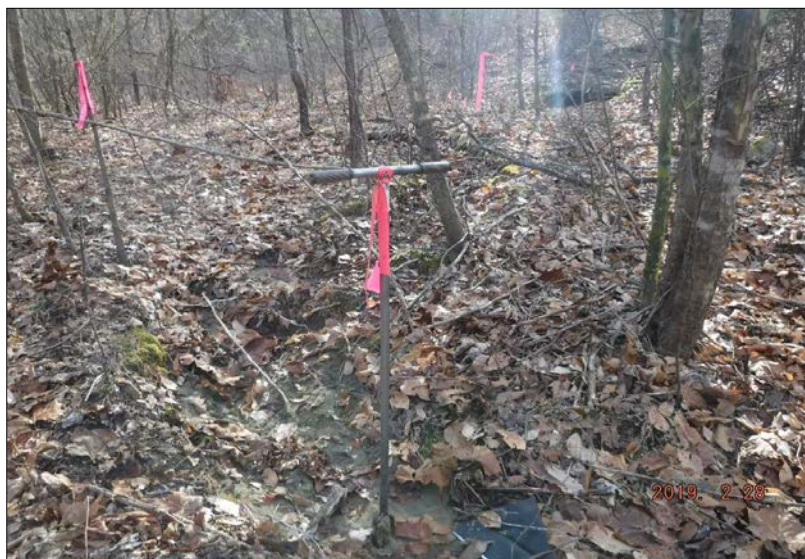
Looking upstream at stream reach 94-A. The right riparian buffer consisted of 100% mature forest cover. The left riparian buffer consisted of 75% mature forest cover and 25% impervious surfaces associated with Soapstone Road.

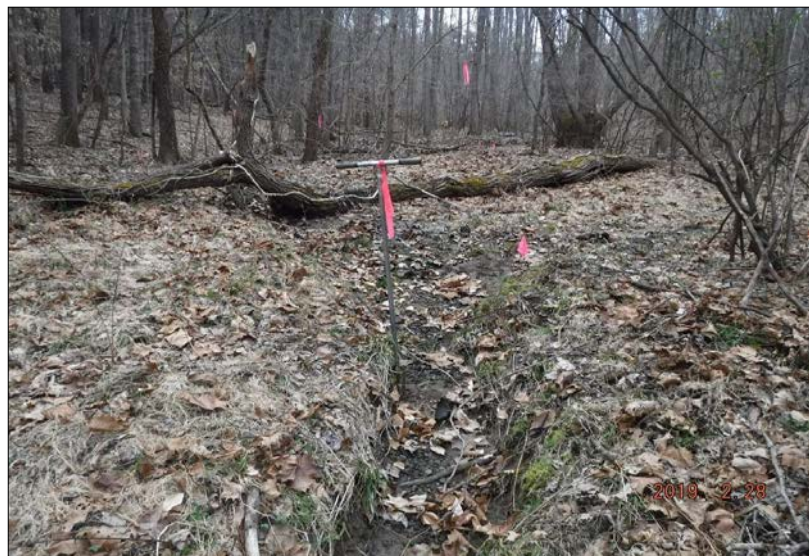
Looking upstream at stream reach 95-A. The right riparian buffer consisted of 95% mature forest cover and 5% sparse herbaceous vegetation. The left riparian buffer consisted of 100% mature forest cover.

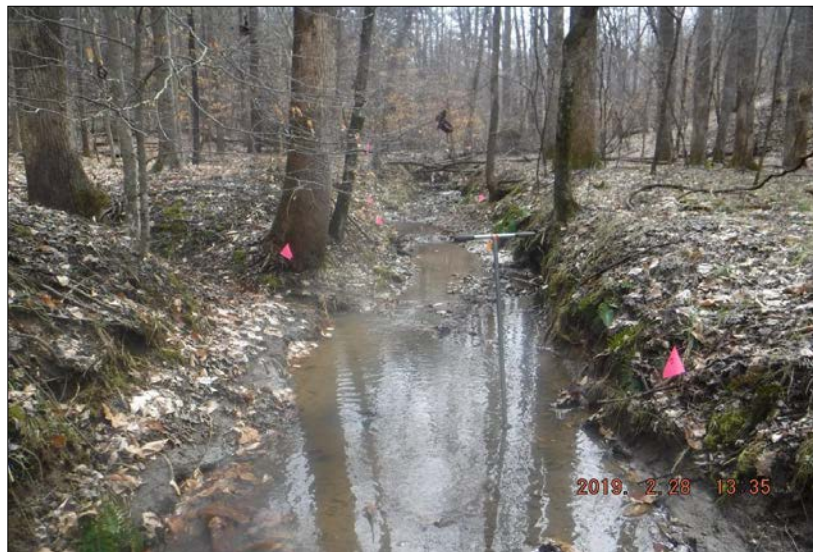
Looking upstream at stream reach 97-B. The reach was slightly incised with few areas of erosion. The right and left riparian buffers consisted of 100% mature forest cover. The in-stream habitat contained leaf packs, root wads, woody debris and varied substrate sizes. The reach lacked channel alterations.

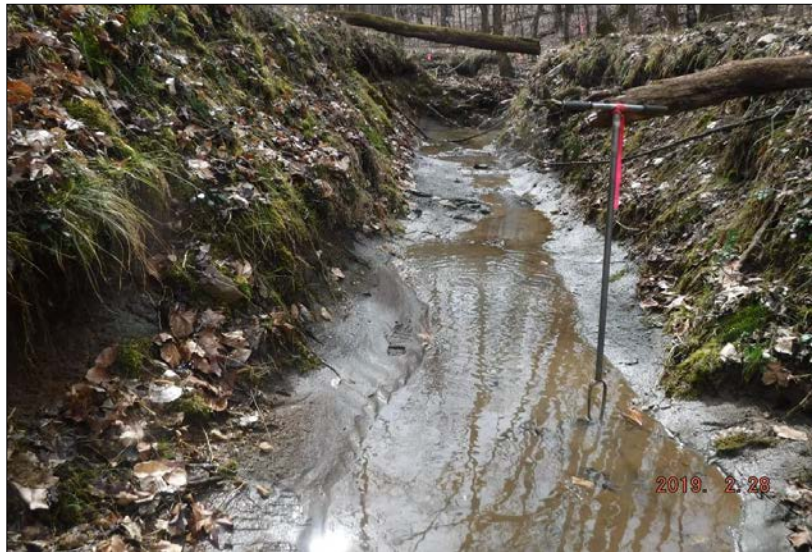
Looking upstream at stream reach 97-C. The reach had incised banks with some active erosion. The right and left riparian buffers consisted of 100% mature forest cover. The in-stream habitat was suboptimal with stable elements in 30-50% of the reach. The reach lacked channel alterations.

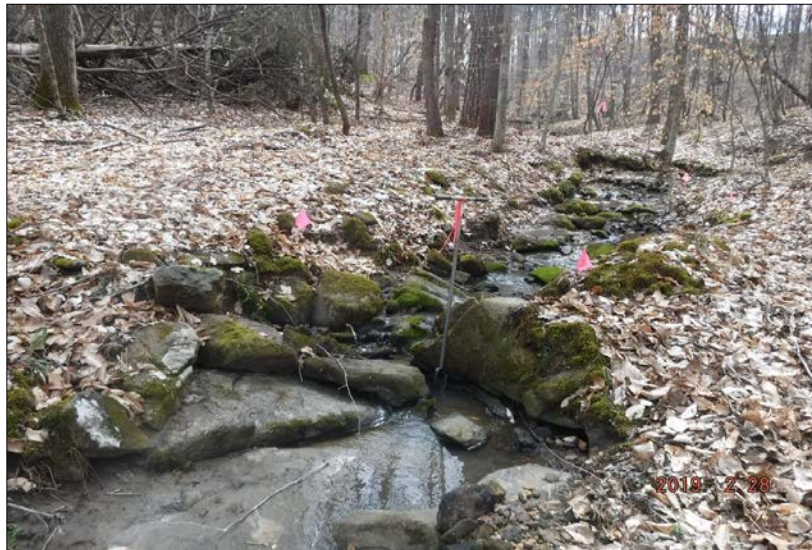
Looking upstream at stream reach 97-D. The reach was slightly incised with few areas of erosion. The right and left riparian buffers consisted of 100% mature forest cover. The in-stream habitat was optimal with stable elements in greater than 50% of the reach, including varied water velocity and depths, riffle pool complexes and varied substrate sizes. The reach lacked channel alterations.

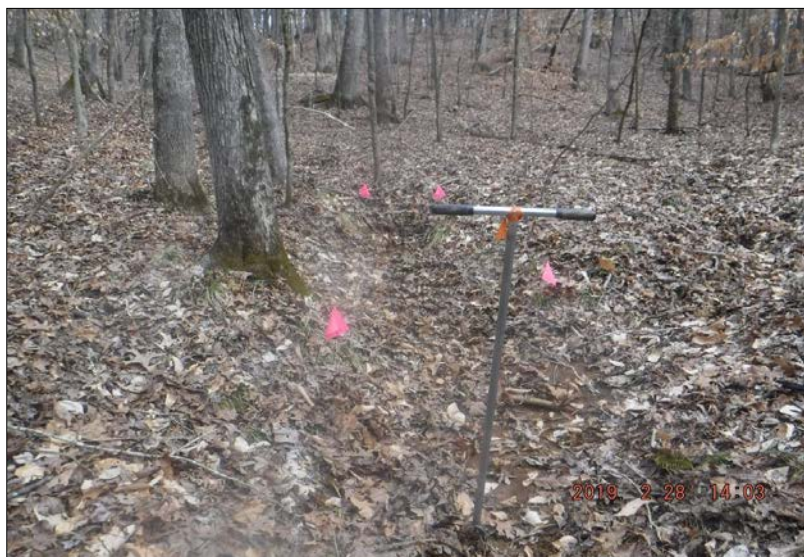
Looking upstream at stream reach 98-A. The right and left riparian buffer consisted of 100% mature forested cover.

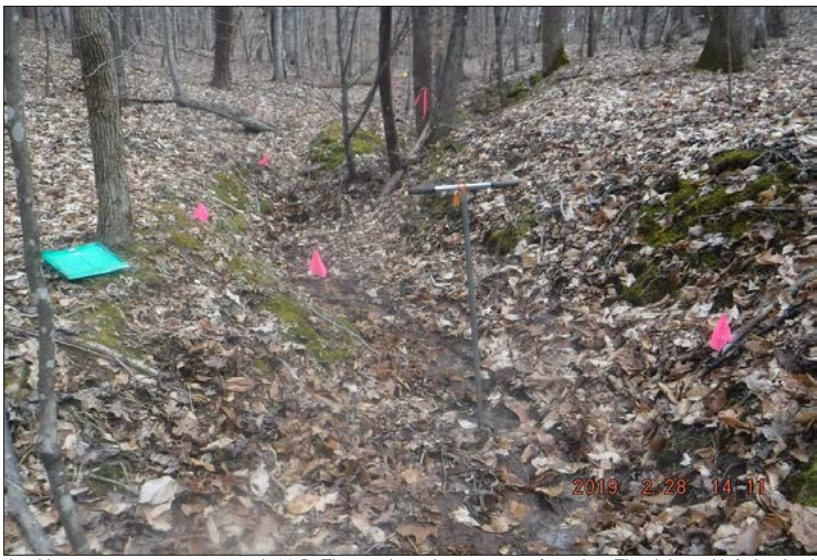
Looking upstream at stream reach 98-B. The reach moderate areas of erosion. The right and left riparian buffers consisted of 100% mature forest cover. The reach lacked in-stream habitat elements and did not have any channel alterations.

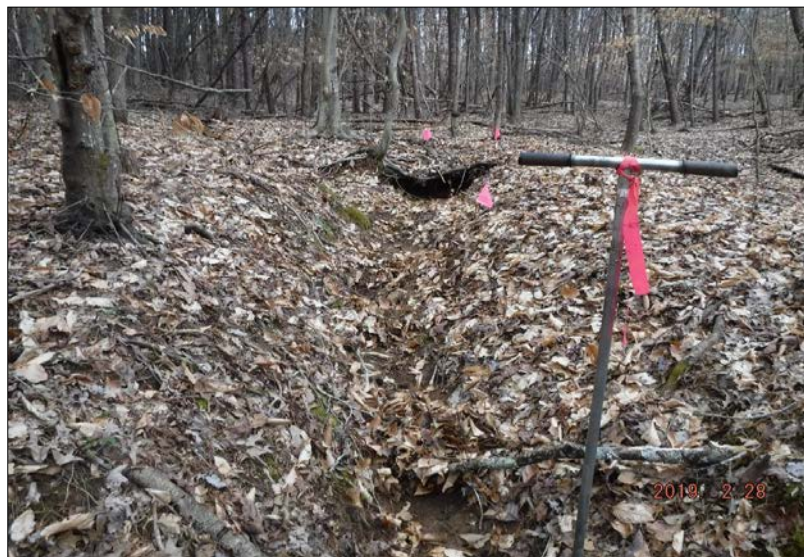
Looking upstream at stream reach 99-A. The right and left riparian buffers consisted of 100% mature forest cover.

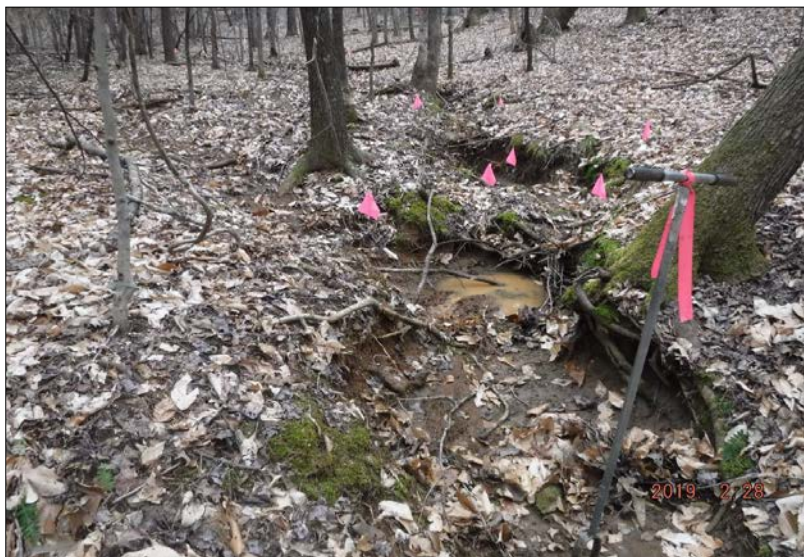
Looking upstream at stream reach 99-B. The right and left riparian buffers consisted of 100% mature forest cover.

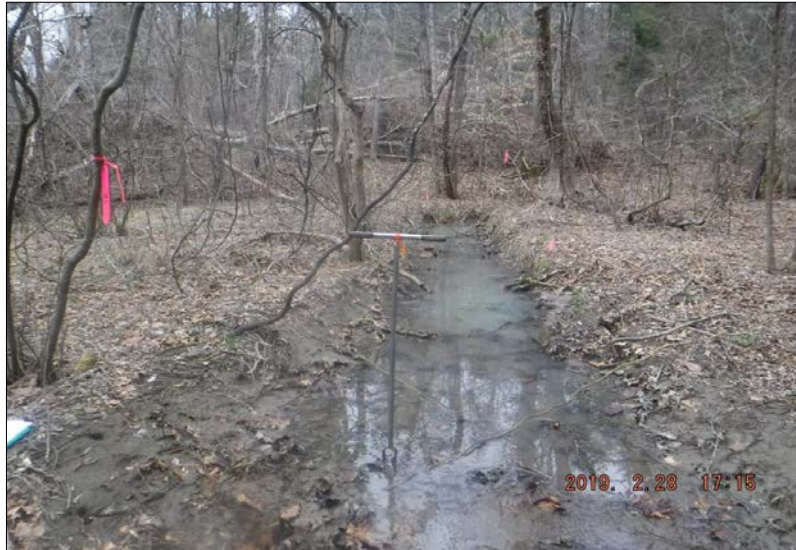
Looking upstream at stream reach 100-A. The reach had slightly incised banks with vegetative protection present. The right and left riparian buffers consisted of 100% mature forest cover containing wetlands. The in-stream habitat was marginal with stable elements in 10-30% of the reach. No channel alterations were observed.

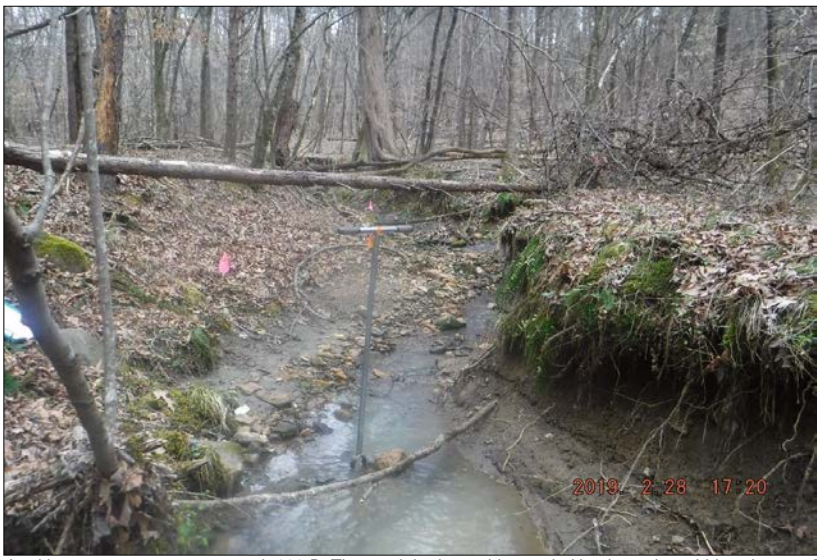
Looking upstream at stream reach 100-B. The reach had unstable, eroded banks and a cobble substrate. The right and left riparian buffers consisted of 100% mature forest cover with wetlands. The in-stream habitat contained undercut banks, woody debris and various substrate sizes. No channel alterations were observed.

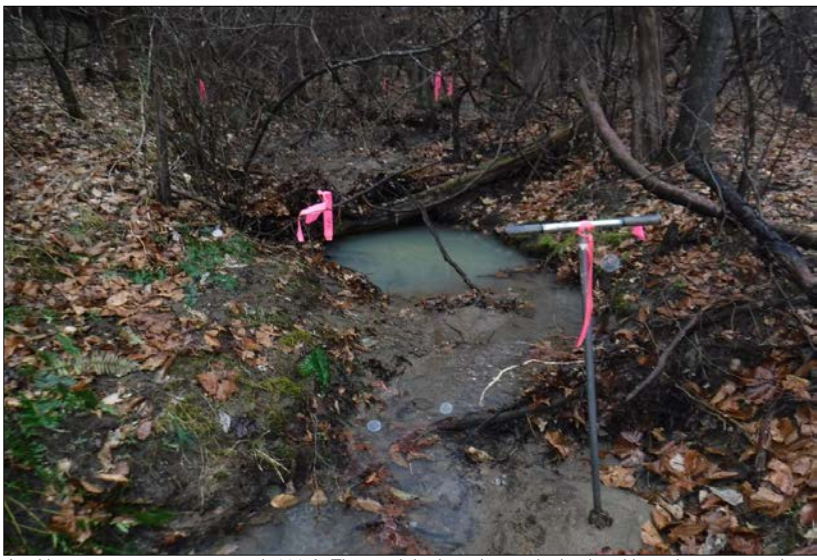
Looking upstream at stream reach 101-A. The reach had erosion on the banks with moderate vegetative protection present. The right and left riparian buffers consisted of 100% mature forest cover. The in-stream habitat was suboptimal with stable elements in 30-50% of the reach. No channel alterations were observed.

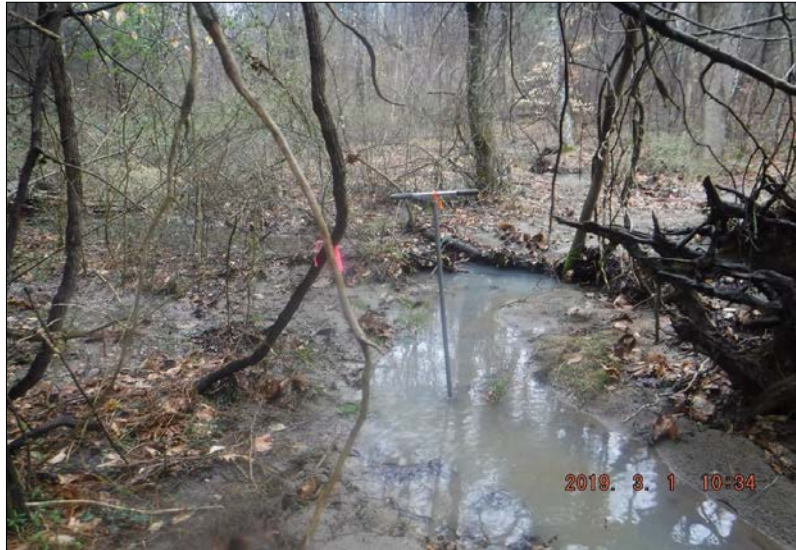
Looking upstream at stream reach 101-B. The reach had little incision and vegetative protection present. The right and left riparian buffers consisted of 100% mature forest cover. The in-stream habitat contained root wads and leaf packs. No channel alterations were observed.

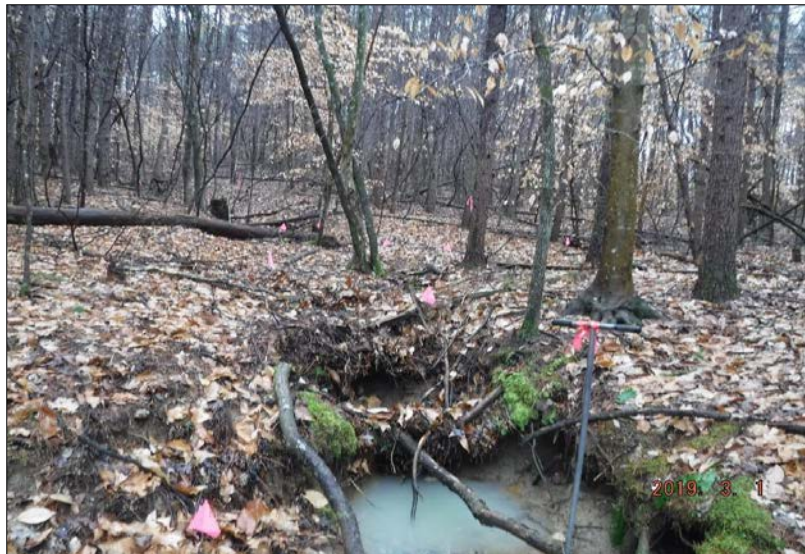
Looking upstream at stream reach 102-A. The right and left riparian buffers consisted of 100% mature forest cover.

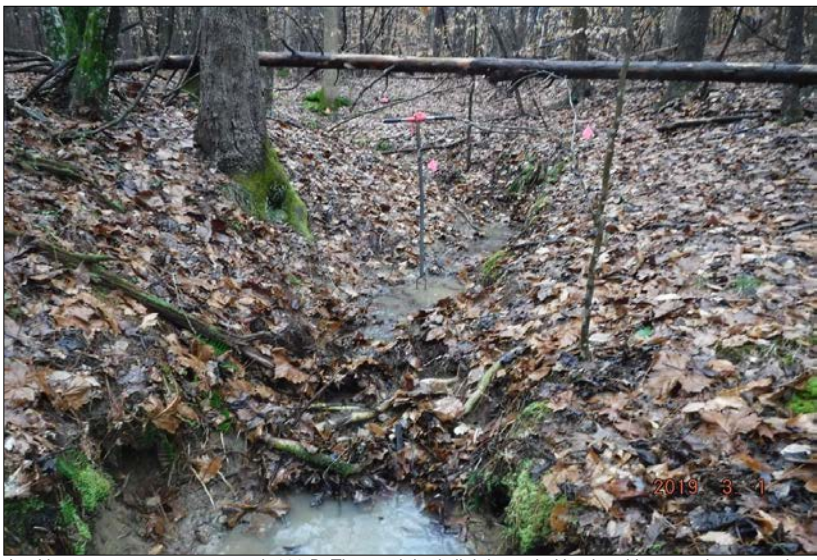
Looking upstream at stream reach 102-B. The reach had slightly eroded banks with vegetative protection present. The right and left riparian buffers consisted of 100% mature forest cover. The in-stream habitat was marginal and contained leaf packs. No channel alterations were observed.

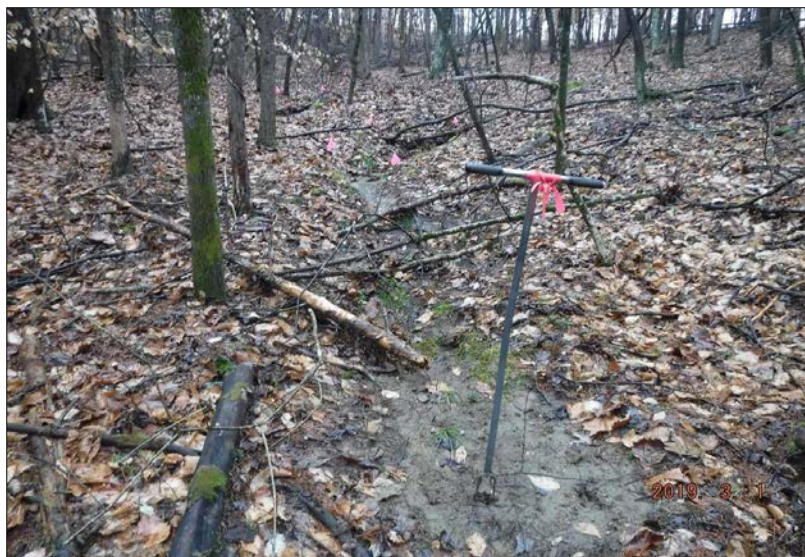
Looking upstream at stream reach 103-A. The right and left riparian buffers consisted of 100% mature forest cover.

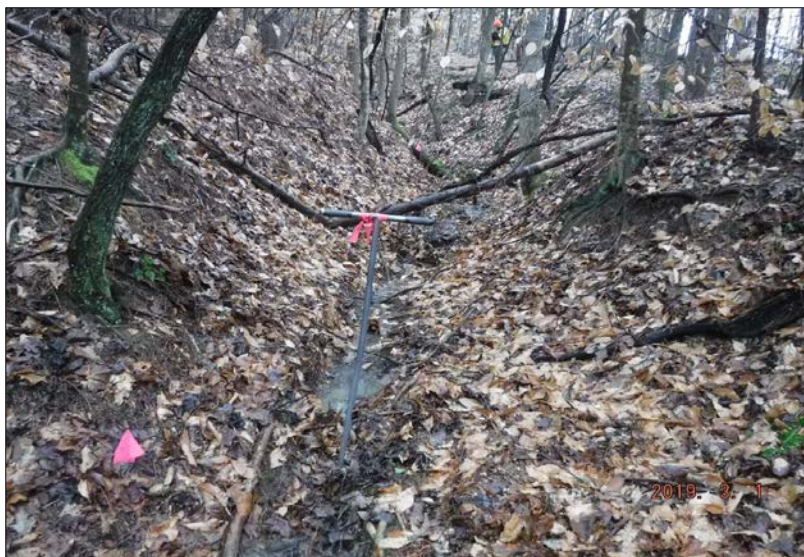
Looking upstream at stream reach 104-A. The right and left riparian buffers consisted of 100% mature forest cover.

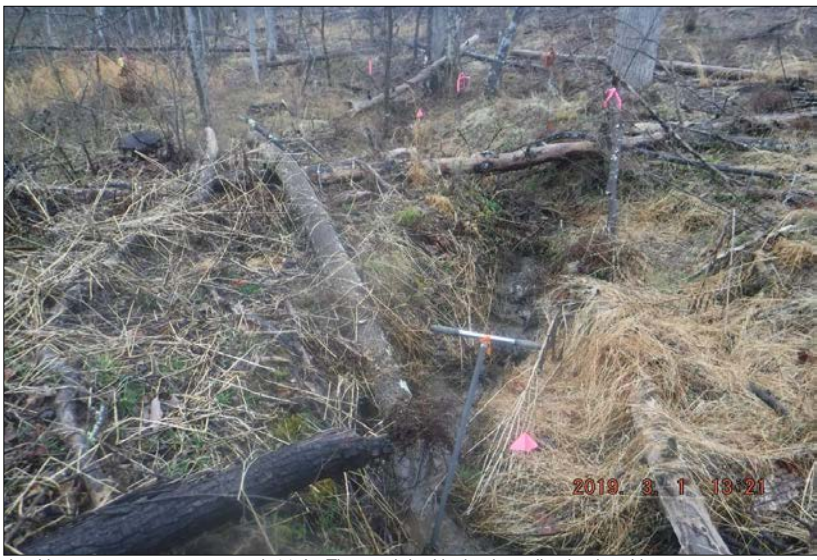
Looking upstream at stream reach 21-A. The reach had incised, eroding banks with some vegetative protection present. The right riparian buffer consisted of 5% mature forest cover, and 95% denuded land from logging. The left riparian buffer consisted of 90% denuded land from logging, and 10% PSS wetland. The in-stream habitat was poor with stable elements in less than 10% of the reach. Channel alterations include fill at the top of the stream deposited to construct a logging road.

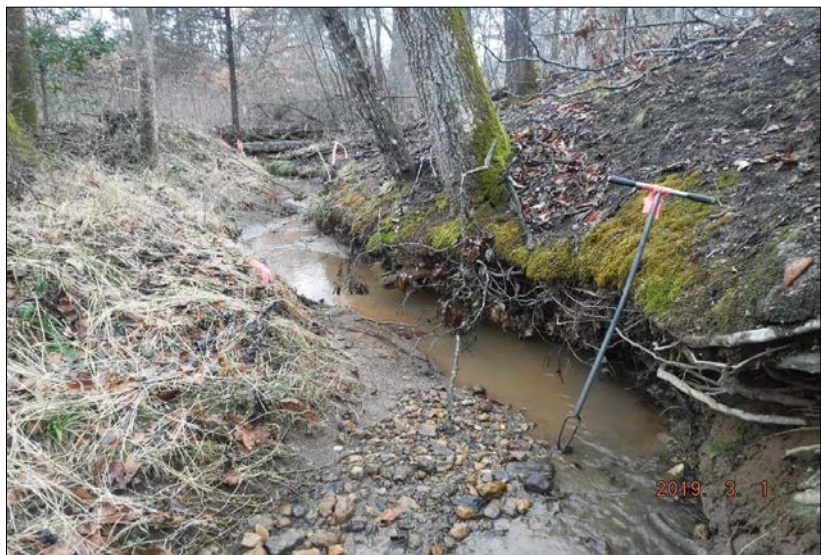
Looking downstream at stream reach 106-A. The reach was incised with some erosion and vegetative protection present. The right riparian buffer consisted of 25% mature forest cover, 5% maintained vegetation, and 70% denuded clear cut land. The left riparian buffer contained 20% mature forest cover, 10% maintained vegetation, and 70% denuded clear cut land. The in-stream habitat was marginal with stable elements in 10-30% of the reach, including cobbles, undercut banks and shade. No channel alterations were observed.

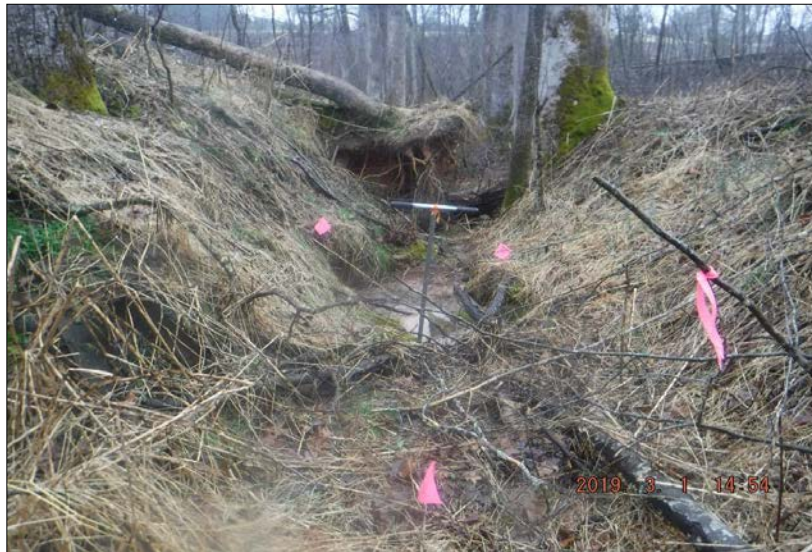
Looking downstream at Stream Reach 107-A. The reach was overwidened and incised with unstable banks. The right and left riparian buffer consisted of 100% poor canopy cover and had denuded surfaces due to logging activity. There is less than 10% in-stream habitat present within this reach. There are no channel alterations.

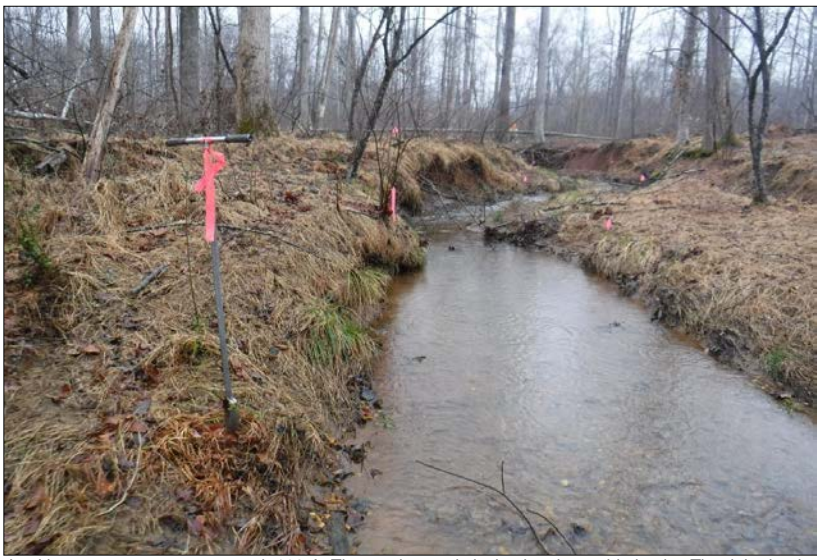
Looking upstream at stream reach 108-A. The reach severely incised and unstable banks. The right riparian buffer consisted of 20% mature tree cover, 75% herbaceous vegetation, and 5% lack of vegetation. The left buffer contained 5% mature tree cover, 20% mature tree cover with no understory, and 75% logged land. The in-stream habitat was suboptimal with stable elements in 30-50% of the reach. No channel alterations were observed.

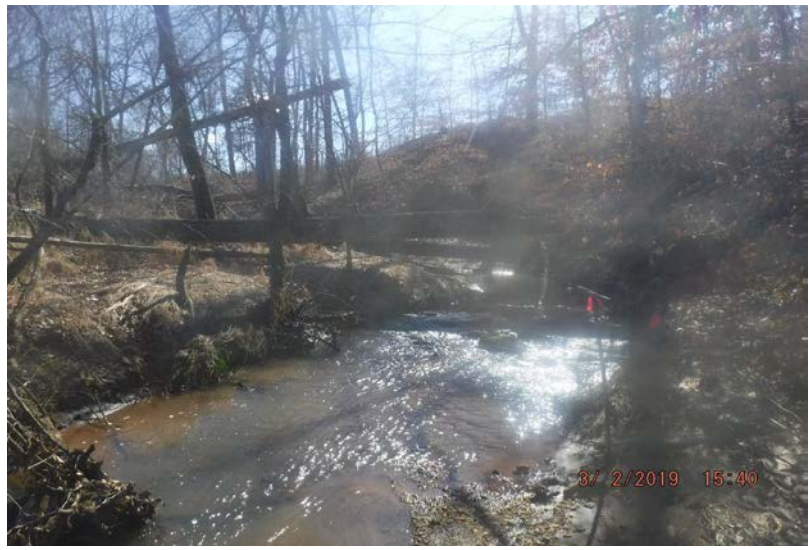
Looking upstream at Stream Reach 108-A. The reach was incised with areas of active erosion. The right riparian buffer consisted of 60% of canopy cover and 40% of marginal canopy cover that had a non-maintained herbaceous cover with denuded surfaces due to logging activity. The left riparian buffer consisted of 90% canopy cover and 10% of poor canopy cover with denuded surfaces due to logging activity. The instream habitat consisted of riffles, pools, leaf packs and substrate of various particle size but had excess sediment and silt due to active erosion. There reach had no channel alterations

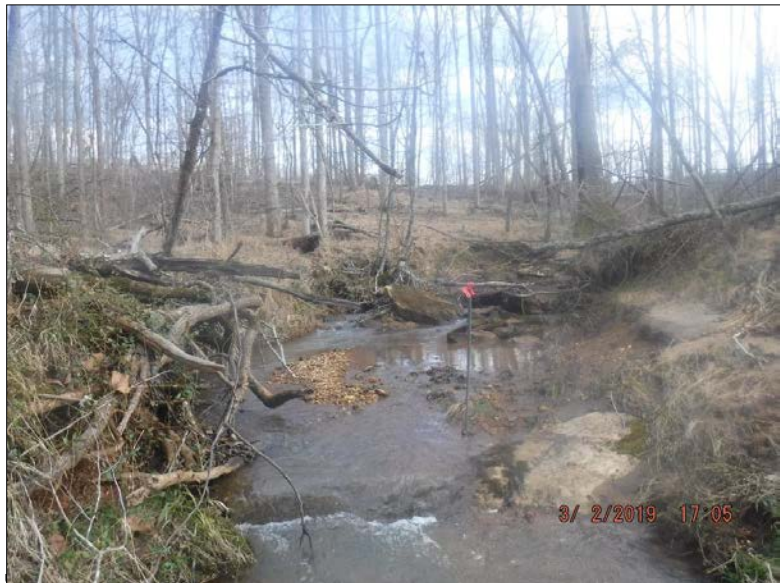
Looking down stream. The right riparian buffer consisted of 100% optimal canopy cover. The left riparian buffer consisted of 10% optimal canopy cover and 90% non-maintained herbaceous ground cover with marginal canopy cover due to recent logging activity. The instream habitat consisted of riffles, pools, leaf packs and substrate of various particle size but had excess sediment and silt due to active erosion. The reach had no channel alterations.

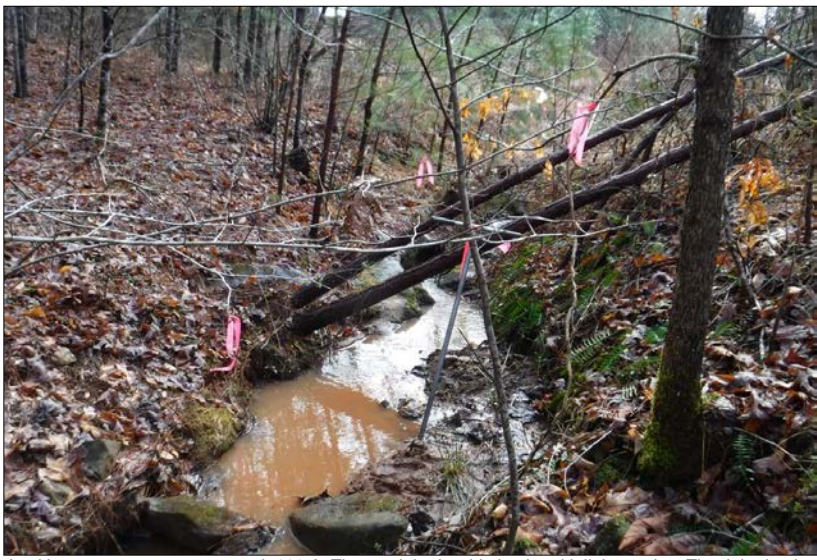
Looking upstream at stream reach 109-A. The reach had stable banks with little erosion. The right riparian buffer consisted of 80% mature forest cover with 30-60% canopy cover and a non-maintained understory, and 20% dense herbaceous vegetation. The left buffer contains 100% mature forest cover with 30-60% canopy cover and a non-maintained understory. The in-stream habitat contained varied substrate sizes and leaf packs. No channel alterations were observed.

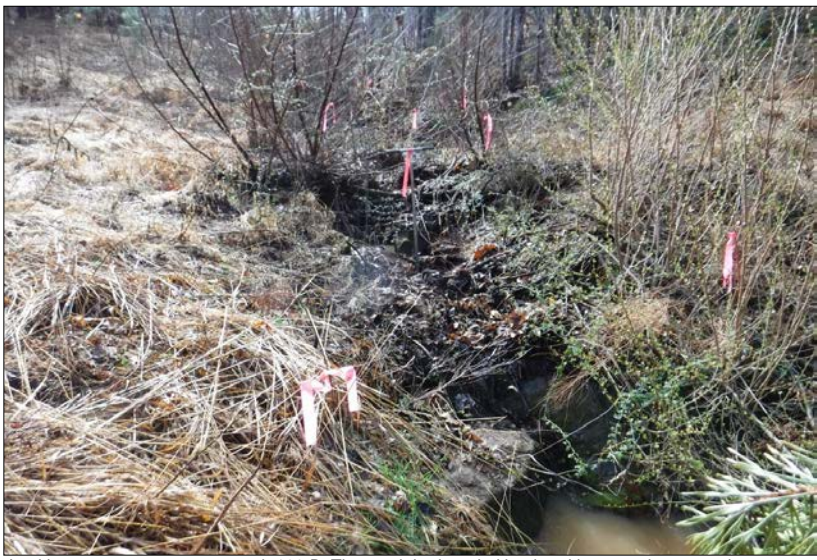
Looking upstream at stream reach 109-B. The reach had eroded banks with vegetative protection present. The right and left riparian buffers consisted of 100% dense herbaceous vegetation with <30% canopy cover. The in-stream habitat was marginal with stable elements in 10-30% of the reach. No channel alterations were observed. This reach was within a maintained utility right of way.

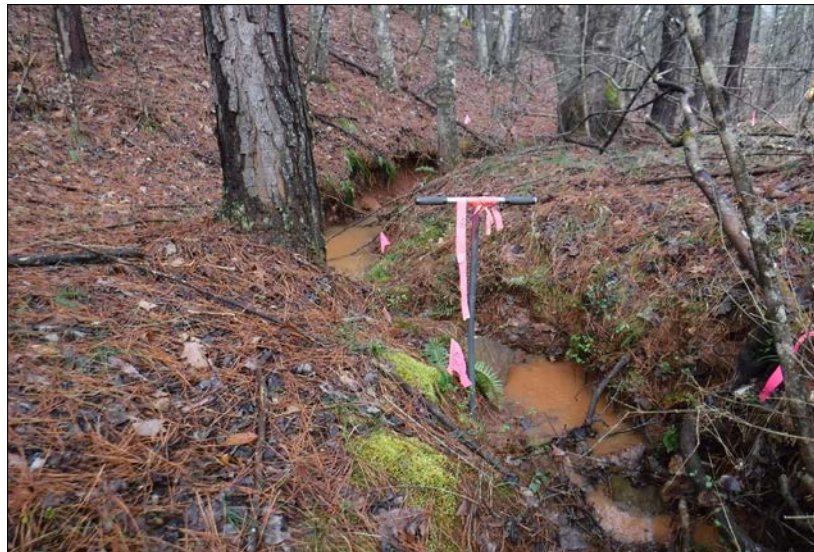
Looking upstream at stream reach 109-C. The reach has deeply incised, unstable banks. The right riparian buffer consisted of 70% dense shrub and herbaceous vegetation, 20% mature forest cover with 30-60% canopy cover, and 10% logged land. The left buffer contained 20% mature forest cover with 30-60% canopy cover and 80% mature forest cover. The in-stream habitat was marginal with stable elements in 10-30% of the reach. Channel alterations include a spoil pile at the headwaters from logging activities.

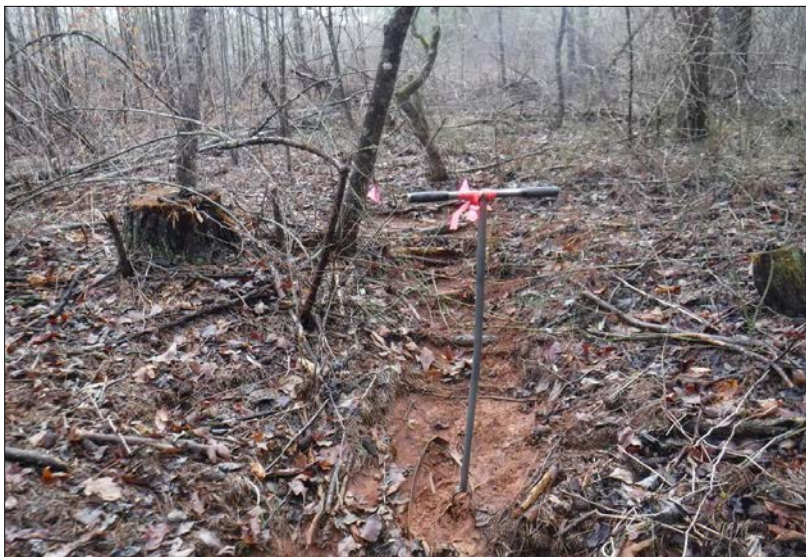
Looking upstream at stream reach 109-D. The right riparian buffer consisted of 30% mature trees cover, 60% non-maintained dense shrub and herbaceous vegetation, and 10% non-vegetated land. The left riparian buffer consisted of 100% mature forest cover cover.

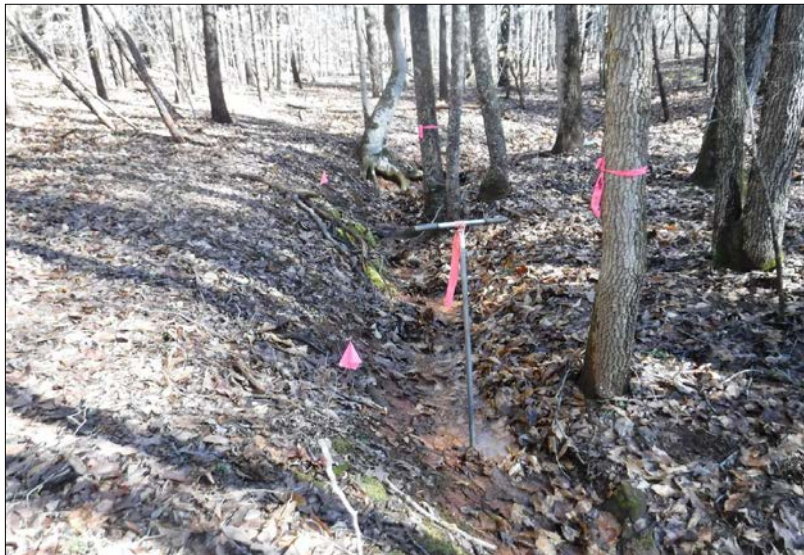
Looking upstream at stream reach 110-A. The right and left riparian buffers consisted of 100% mature forest cover.

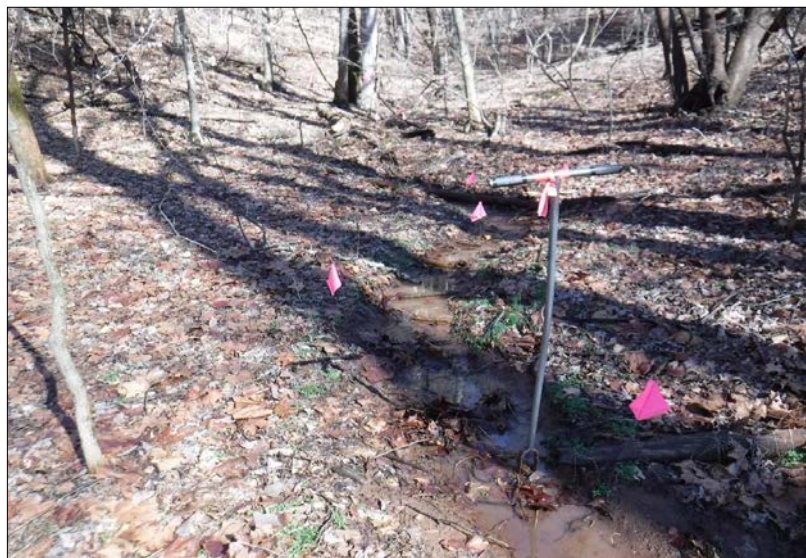
Looking upstream at stream reach 111-A. The right and left riparian buffers consisted of 100% mature forest cover.

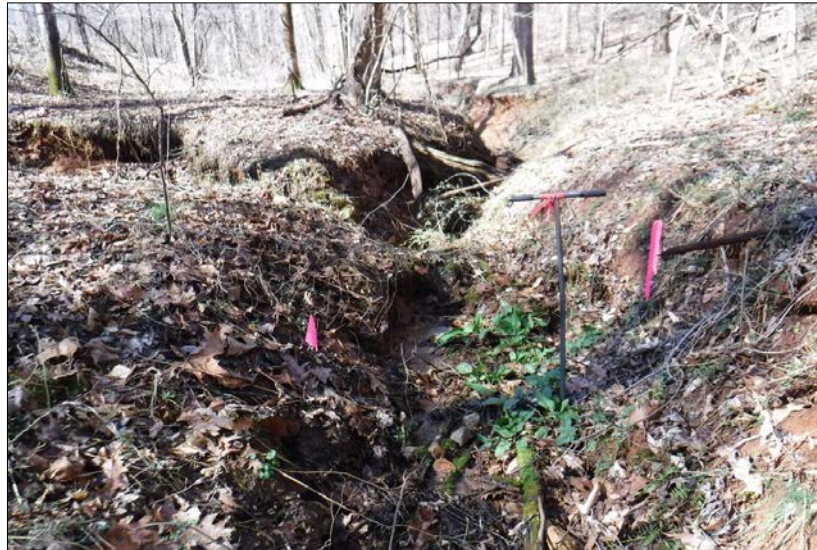
Looking upstream at stream reach 112-A. The channel is slightly incised with some erosion along the banks. The right and left riparian buffers consisted of 100% mature forest cover, with wetlands along the left bank. The in-stream habitat was suboptimal with stable elements in 30-50% of the reach. No channel alterations were observed.

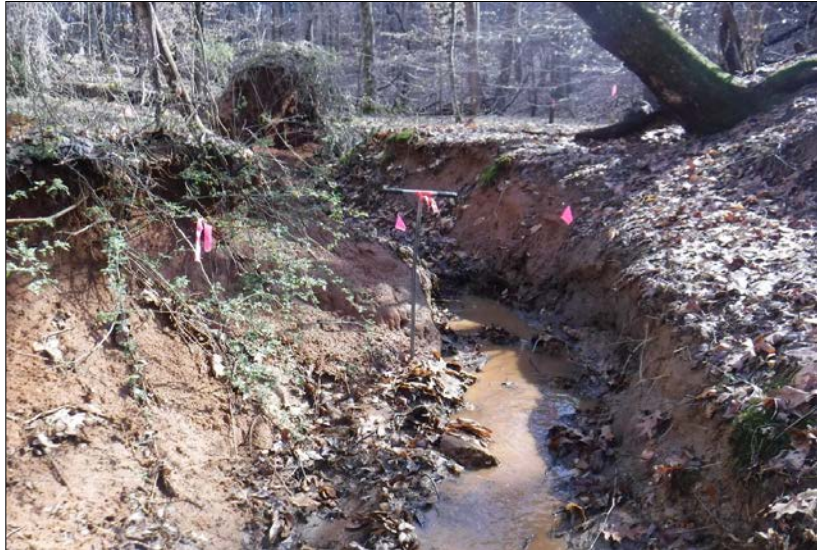
Looking upstream at stream reach 113-A. The reach had severely incised and eroded banks. The right riparian buffer consisted of 100% mature forest cover. The left buffer contained 60% mature forest cover and 40% maintained vegetation with kudzu cover. The in-stream habitat was poor, containing leaves and few pools. No channel alterations were observed.

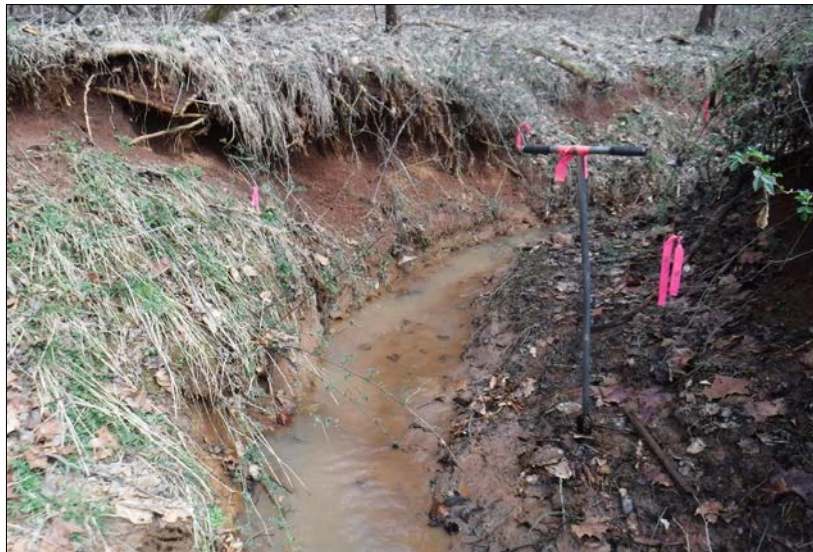
Looking upstream at stream reach 113-B. The reach had severely incised and eroded banks. The right riparian buffer consisted of 100% mature forested cover. The left buffer contained 30% mature forest cover and 70% maintained vegetation with kudzu cover. The in-stream habitat was poor, containing leaves and few pools. No channel alterations were observed.

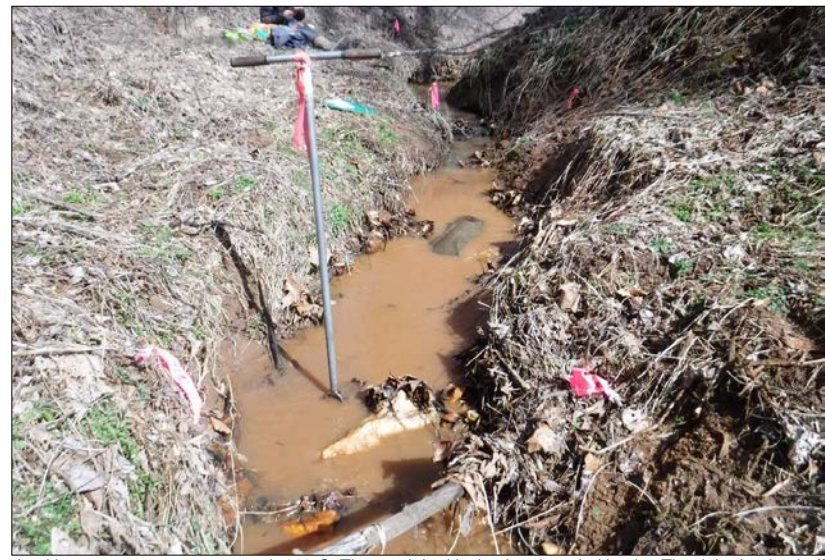
Looking upstream at stream reach 113-C. The reach had incised and eroded banks. The right riparian buffer consisted of 40% mature forested cover and 60% maintained vegetation. The left buffer contained 98% maintained vegetation with kudzu cover and 2% PEM wetland cover. The in-stream habitat was poor, containing leaves and few pools. No channel alterations were observed.

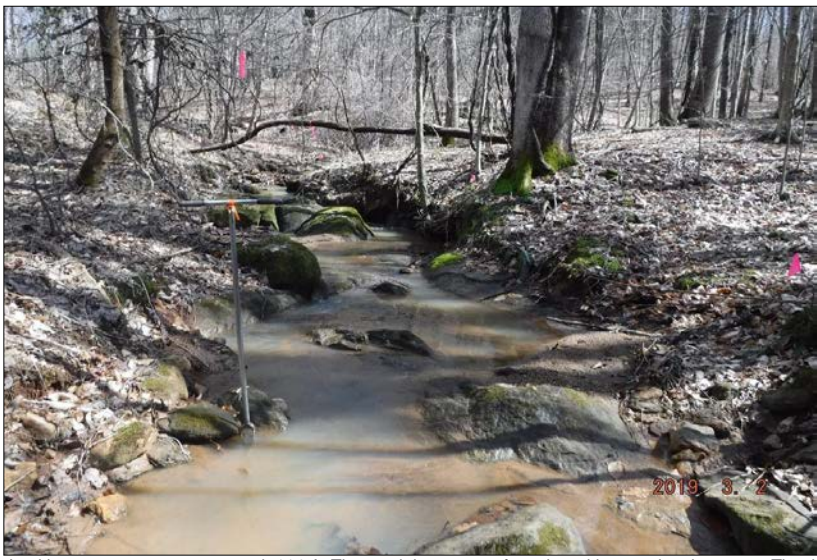
Looking upstream at stream reach 114-A. The reach has areas of erosion with natural rock present. The right riparian buffer consisted of 50% mature forest cover and 50% herbaceous vegetation. The left buffer consisted of 100% mature forest cover. The in-stream habitat was marginal with stable elements in 10-30% of the reach, including varied water velocity and depths, shade and undercut banks. Channel alterations include an ATV stream crossing.

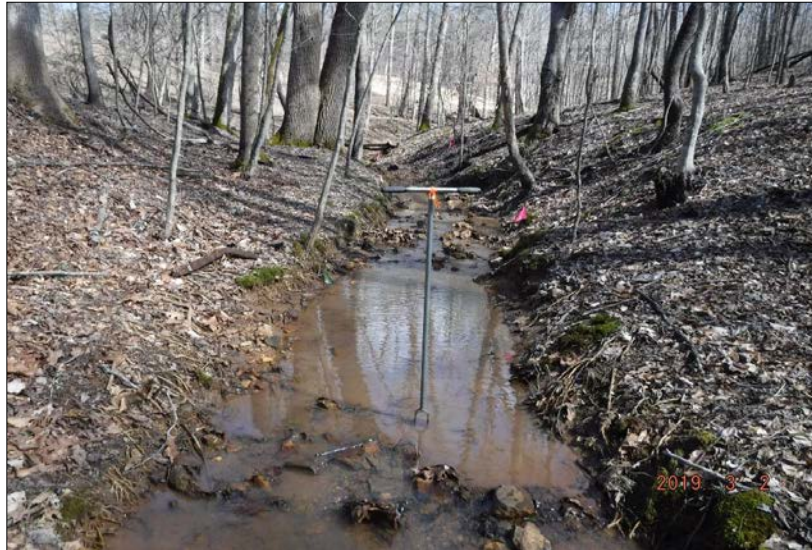
Looking upstream at stream reach 114-B. The reach has stable banks with few areas of erosion present. The right riparian buffer consisted of 95% mature forest cover and 5% maintained herbaceous vegetation. The left buffer consisted of 100% mature forest cover. The in-stream habitat included shade and riffles. No channel alterations were observed.

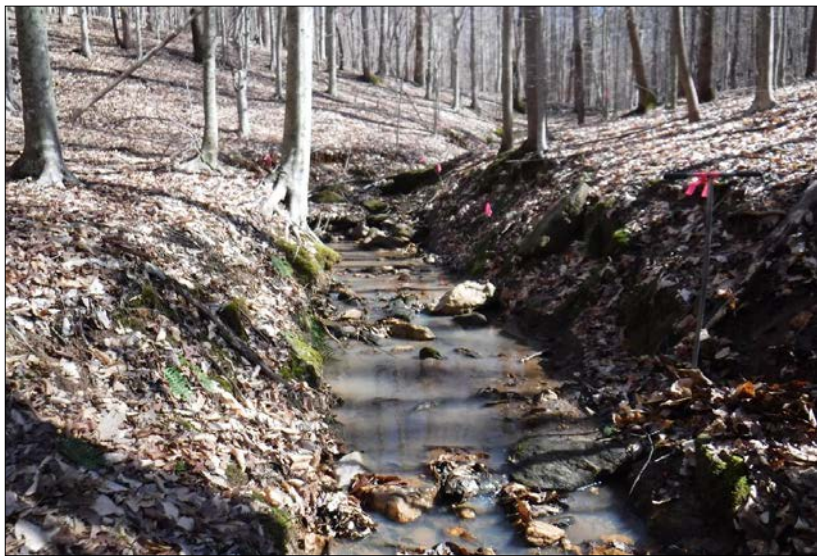
Looking upstream at stream reach 115-A. The reach has slightly incised banks, with no channel alterations observed. The right and left riparian buffers consisted 100% mature forest cover. The in-stream habit was optimal and contained varied substrate sizes and shade. No channel alteration was present within this reach.

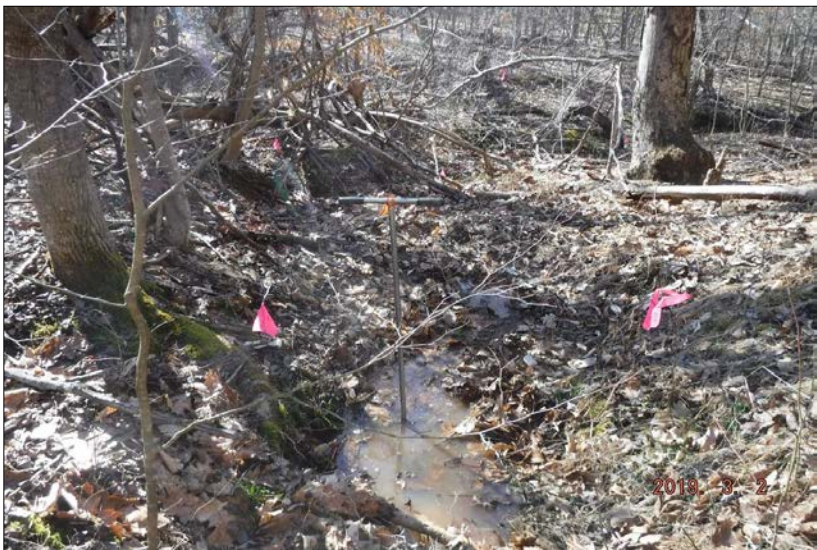
Looking downstream at stream reach 116-A. The reach had stable banks with some active erosion. The right and left riparian buffers consisted of 100% mature forest cover. The in-stream habitat was poor with stable elements in less than 10% of the reach. There are no known channel alterations.

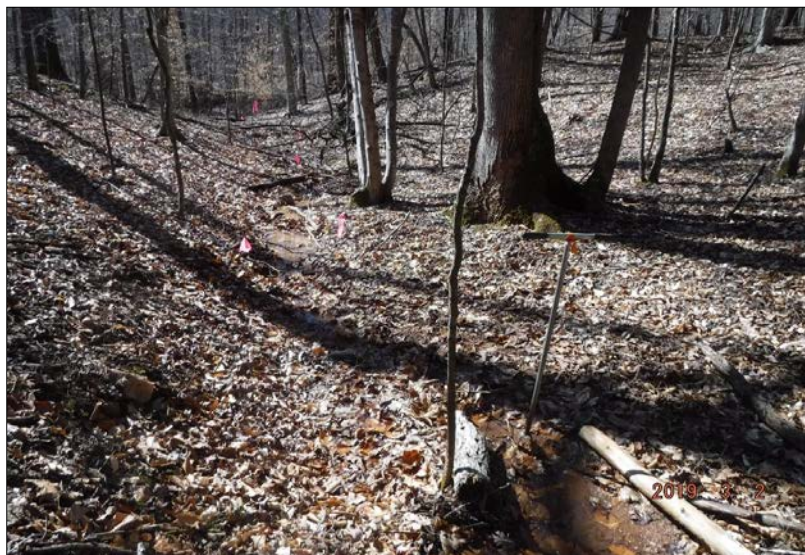
Looking downstream at stream reach 116-B. The right and left riparian buffers consisted of 100% mature forest cover.

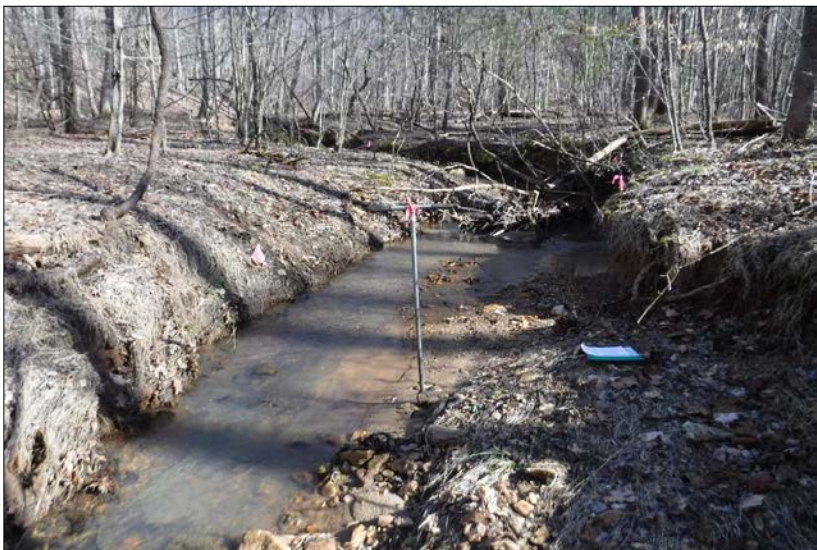
Looking upstream at stream reach 117-A. The reach had overwidened, unstable banks. The right and left riparian buffers consisted of 100% mature forest cover. The in-stream habitat was suboptimal and contained woody debris, undercut banks and various substrate sizes. There are no known channel alterations.
