Stream Assessment Form (Form 1)

Unified Stream Methodology for use in Virginia

Project #	Project Name (Applicant)	Locality	Cowardin Class.	HUC	Date	SAR # / Data Point	Impact/SAR Length	Impact Factor	
	Martinsville Connector (VDOT)	Henry	R3	02070010	3/01/2019	A		N/A	
Name(s) of Evaluator(s)		Stream Name and Information					Stream Map		
SA, JB		Unnamed Tributary to Marrowbone Creek

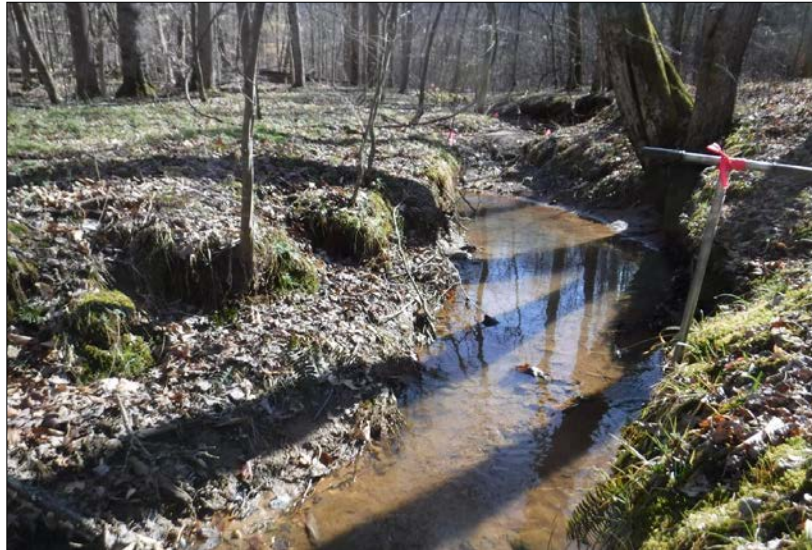
Looking upstream at stream reach 117-B. The reach had incised banks that have overwidened. The right and left riparian buffers consisted of 100% mature forest cover with wetlands within the left riparian buffer. The in-stream habitat was suboptimal with stable elements in 30-50% of the reach. There are no known channel alterations.

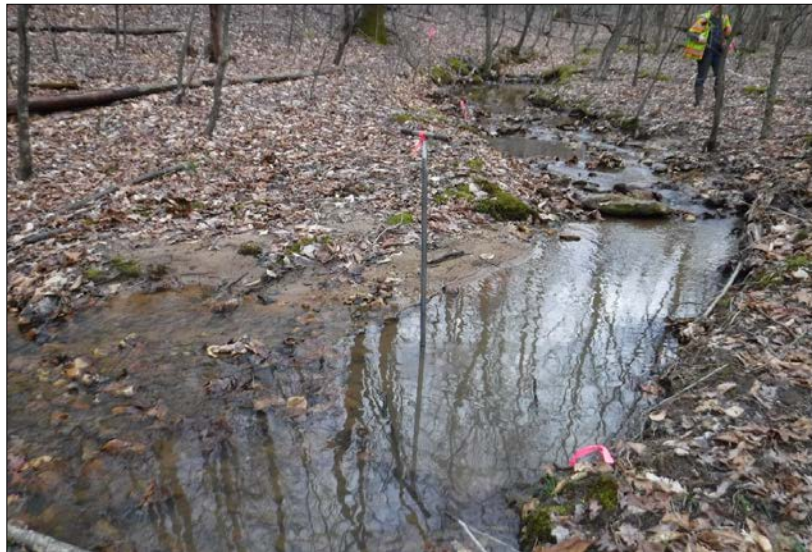
Looking upstream at stream reach 117-C. The reach had little incision and erosion present. The right and left riparian buffers consisted of 100% mature forest cover with wetlands. The in-stream habitat was suboptimal and contained various substrate sizes. There are no known channel alterations.

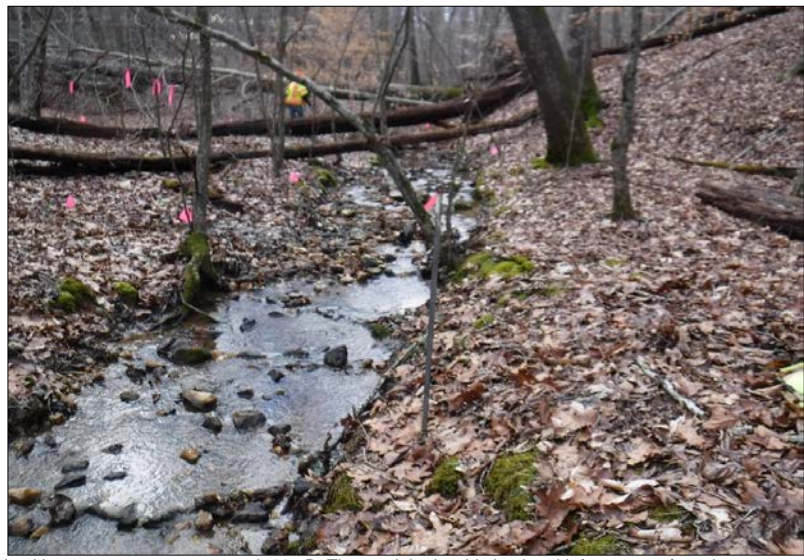
Looking upstream at stream reach 117-D. The reach had stable banks with few areas of erosion present. The right and left riparian buffers consisted of 100% mature forest cover with wetlands. The in-stream habitat was optimal with stable elements in greater than 50% of the reach. No channel alterations were observed.

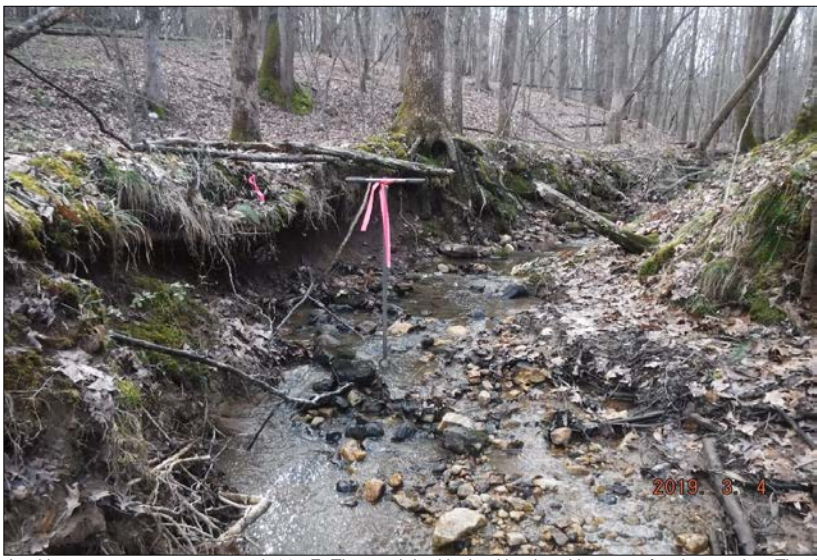
Looking upstream at stream reach 117-E. The reach had incised banks with areas of active erosion. The right and left riparian buffers consisted of 100% mature forest cover with wetlands. The in-stream habitat was optimal with stable elements in greater than 50% of the reach. There are no known channel alterations.

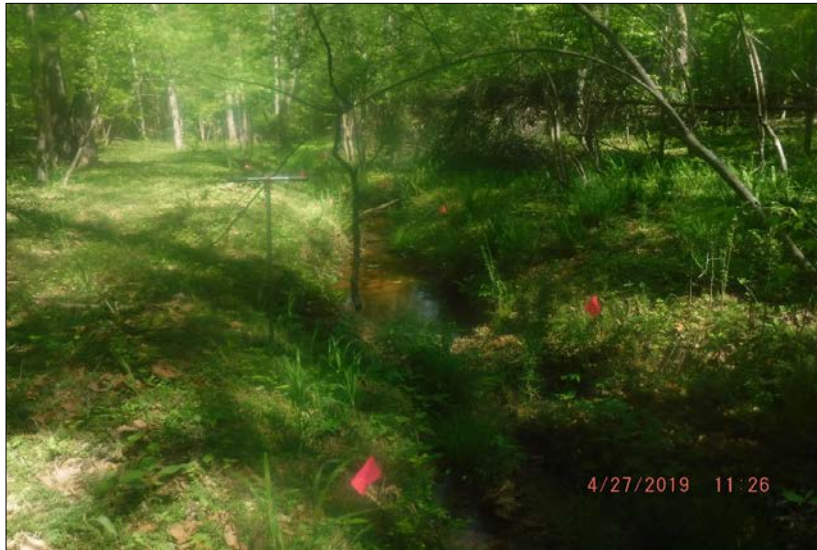
Looking downstream at Stream Reach 117-F. The stream is slightly incised with few areas of active erosion and 60-80% vegetative surface protection. The left and right bank riparian buffers consist of mature forest with greater than 60% tree canopy cover. Instream habitat was present in 30- 50% of the stream. No channel alteration was present in the reach.

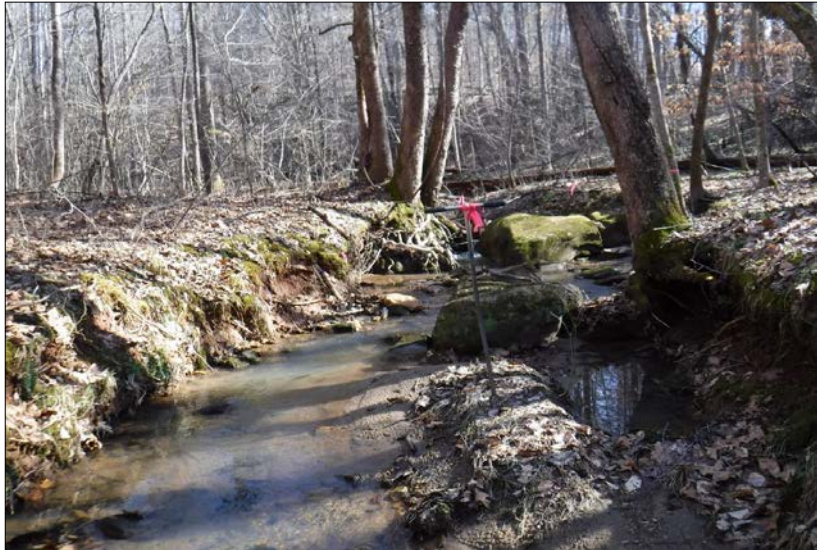
Looking upstream at stream reach 118-A. The reach has incised banks with moderate erosion present. The right and left riparian buffers consisted of 100% mature forest cover. The in-stream habitat was optimal with stable elements in greater than 50% of the reach. There are no known channel alterations.

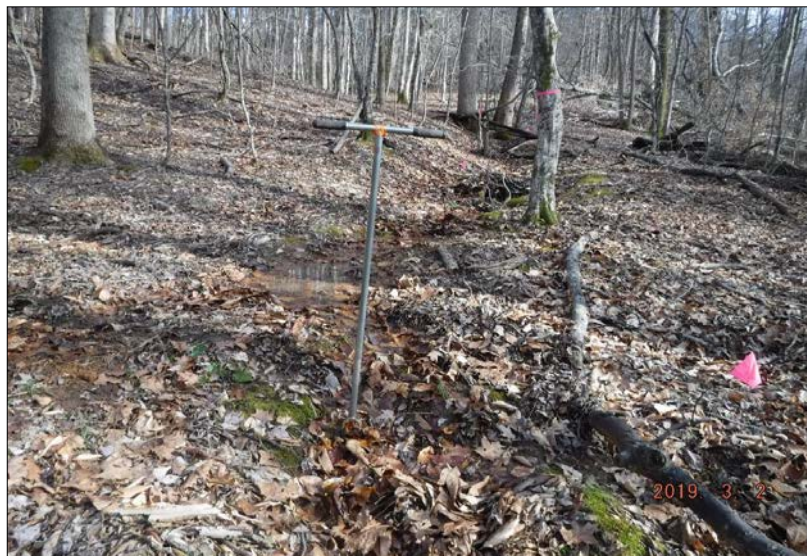
Looking upstream at stream reach 119-A. The right and left riparian buffers consisted of 100% mature forest cover.

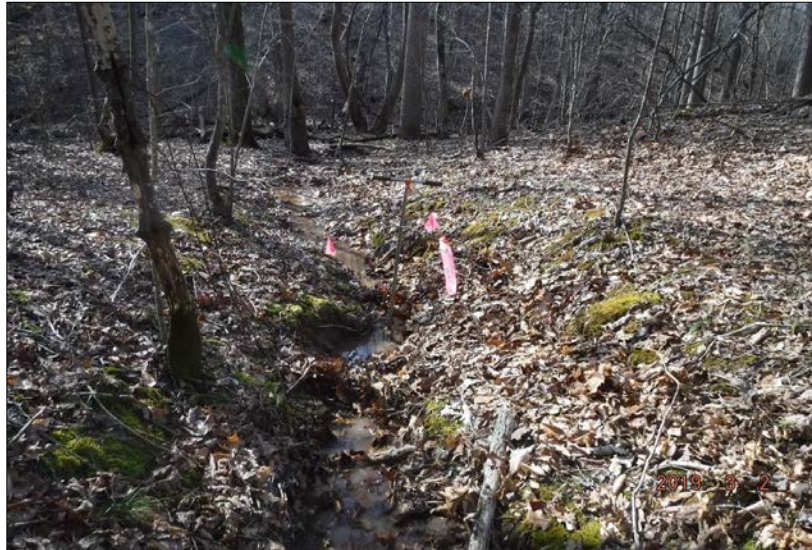
Looking upstream at stream reach 119-B. The reach had few areas of erosion. The right and left riparian buffers consisted of 100% mature forest cover. The reach lacked habitat elements. No channel alteration in this reach.

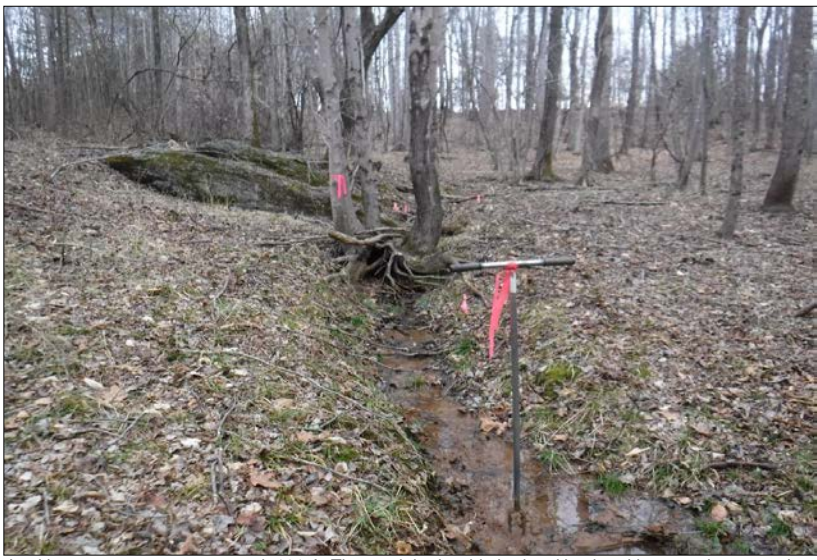
Looking upstream at stream reach 121-A. The reach had stable bed and banks with vegetative protection and minor erosion. The right riparian buffer consisted of 95% mature forest cover and 5% herbaceous field, and the left riparian buffer consisted of 100% mature forest cover. The in-stream habitat was marginal, and no channel alterations were observed.

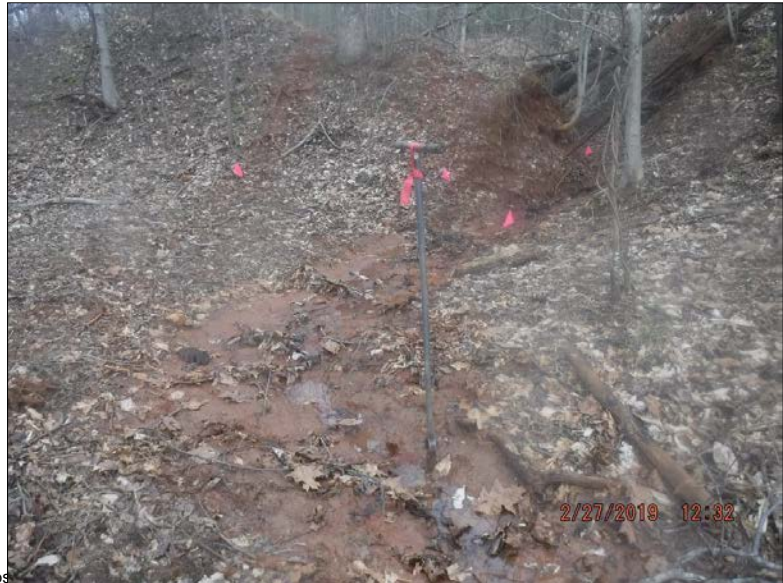
(WSSI Photo Location L:\9999.01\Images\Stream Assessment\IMG_2733.jpg)

Looking up stream bank, and had active deposition. The left bank consisted of 60% suboptimal canopy cover and the right bank consisted of 100% optimal canopy cover. The instream habitat was poor throughout the reach, lacking riffles, pools, leaf packs and substrate of various particle sizes. The reach had channel alterations due to active livestock.

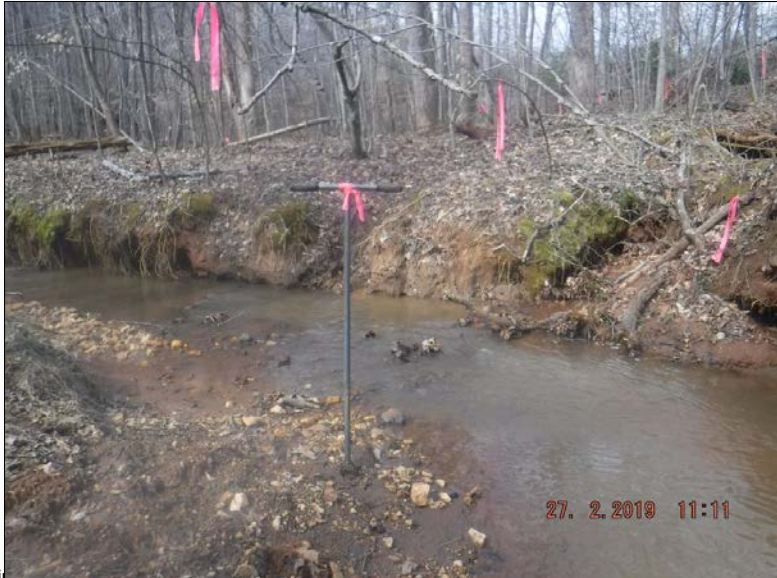
(WSSI Photo Location L:\30000s\30500\30544.01\Photos\01-Ex Conditions\Alignment 4BVB)

Looking upstream from the survey point. The riparian zone consists of 100% optimal canopy cover. The instream habitat throughout the reach consisted of riffles, pools, leaf packs and substrate of various particle size. The reach had channel alterations due to active livestock.

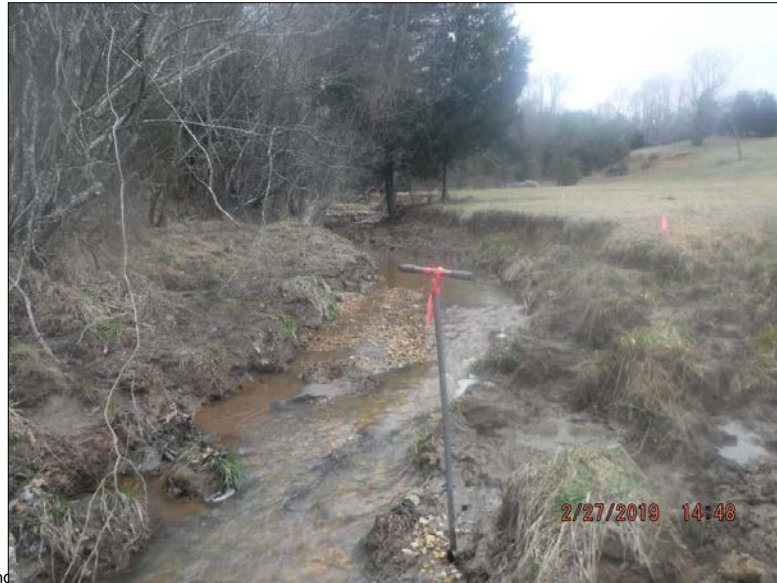
Looking [direction] riparian buffer consisted of 100% optimal canopy cover. The right riparian buffer consisted of 95% open active livestock pasture and 5% optimal canopy cover. The instream habitat consisted of riffles, pools and substrate of various particle sizes, but had excess sediment and silt due to active erosion. The reach had channel alterations due to active livestock.

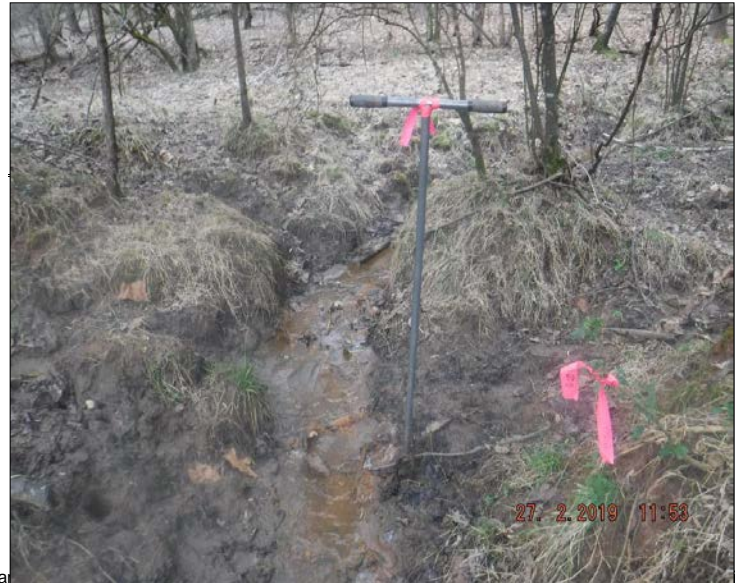
Lookin upstream. Stream consists of 100% optimal canopy cover. In-stream habitat elements are present in 30-50% of the reach. The reach is altered by livestock.

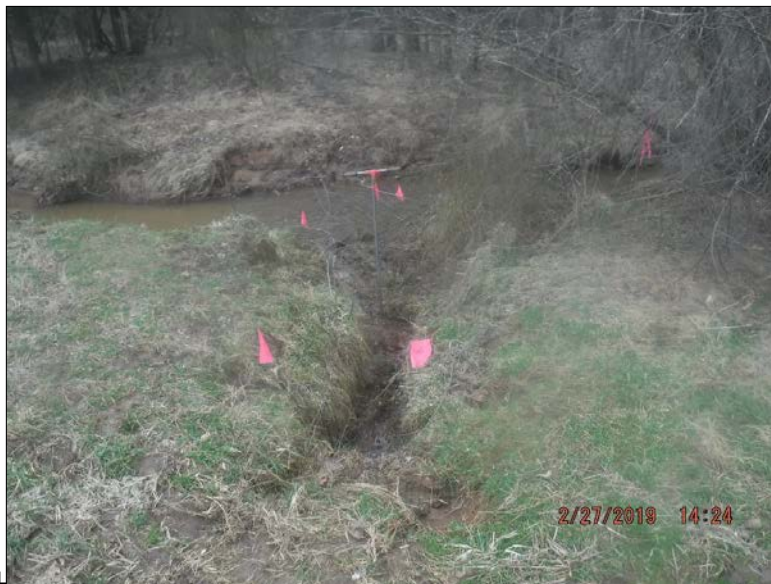
and 5% suboptimal canopy cover. The left riparian buffer is 100% open active cattle pasture.

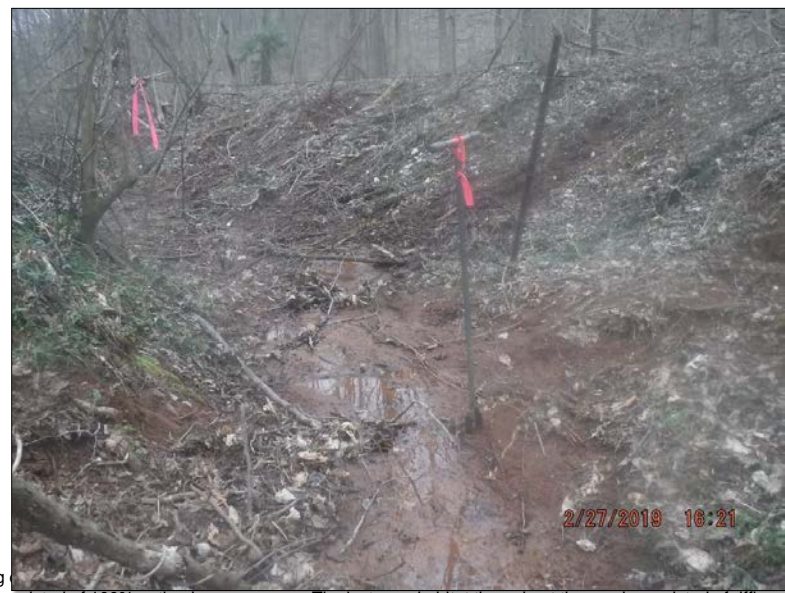
Looking riparian buffer consisted of 100% optimal canopy cover. The instream habitat throughout the reach consisted of riffles, pools, and leaf packs. The channel had no alterations.

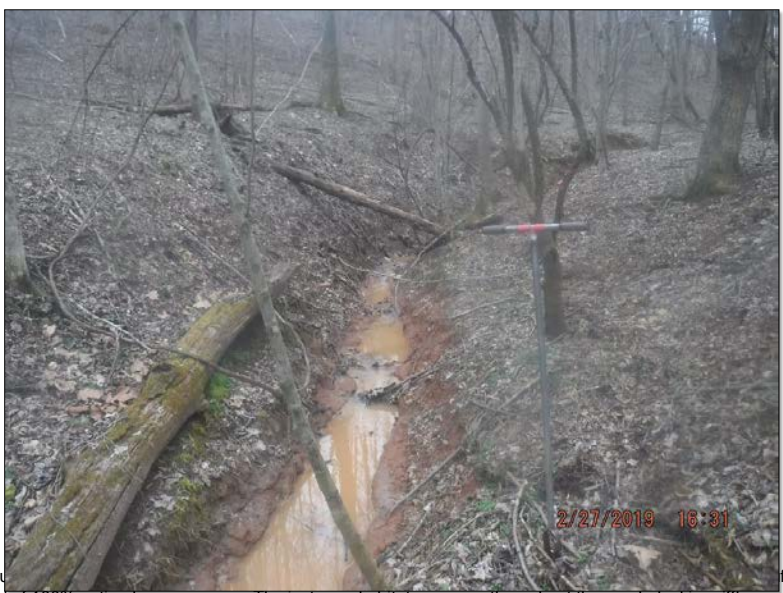
Looking uffer consisted of 100% optimal canopy cover. The instream habitat was poor throughout the reach, lacking riffles, pools, leaf packs and substrate of various particle sizes. The channel had no alterations.

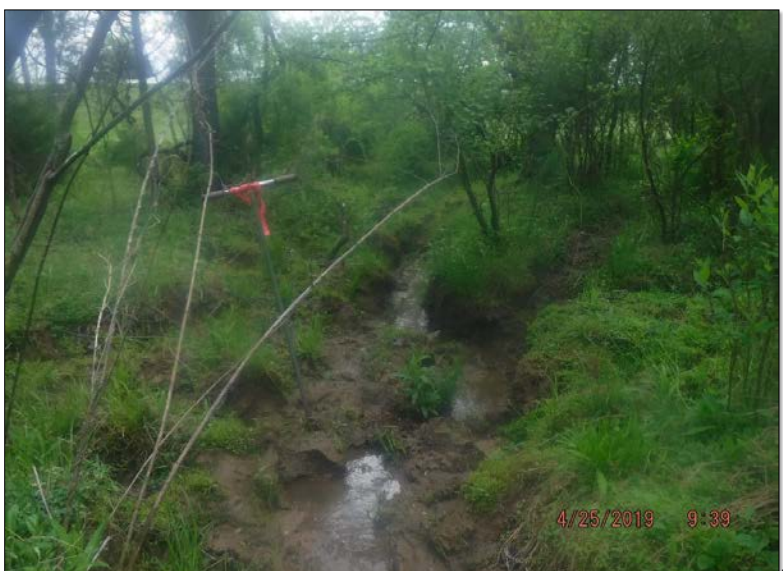
Looking down the stream banks with moderate sediment deposits. The left and right bank riparian buffers consist of wetlands. Instream habitat is present in 10-30% of the reach. Livestock alters 40-60% of the channel for this stream reach.

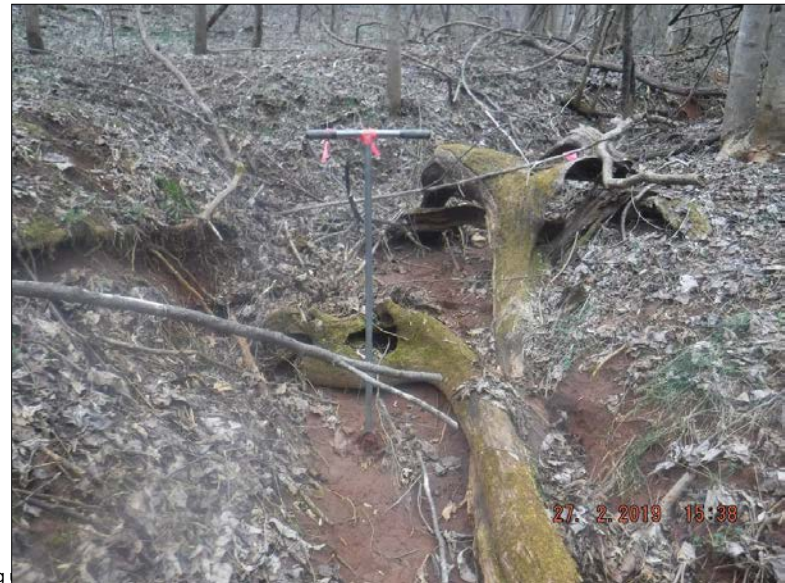
Looking [direction] offers consisted of 100% optimal canopy cover. The instream habitat was poor throughout the reach, lacking riffles, pools, leaf packs and substrate of various particle sizes. The reach had no channel alterations.

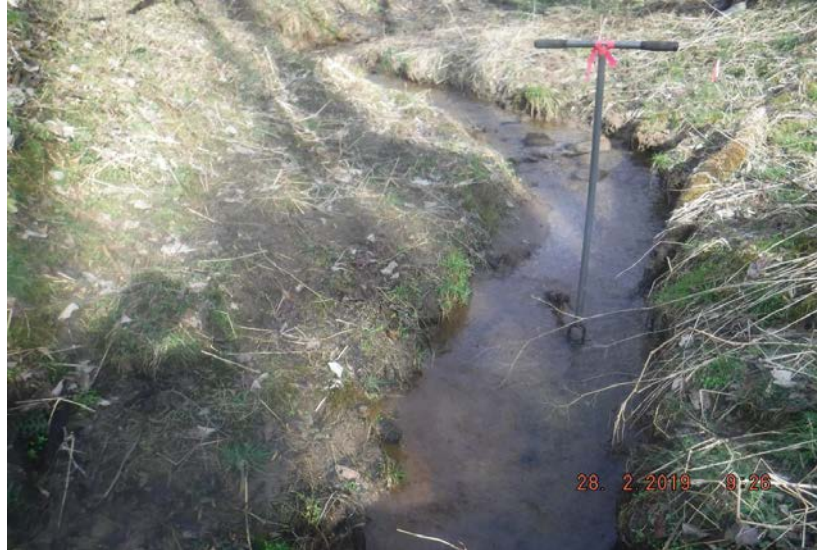
Looking upstream at Stream Reach 128-A. The reach had optimal channel condition. The right and left riparian buffer consisted of 100% optimal canopy cover. The instream habitat throughout the reach consisted of riffles, pools, leaf packs and substrate of various particle size. The reach had no channel alterations.

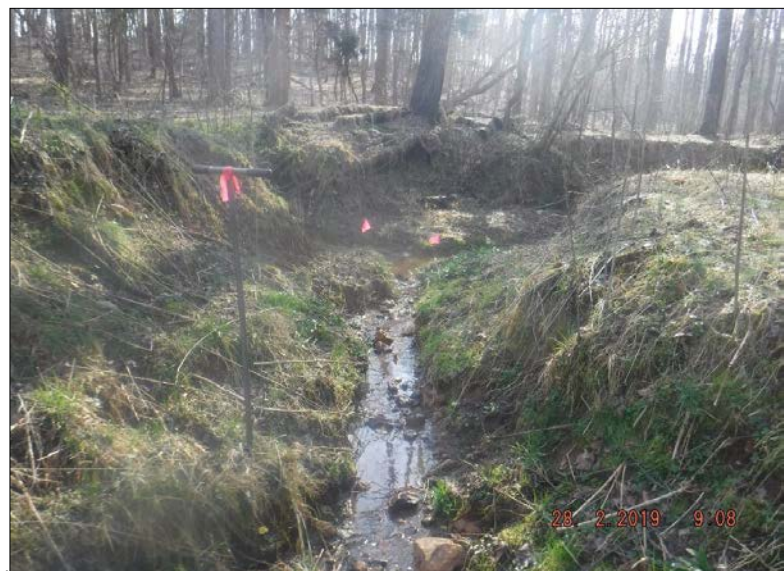
Looker consisted of 80% optimal canopy cover and 20% of non-maintained herbaceous cover with suboptimal canopy cover. The left riparian buffer consisted of 100% optimal canopy cover. The instream habitat consisted of leaf packs and substrate of various particle size but lacked riffle pool complexes. The reach had no channel alterations.

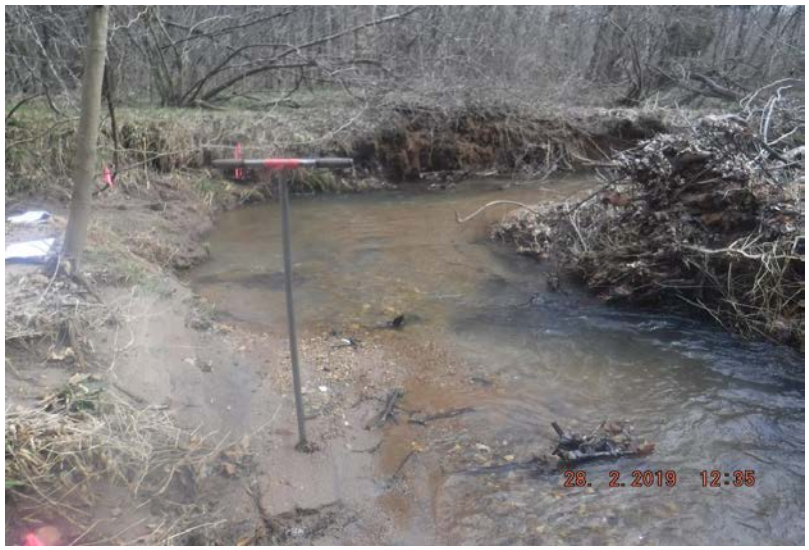
Looking downstream at Stream Reach 130-A. The reach was moderately incised with areas of active erosion. The right and left riparian buffer consisted of 100% optimal canopy cover. The instream habitat consisted of leaf packs and substrate of various particle size but lacked riffle and pool complexes and had excess sediment and silt due to active erosion. The reach had no channel alterations.

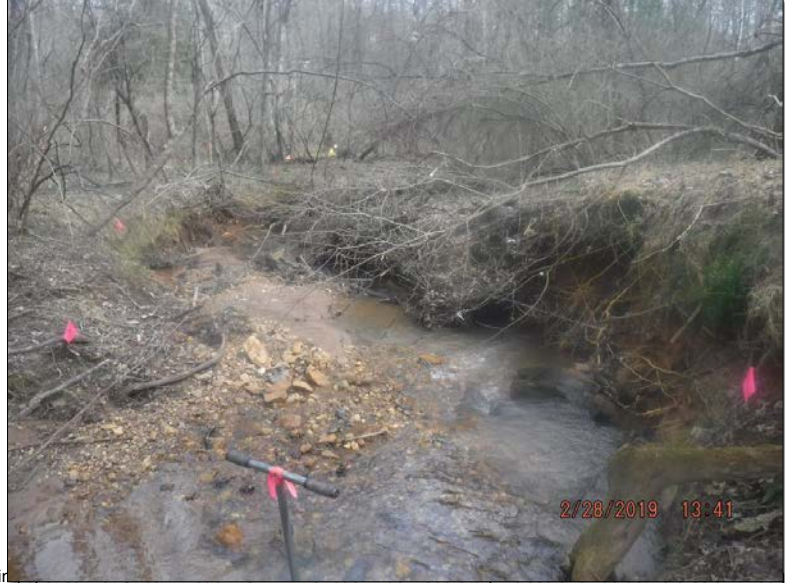
Looking throughout. The right and left riparian buffers consisted of 100% optimal canopy cover. The instream habitat throughout the reach consisted of riffles, pools, leaf packs and substrate of various particle size. The reach had no channel alterations.

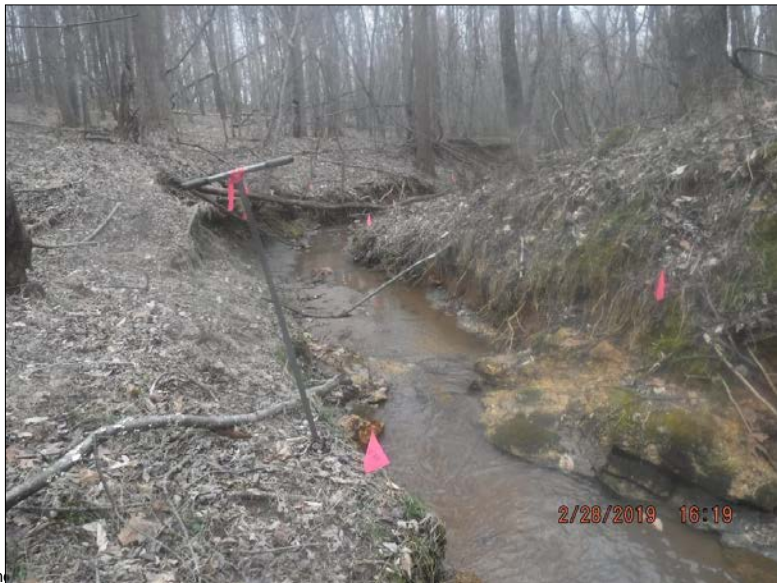
Looking throughout. The right and left riparian buffer consisted of 100% optimal canopy cover. The instream habitat throughout the reach consisted of riffles, pools, leaf packs and substrate of various particle size. The reach had no channel alterations.

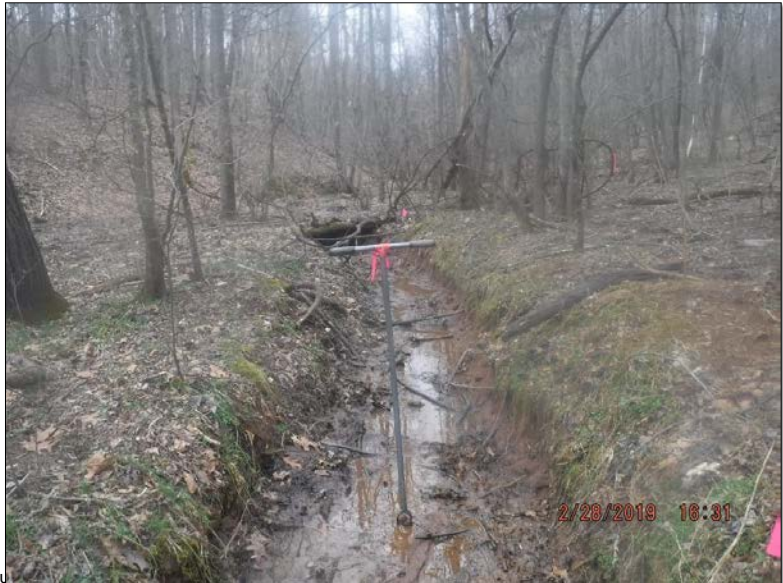
Looking up right and left riparian buffer consisted of 100% optimal canopy cover. The instream habitat consisted of leaf packs and substrate of various particle size but lacked riffle pool complexes and had excess sediment and silt due to active erosion. The reach had no channel alterations.

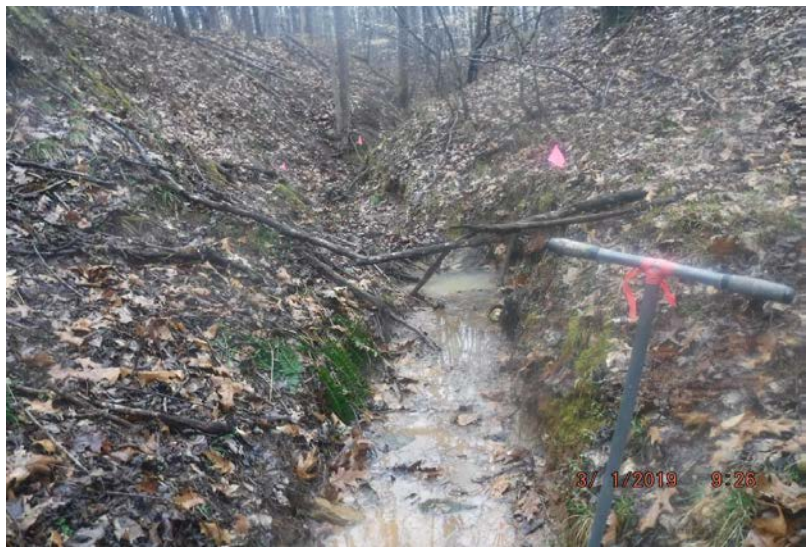
Looking upstream at Stream Reach 133-B. The reach was moderately incised with areas of active erosion. The right and left riparian buffer consisted of 100% optimal canopy cover. The instream habitat consisted of riffles, pools, leaf packs and substrate of various particle size but had excess sediment and silt due to active erosion. The reach had no channel alterations.

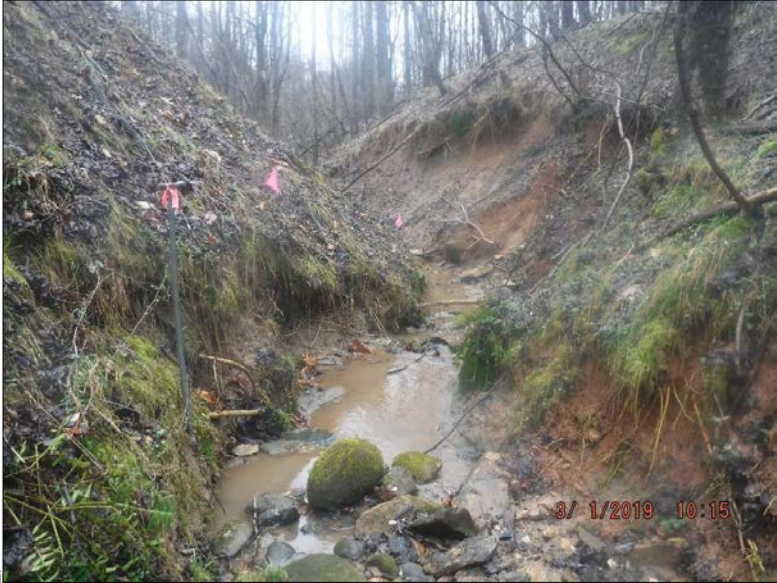
Looking down the stream channel. The right and left riparian buffer consisted of 100% optimal canopy cover. The instream habitat consisted of riffles, pools, leaf packs and substrate of various particle size but had excess sediment and silt due to active erosion. The reach had no channel alterations.

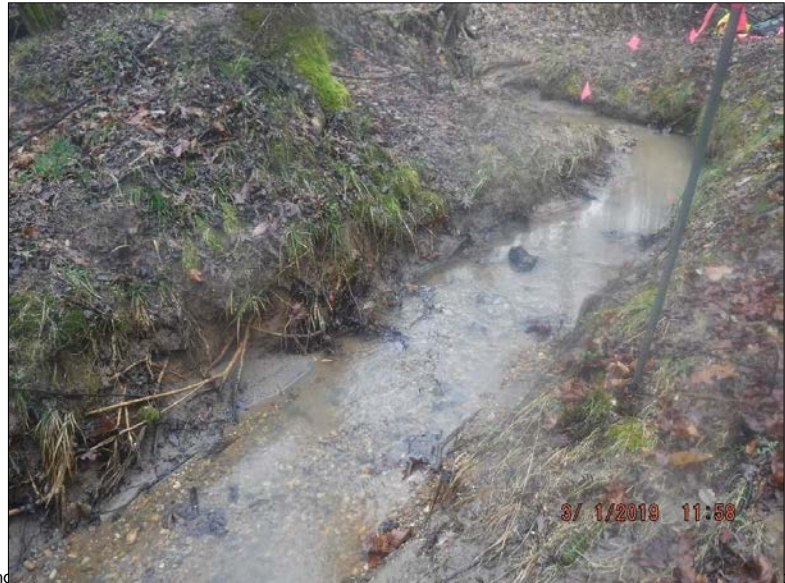
Looking [direction] buffer consisted of 100% optimal canopy cover. The instream habitat consisted of riffles, pools, leaf packs and substrate of various particle size but had excess sediment and silt due to active erosion. The reach had no channel alterations.

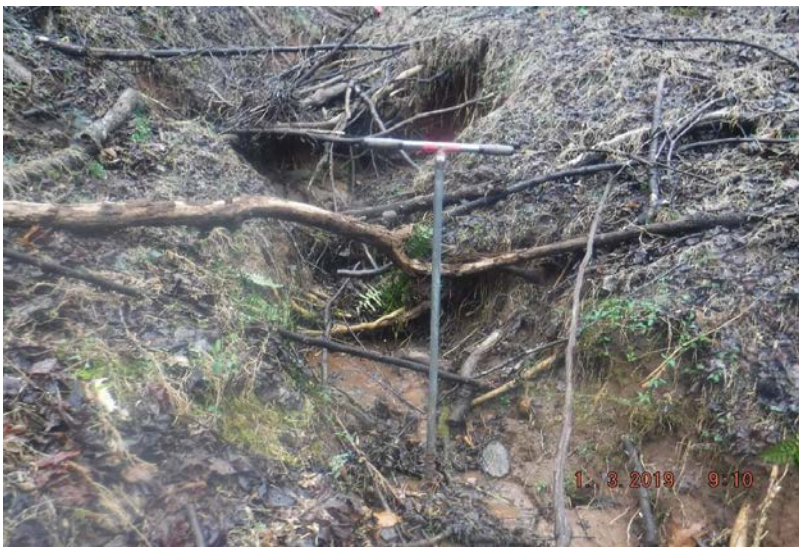
Looking upstream at Stream Reach 135-A. The reach was moderately incised with areas of active erosion. The right and left riparian buffer consisted of 100% optimal canopy cover. The instream habitat had leaf packs and substrate of various particle size but lacked riffle and pool complexes. The reach had no channel alterations.

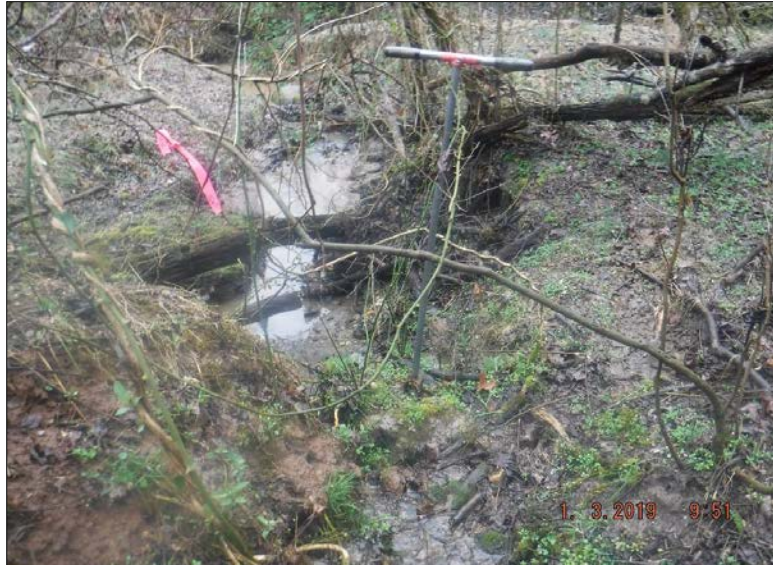
Looking [direction] consisted of 100% optimal canopy cover. The instream habitat was marginal throughout the reach, lacking riffles, pools and leaf packs. The reach had no channel alterations.

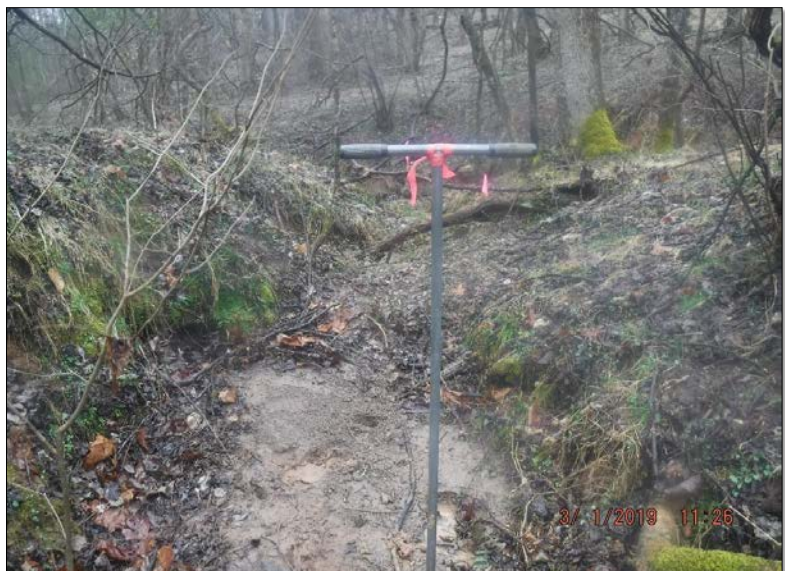
Looking consisted of 100% optimal canopy cover. The instream habitat was marginal throughout the reach, lacking riffles, pools and leaf packs. The reach had no channel alterations.

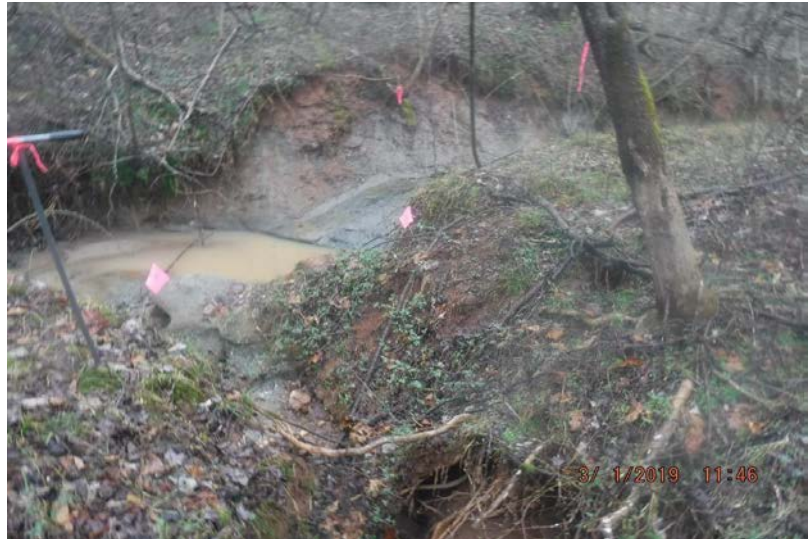
Looking downstream at Stream Reach 138-A. The reach was severely incised with active erosion throughout. The right and left riparian buffer consisted of 100% optimal canopy cover. The instream habitat was poor throughout the reach, lacking riffles, pools and leaf packs. The reach had no channel alterations.

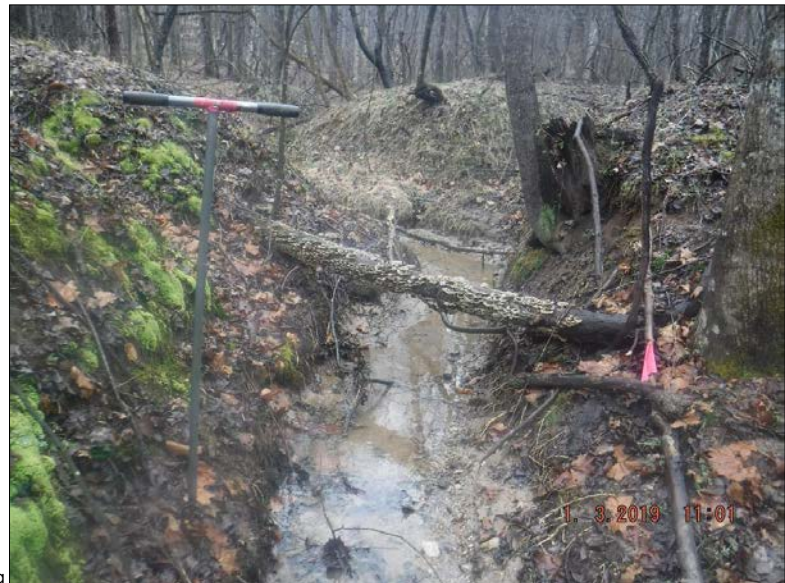
Looking [] buffer consisted of 100% optimal canopy cover. The instream habitat consisted of riffles, pools, leaf packs and substrate of various particle size but had excess sediment and silt due to active erosion. The reach had no channel alterations.

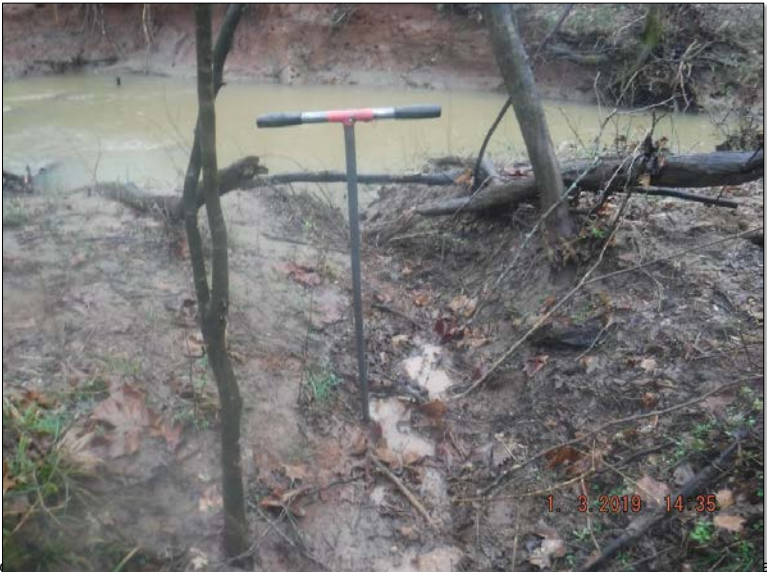
Looking [direction] and left riparian buffer consisted of 100% optimal canopy cover. The instream habitat was poor throughout the reach, lacking riffles, pools, substrate of various particle sizes and leaf packs. The reach had no channel alterations.

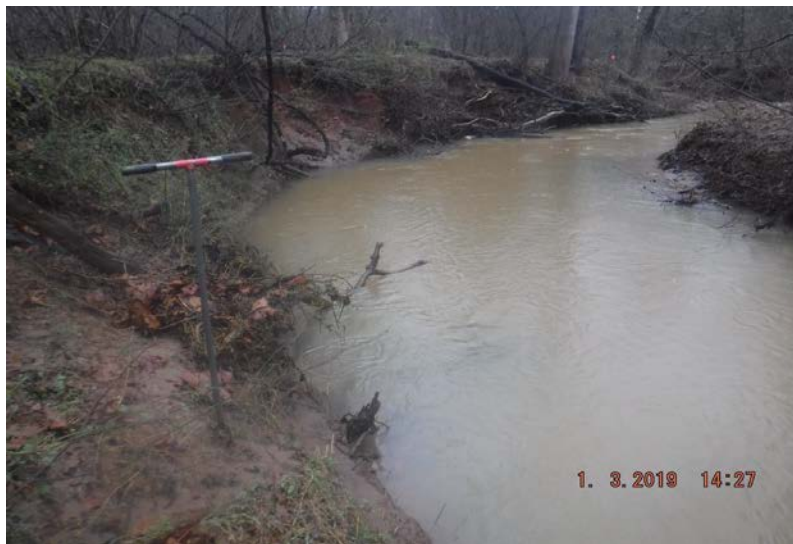
Looking downstream at Stream Reach 141-A. The reach was incised with areas of active erosion. The right and left riparian buffer consisted of 100% optimal canopy cover. The instream habitat consisted of leaf packs and substrate of various particle size but lacked riffle and pool complexes and had excess sediment and silt due to active erosion. The reach had no channel alterations

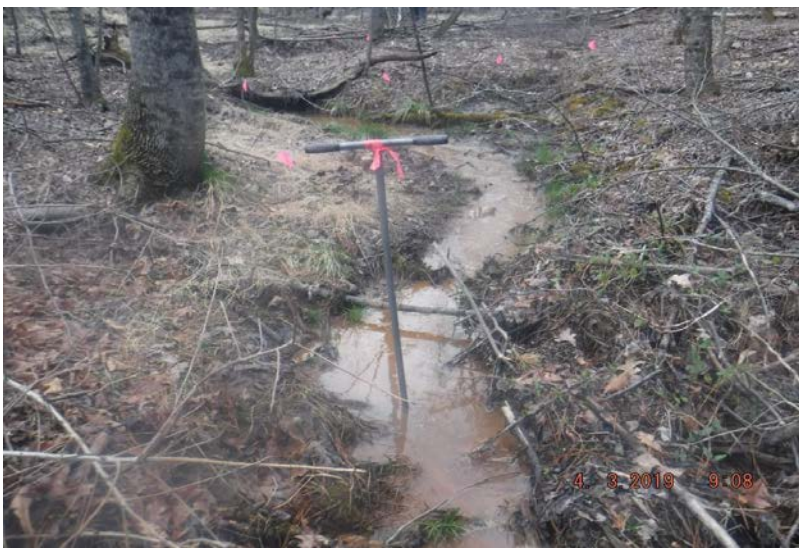
Looking upstream at Stream Reach 142-A. The reach had areas of active erosion. The right and left riparian buffer consisted of 100% suboptimal canopy cover due to recent logging activity. The instream habitat was marginal throughout the reach, lacking riffles, pools and leaf packs. The reach had no channel alterations.

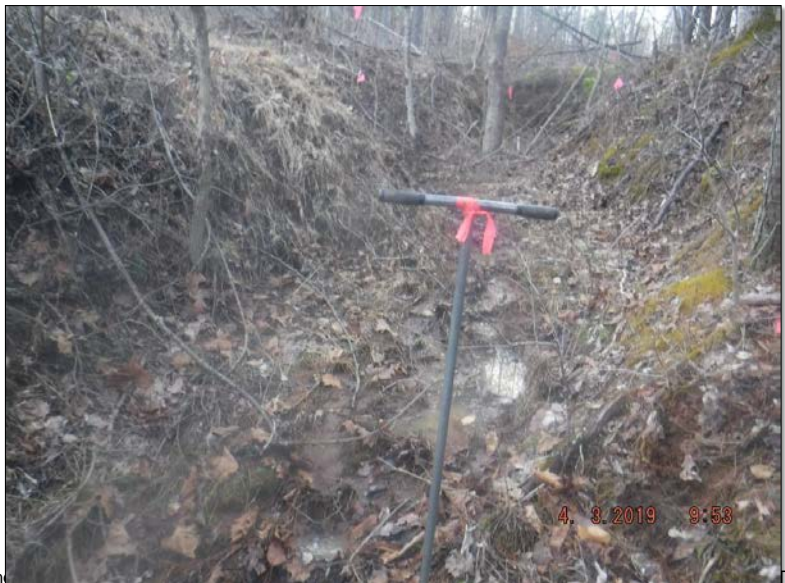
Looking [left] The right riparian buffer consisted of 30-60% subpotimal canopy cover with a non-maintained understory. The left riparian buffer consisted of 30-60% subpotimal canopy cover with a non-maintained herbaceous understory and areas of denuded land due to recent logging activity. The instream habitat was marginal throughout the reach, lacking riffles, pools and leaf packs. The reach had no channel alterations.

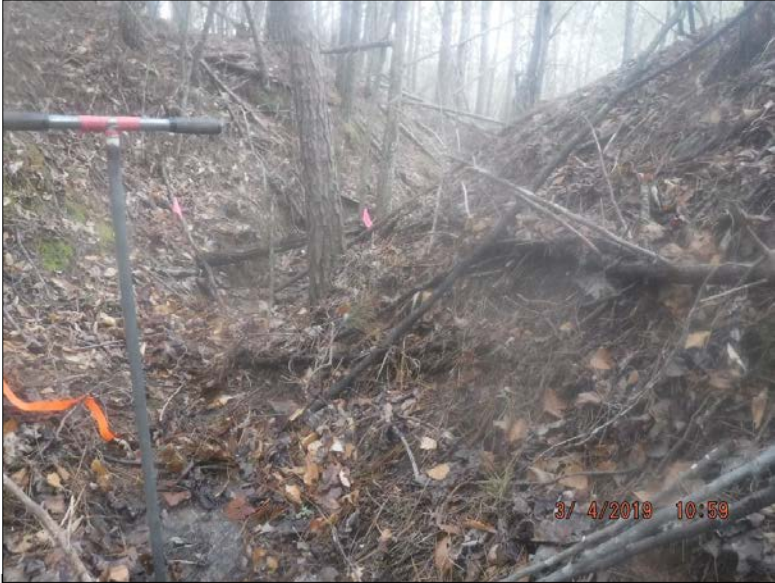
Looking up... in buffer consisted of 30-60% suboptimal canopy cover with a non-maintained understory and areas of denuded surfaces due to recent logging activity. The left riparian buffer consisted of 100% optimal canopy cover. The instream habitat was marginal throughout the reach, lacking riffles, pools and leaf packs. The reach had no channel alterations.

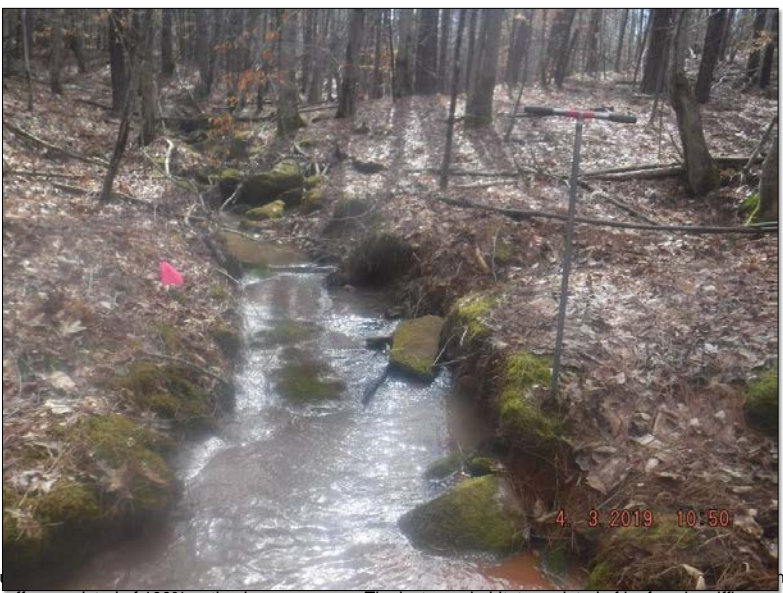
Looking [] and left riparian buffer consisted of 100% optimal canopy cover. The instream habitat consisted of leaf packs, riffle, pools and substrate of various particle size. The reach had no channel alterations.

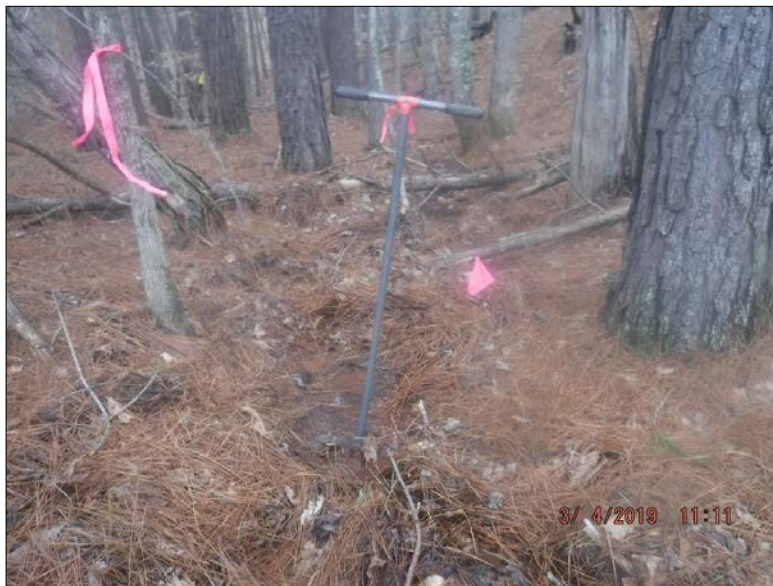
cover and 60% of non-maintained herbaceous understory with marginal canopy cover. The left riparian buffer consisted of 100% canopy cover.

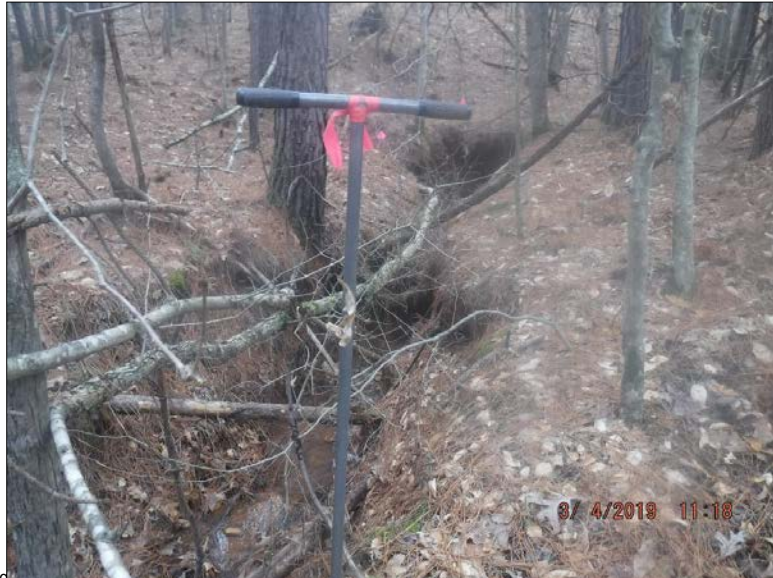
Looking [direction] incision. The right riparian buffer consisted of 30% optimal canopy cover and 70% of non-maintained dense herbaceous understory with marginal canopy cover. The left riparian buffer consisted of 100% optimal canopy cover. The instream habitat was marginal throughout the reach and had substrate of various particle sizes and leaf packs. The reach had no channel alterations.

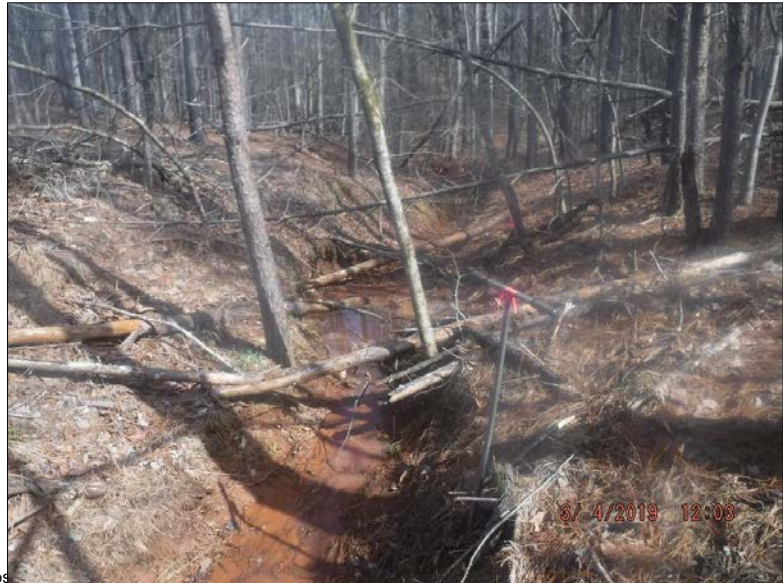
Looking ups... buffer consisted of 65% optimal canopy cover and 35% non-maintained herbaceous understory with marginal canopy cover due to recent logging activity. The left riparian buffer consisted of 15% canopy cover and 85% non-maintained understory with marginal canopy cover due to recent logging activity. The instream habitat was marginal throughout the reach, lacking substrate of various particle sizes, leaf packs and shade. The reach had no channel alterations.

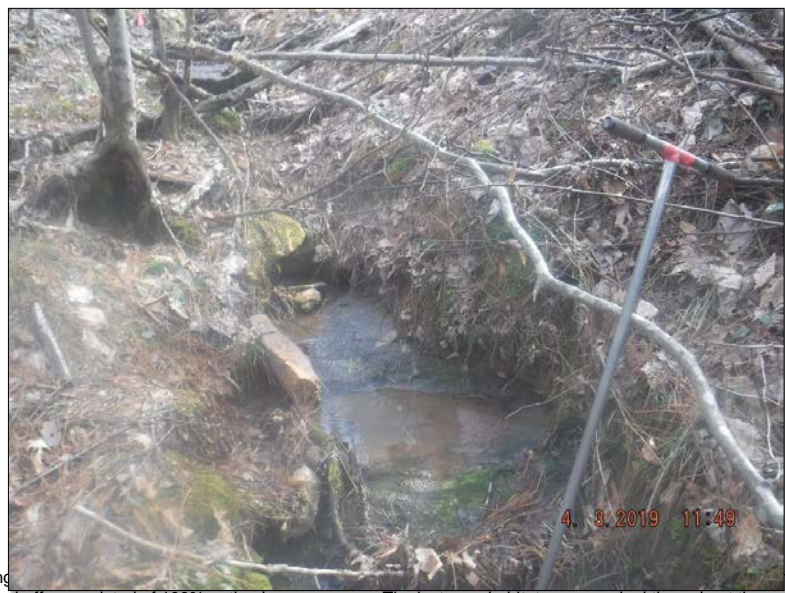
Looking the right and left
riparian buffer consisted of 100% optimal canopy cover. The instream habitat was marginal throughout the reach, lacking riffles, pools complexes. The reach had no channel alterations.

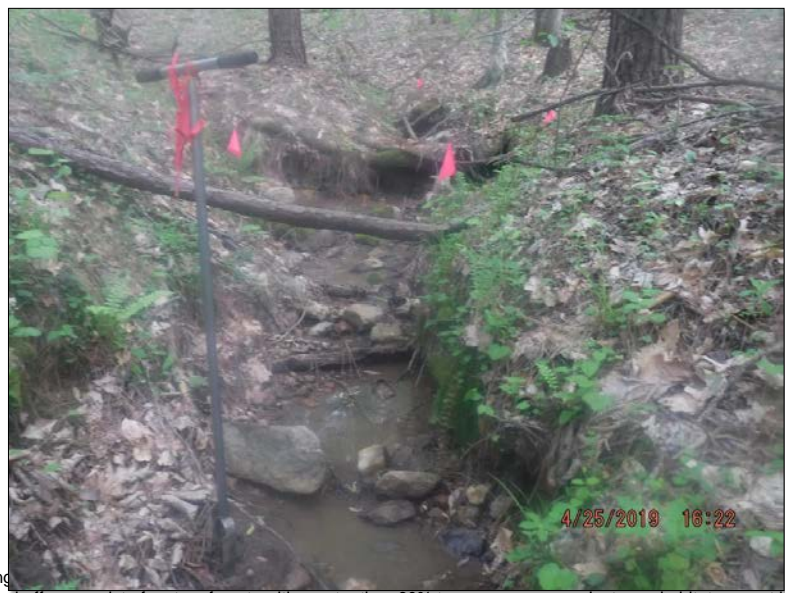
Looking and right bank
riparian buffers consist of mature forests with greater than 60% tree canopy cover. Instream habitat present in 10-30% of the reach. No channel alteration present within the reach.
