Stream Assessment Form (Form 1)

Unified Stream Methodology for use in Virginia

Project #	Project Name (Applicant)	Locality	Cowardin Class.	HUC	Date	SAR # / Data Point	Impact/SAR Length	Impact Factor	
	Martinsville Connector (VDOT)	Henry	R3	02070010	3/01/2019	A		N/A	
Name(s) of Evaluator(s)		Stream Name and Information					Stream Map		
SA, JB		Unnamed Tributary to Marrowbone Creek

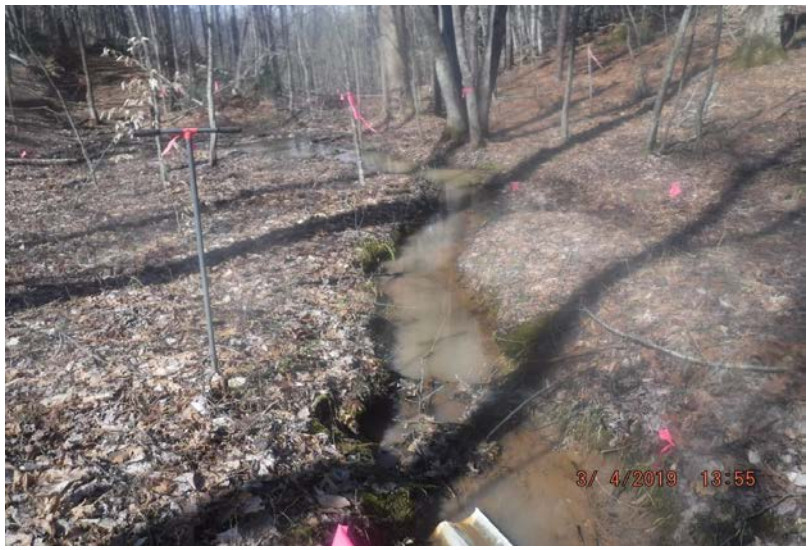
Looking downstream at Stream Reach 149-A. The reach was moderately incised with areas of active erosion. The right and left riparian buffer consisted of 100% optimal canopy cover. The instream habitat was marginal throughout the reach, lacking riffles, pools complexes. The reach had minor channel alterations.

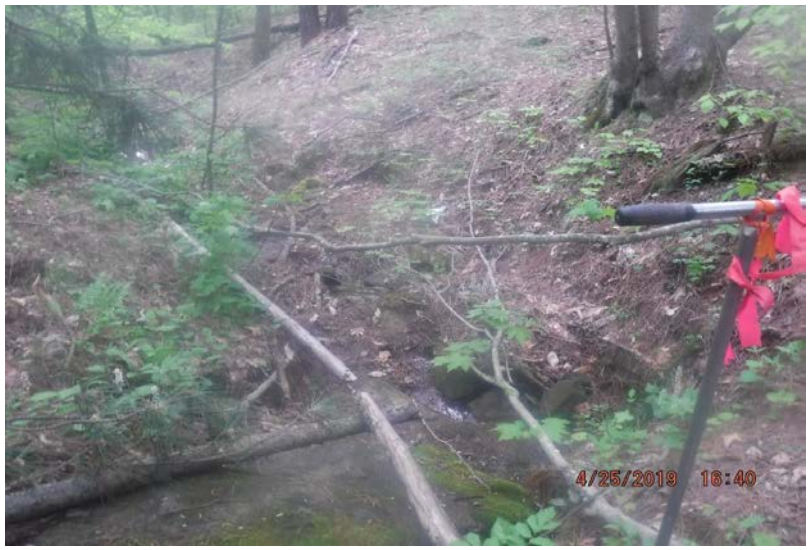
Looking downstream at Stream Reach 149-B. The stream is often incised with vegetative protection on 40-60% of the banks. The left and right riparian buffers consist of mature forest with greater than 60% tree canopy cover. Instream habitat is present in 30-50% of the stream reach. No channel alteration is present within the reach.

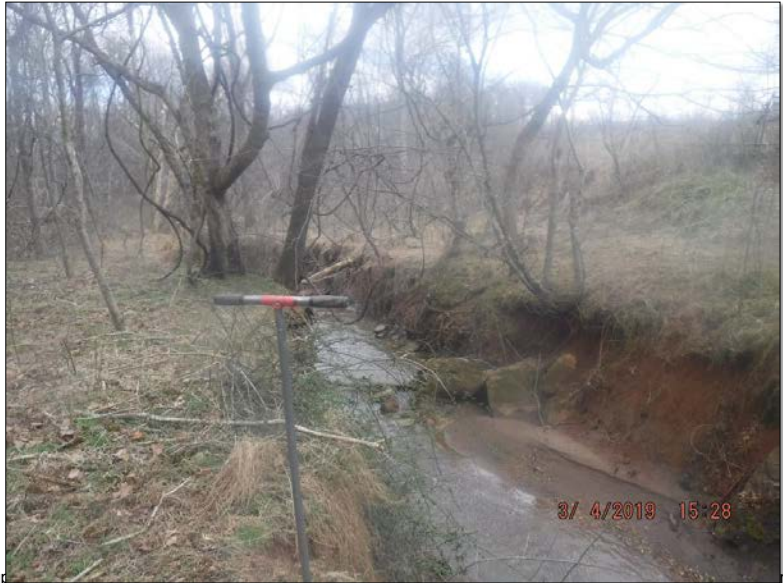
Looking up... buffer consisted of 100% optimal canopy cover. The left riparian buffer consisted of 80% canopy cover and 20% of less dense canopy cover. The instream habitat consisted of riffles, pools, leaf packs and substrate of various particle size. The reach had no channel alterations.

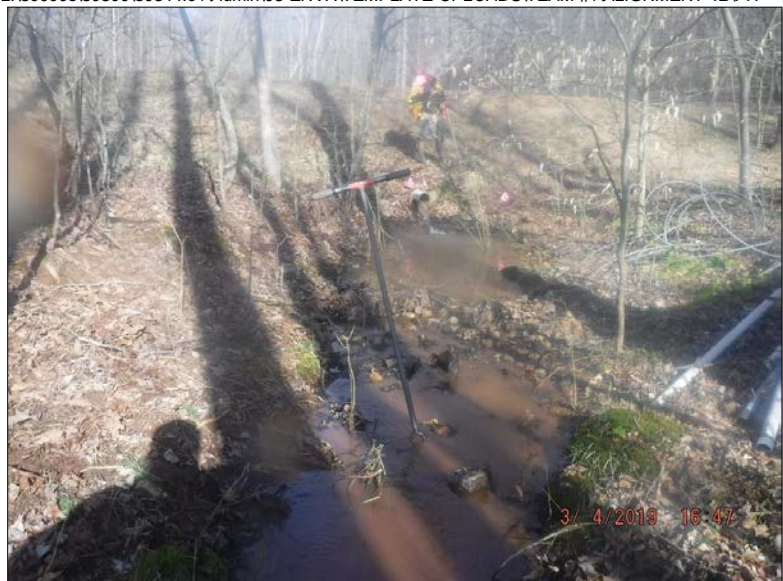
Looking upstream at reach 151-A. The reach was incised with areas of active erosion. The right riparian buffer consisted of 10% optimal canopy cover and 90% suboptimal tree cover. The left riparian buffer consisted of 95% optimal canopy cover and 5% suboptimal suboptimal canopy cover. The instream habitat was marginal throughout the reach due to excess sediment and silt. The reach had minor channel alterations due to a culvert and an impundment created online above this reach.

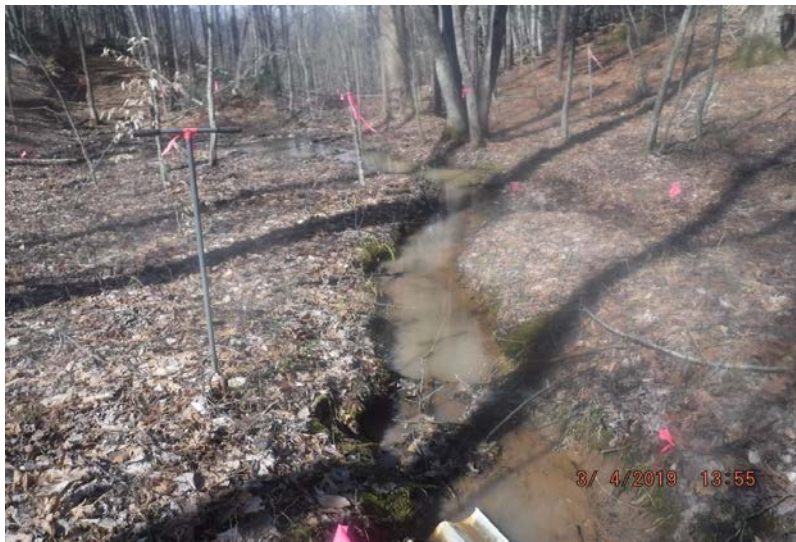
Looking upstream at Stream Reach 151-B. The reach had optimal channel condition. The right and left riparian buffer consisted of 100% optimal canopy cover. The instream habitat throughout the reach consisted of riffles, pools, leaf packs and substrate of various particle size. The reach had no channel alterations.

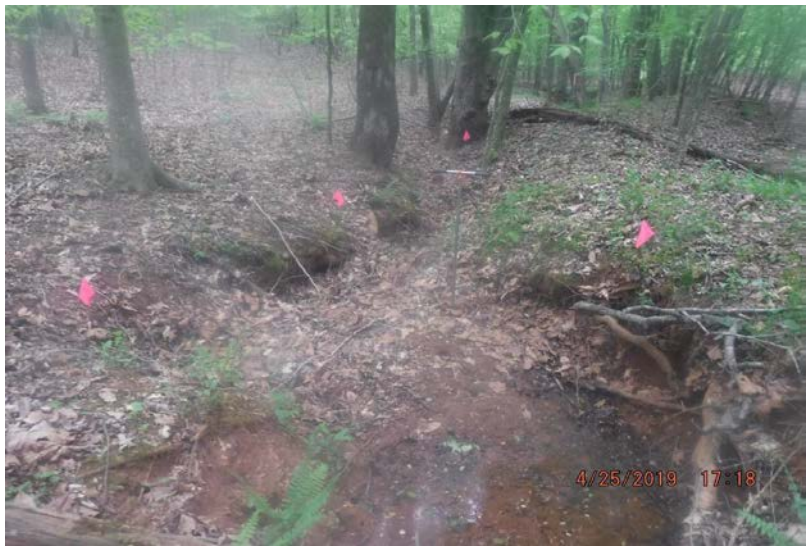
Looking downstream at Stream Reach 151-C. The stream is incised with erosion occurring on both stream banks. The left and right bank riparian buffers consist of mature forest with greater than 60% tree canopy cover. Instream habitat is present in 10-30% of the reach. No channel alteration is present with the stream reach.

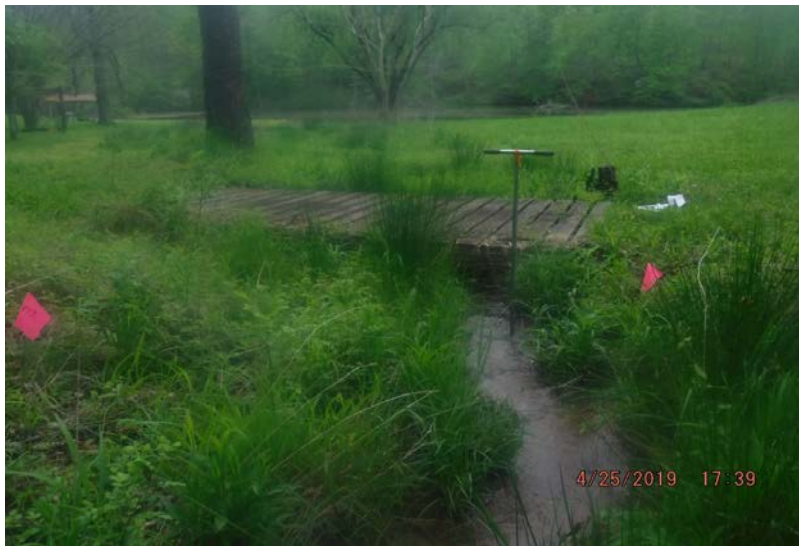
Looking downstream at Stream Reach 151-D. The stream has minimal incision and erosion with 80-100% vegetative surface protection. The left bank riparian buffer consists of a wetland and maintained lawn. The right bank riparian buffer consists of a wetland, maintained lawn, and forest with 30-60% tree canopy cover and maintained understory. Instream habitat is present in in 30-50% of the reach. Channel alteration is present in less than 20% of the reach due to a bridge.

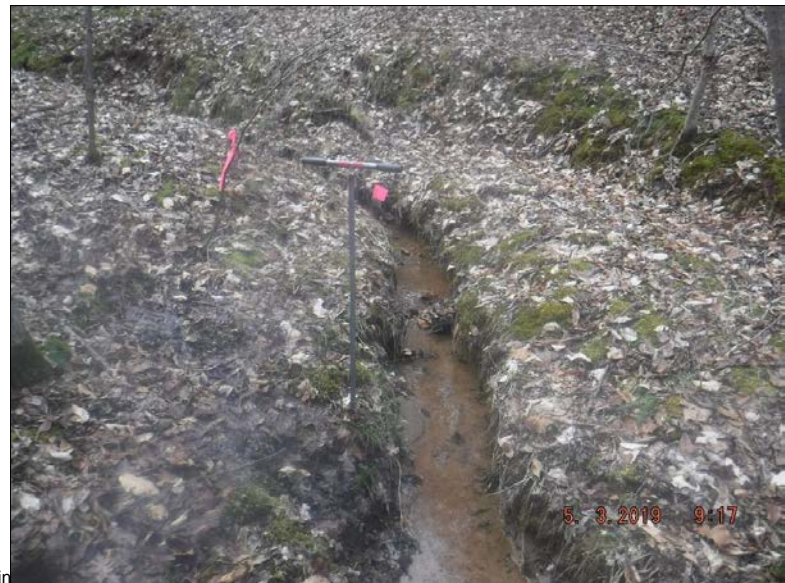
Looking down stream. The stream bed consisted of 100% optimal canopy cover. The instream habitat throughout the reach consisted of leaf packs and substrate of various particle size but lacked riffle and pool complexes. The reach had no channel alterations.

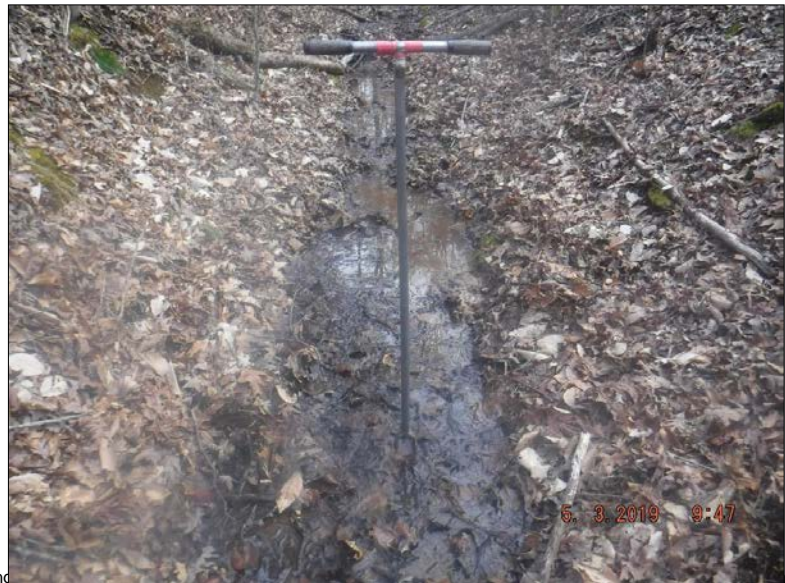
Looking in buffer consisted of 100% optimal canopy cover. The instream habitat throughout the reach consisted of leaf packs but lacked substrate of various particle size and riffle and pool complexes. The reach had no channel alterations.

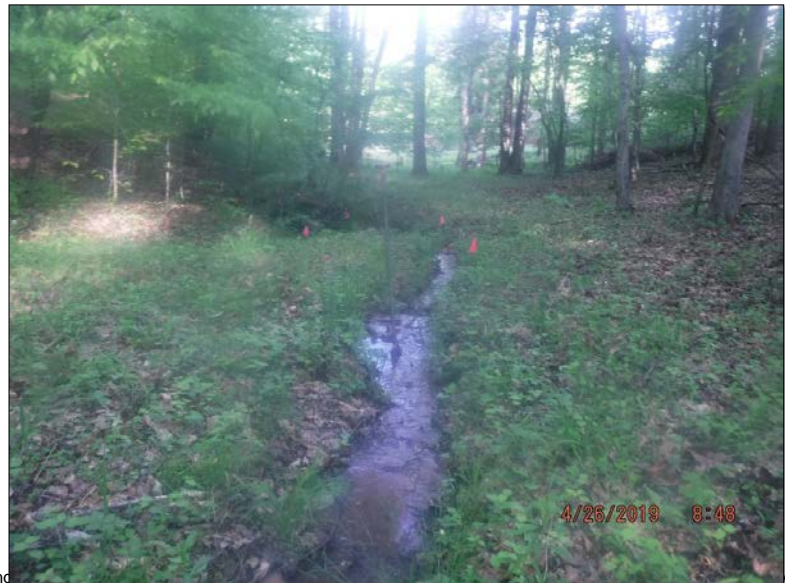
Looking down stream. The left and right bank riparian buffers consist of mature forest with greater than 60% tree canopy cover. Instream habitat is present in 30-50% of the stream. No channel alteration is present in this reach.

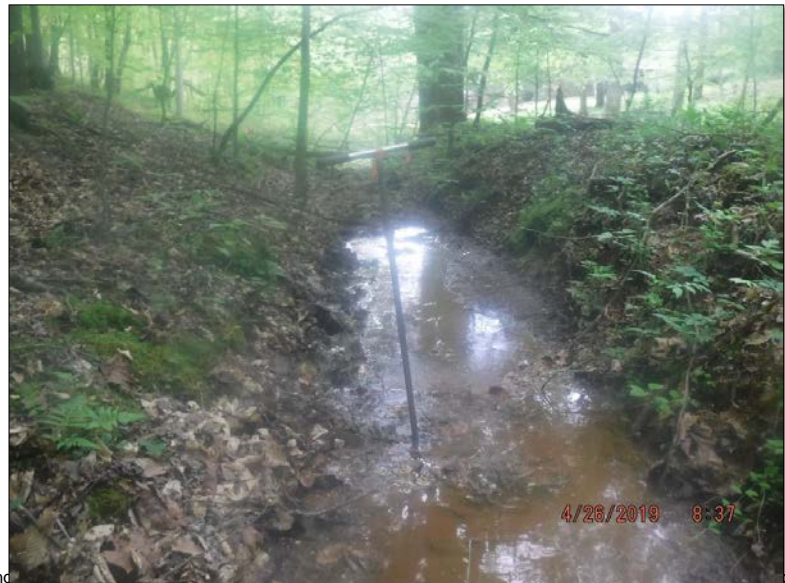
Looking upstream. The left bank riparian buffer consists of mature forest with greater than 60% tree canopy cover. The right bank riparian buffer consists of mature forest with greater than 60% tree canopy cover and portions of mature forest with a maintained understory. Instream habitat is present in 30-50% of the stream. No channel alteration is present in this reach.

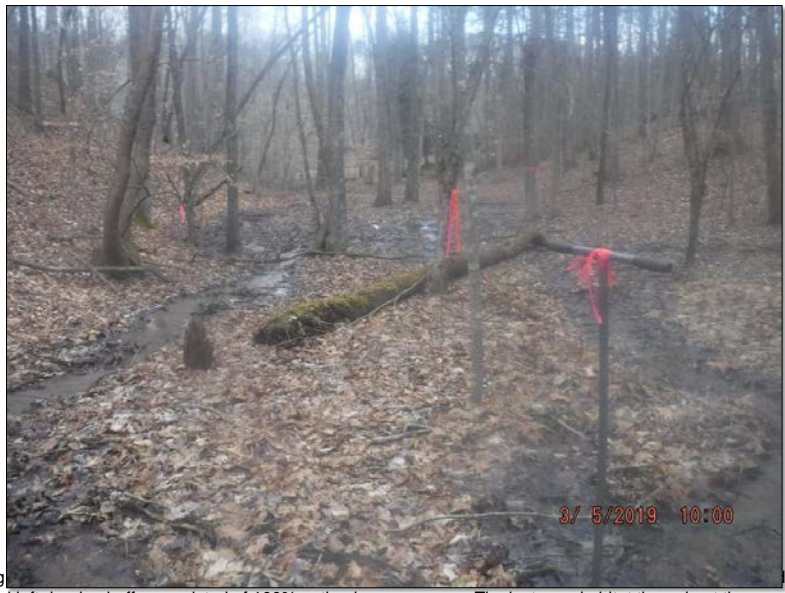
Looking right and left riparian buffer consisted of 100% optimal canopy cover. The instream habitat throughout the reach consisted of leaf packs but lacked substrate of various particle size and riffle and pool complexes. The reach had concrete blocks and metal in streambed.

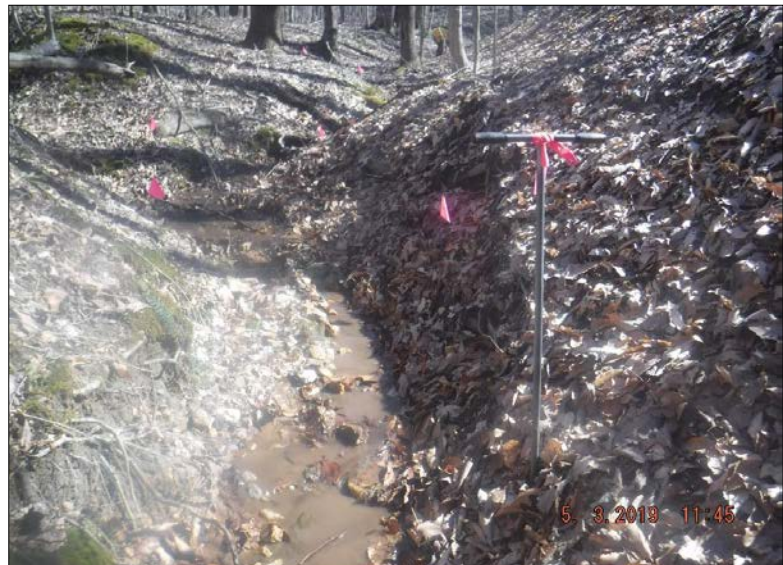
Looking up stream in buffer consisted of 100% optimal canopy cover. The instream habitat throughout the reach consisted of leaf packs and substrate of various particle size but lacked riffle and pool complexes. The reach had no channel alterations.

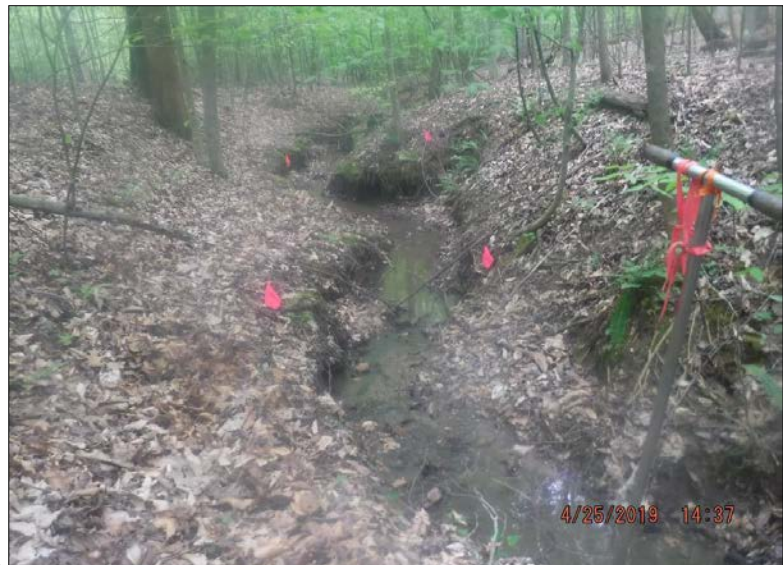
Looking down the stream. The left and right bank riparian buffers consist of mature forests with greater than 60% tree canopy cover. Instream habitat is present in greater than 60% of the reach. No channel alteration is present within this reach.

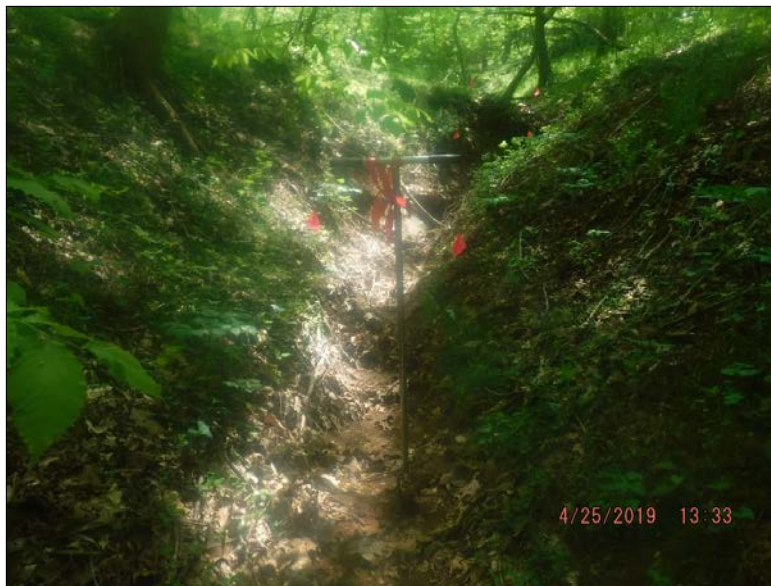
forests with greater than 60% tree canopy cover.

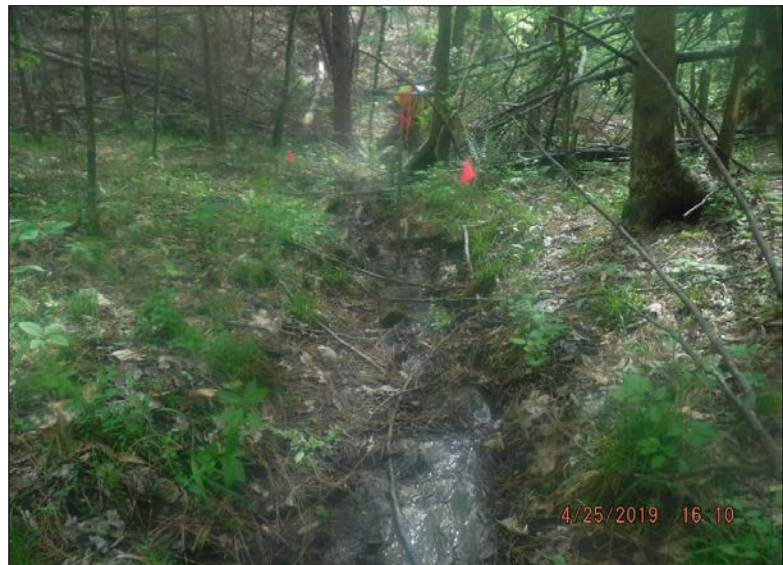
Looking down stream. The left and right bank riparian buffers consist of mature forests with greater than 60% tree canopy cover. Instream habitat is present in 30-50% of the reach. No channel alteration is present within this reach.

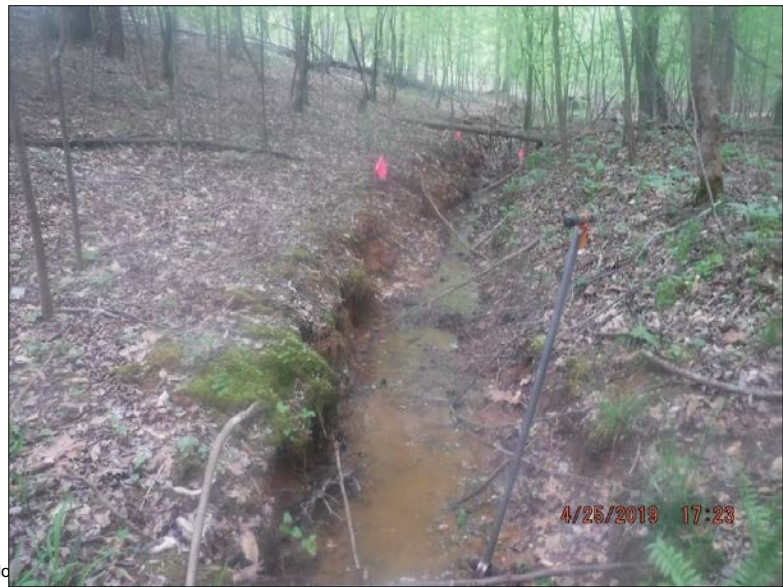
Looking down stream from right bank. riparian buffers consist of mature forests with greater than 60% tree canopy cover. Instream habitat is present in 30-50% of the reach. No channel alteration is present within this reach.

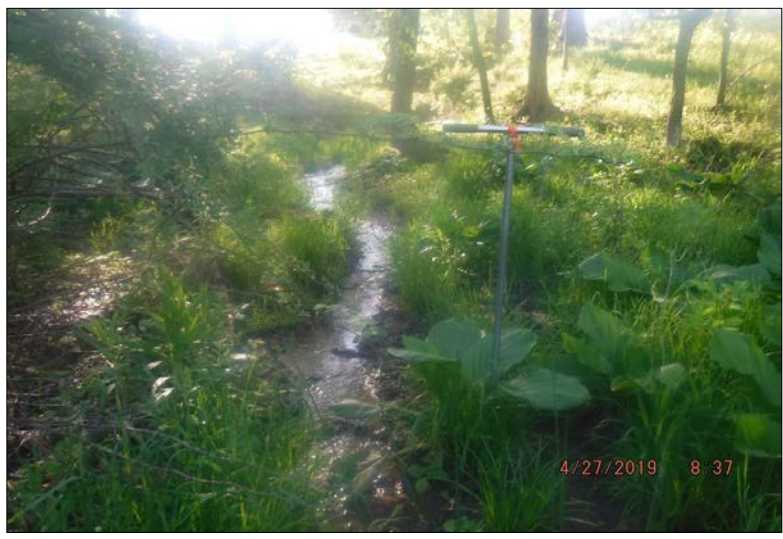
Looking downstream at Stream Reach 158-A. The stream has slight incision with 60-80% vegetative surface protection on the banks. The left and right bank riparian buffers consist of wetlands and mature forest with greater than 60% tree canopy cover. Instream habitat is present in 30-50% of the stream. Channel alteration is not present in the reach.
